**AIRCRAFT SERIOUS INCIDENT REPORT AND EXECUTIVE SUMMARY**

<b>Reference:</b>		CA18/3/2/1367	
<b>Aircraft Registration</b>	ZS-ALJ, ZS-CMG	<b>Date of Incident</b>	23 August 2021		<b>Time of Incident</b> 0545Z
<b>Type of Aircraft</b>	Embraer EMB-135KL, Bombardier CL-600-2B19		<b>Type of Operation</b>		Air Transport Operations (Part 121)
<b>Pilot-in-command Licence Types</b>	Airline Transport Pilot Licence (Both Pilots)		<b>Ages</b>	30; 65	<b>Licences Valid</b> Yes
<b>Pilot-in-command Flying Experience</b>	<b>Total Flying Hours</b>		4 815.0; 17 884.7	<b>Hours on Type</b>	2 262.0; 7 259.6
<b>Last Point of Departure</b>	Cape Town International Aerodrome (FACT), Western Cape (ZS-ALJ) George Aerodrome (FAGG), Western Cape (ZS-CMG)				
<b>Next Point of Intended Landing</b>	George Aerodrome (FAGG), Western Cape (ZS-ALJ) O.R. Tambo International Aerodrome (FAOR), Gauteng (ZS-CMG)				
<b>Damage to Aircraft</b>	Neither of the aircraft sustained damage				
<b>Location of the incident site with reference to easily defined geographical points (GPS readings if possible)</b>

## Occurrence Details

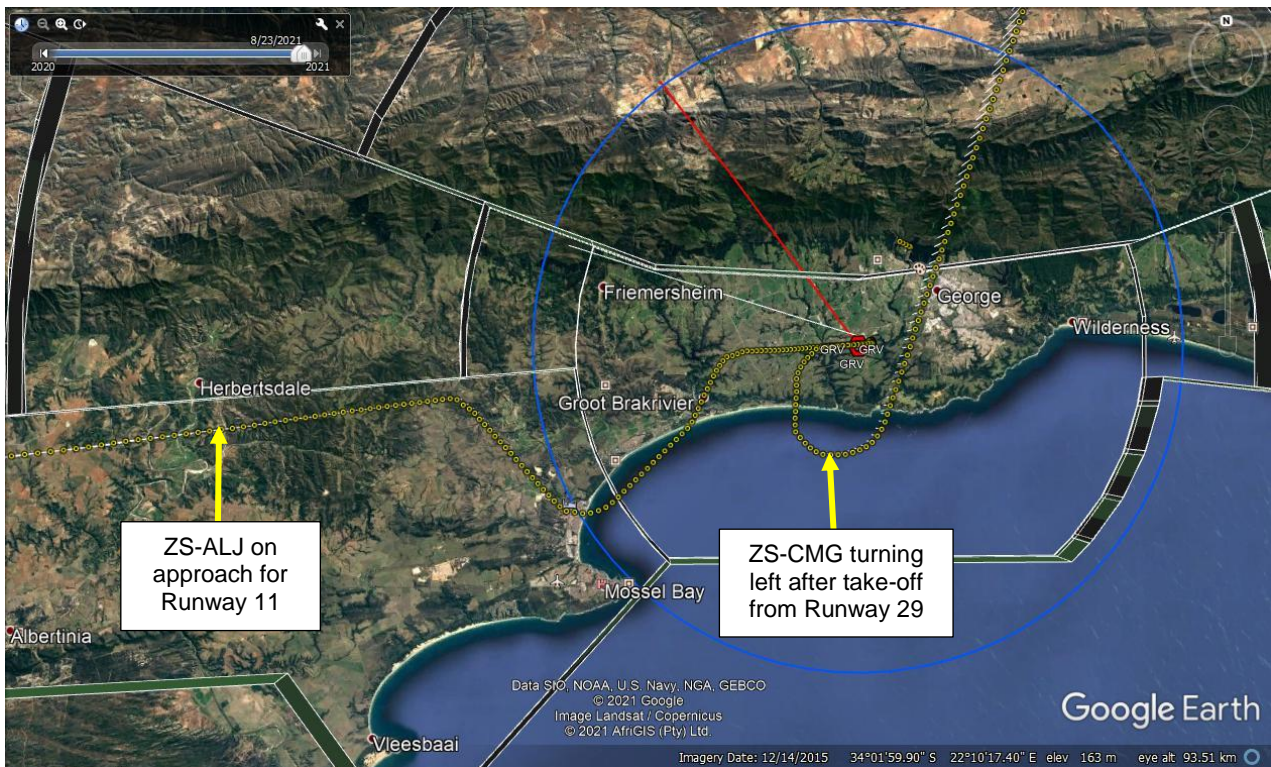
**Figure 3:** The radar tracks flown by ZS-ALJ and ZS-CMG, respectively. (Source: Google Earth)

- 1.1.10 Figure 3 shows the ZS-ALJ aircraft flying a straight-in approach for landing Runway 11 whilst under radar control. The aircraft was then instructed to turn right on a heading of 165° which was towards the town of Mossel Bay. At 05:49:23Z, the aircraft commenced with a left turn for visual approach Runway 11. The radar track flown by ZS-CMG displayed the left turn out after take-off from Runway 29, routing over the sea as broadcasted by the PIC.

- 1.1.2 On the same morning, a Bombardier CL-600-2B19 aircraft with registration ZS-CMG, flight number KEM125, was on a scheduled flight from FAGG to FAOR in Gauteng province. On-board the aircraft were three crew members and 38 passengers. The aircraft was scheduled for departure at FAGG at 0545Z. Both aircraft were tracked on the secondary surveillance radar (SSR) (see Figure 3).

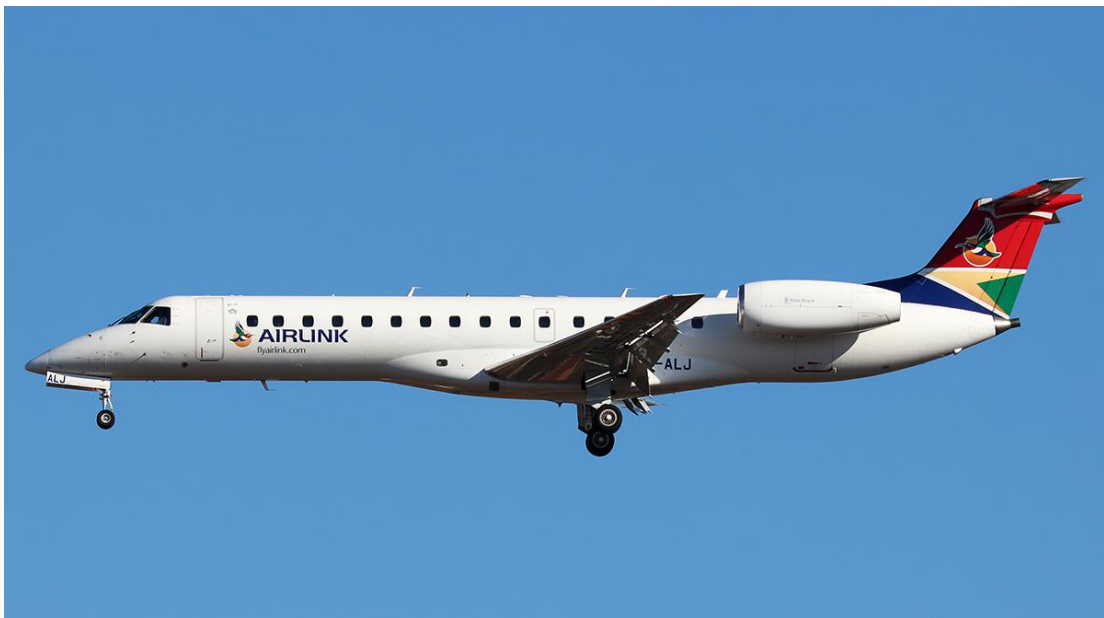
**Figure 4:** Embraer EMB-135KL, ZS-ALJ. (Source: [www.airliners.net](http://www.airliners.net))

The Embraer ERJ 145 family is a series of regional jets produced by Embraer, a Brazilian aerospace company. Family members include the ERJ 135 (37 passengers), ERJ 140 (44 passengers) and ERJ 145 (50 passengers). The aircraft is powered by two Rolls Royce AE3007 series engines with a low-wing configuration.

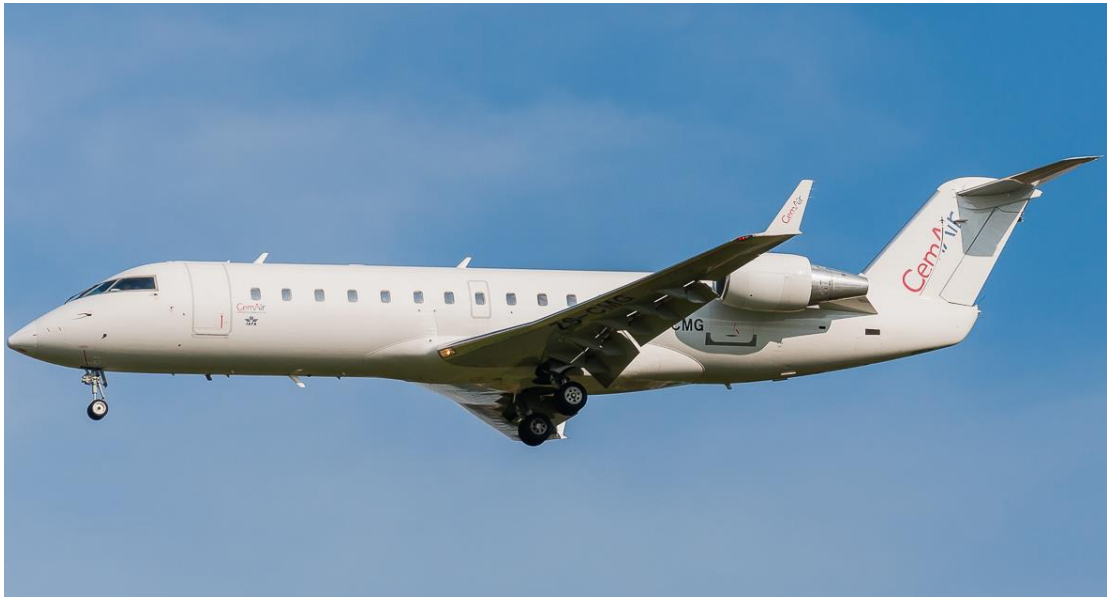
**Figure 5:** Bombardier CL-600-2B19, ZS-CMG. (Source: [www.airliners.net](http://www.airliners.net))

The Bombardier CL-600 series is a low-wing jet powered by two General Electric CF34s turbofan engines mounted in aft fuselage pods. The engines are fitted with thrust reversers to decrease the landing distances. The aircraft was type certified on 10 August 1980 by Transport Canada.

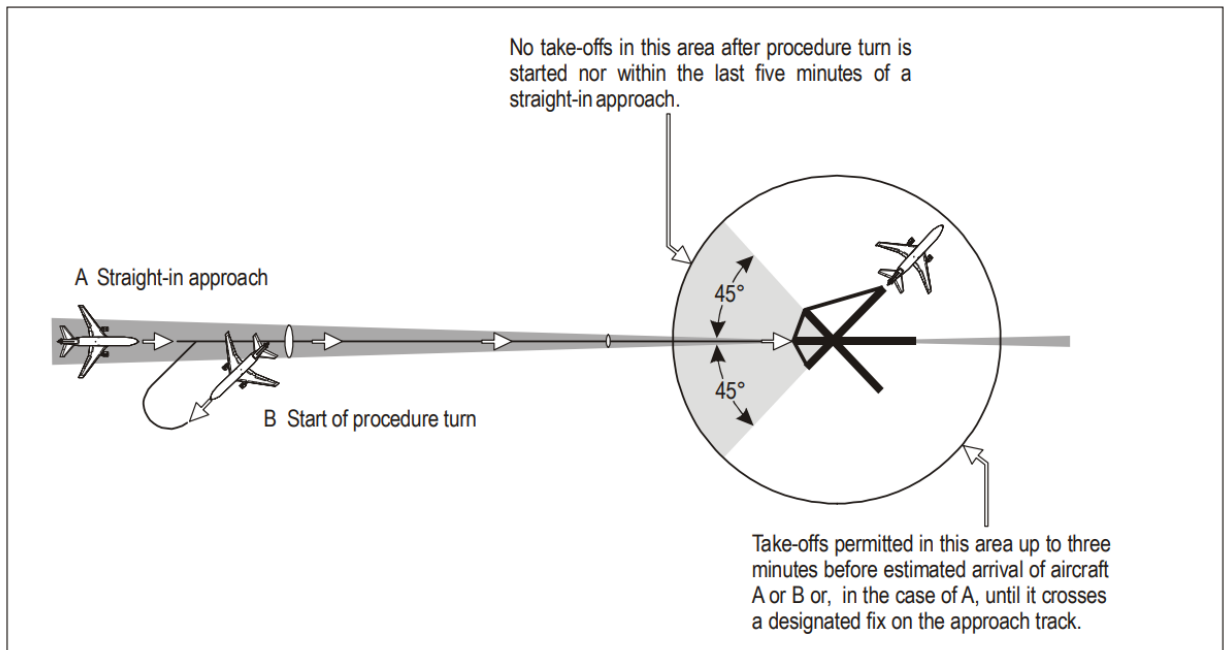
**Illustration 1:** Separation of departing aircraft from arriving aircraft. (Source: ICAO Doc 4444)

*5.7.1.1 If an arriving aircraft is making a complete instrument approach, a departing aircraft may take off:*

- a) in any direction until an arriving aircraft has started its procedure turn or base turn leading to final approach;*
- b) in a direction which is different by at least 45 degrees from the reciprocal of the direction of approach after the arriving aircraft has started procedure turn or base turn leading to final approach, provided that the take-off will be made at least 3 minutes before the arriving aircraft is estimated to be over the beginning of the instrument runway (see Figure 6).*

*5.7.1.2 If an arriving aircraft is making a straight-in approach, a departing aircraft may take off:*

- a) in any direction until 5 minutes before the arriving aircraft is estimated to be over the instrument runway;*
- b) in a direction which is different by at least 45 degrees from the reciprocal of the direction of approach of the arriving aircraft:*

*1) until 3 minutes before the arriving aircraft is estimated to be over the beginning of the instrument runway (see Figure 6); or*
