## LIMITED OCCURRENCE INVESTIGATION REPORT – FINAL

<b>Reference Number</b>	CA18/3/2/1494						
<b>Classification</b>	Serious Incident	<b>Date</b>	10 August 2025		<b>Time</b>	0832Z	
<b>Type of Operation</b>	Private (Part 91)						
<b>Location</b>							
Place of Departure	Wonderboom Aerodrome (FAWB), Gauteng Province		Place of Intended Landing	Malelane Aerodrome (FAMN), Mpumalanga Province			
Place of Occurrence	Runway 27 at Malelane Aerodrome (FAMN), Mpumalanga Province						
GPS Co-ordinates	Latitude	25°28'19.74" S	Longitude	031°34'14.72" E	Elevation	1 155 feet	
<b>Aircraft Information</b>							
Registration	ZS-APS						
Make; Model; S/N	Pilatus PC12/47 (Serial Number: 771)						
Damage to Aircraft	None		Total Aircraft Hours	3 521.0			
<b>Pilot-in-command</b>							
Licence Type	Commercial Pilot Licence		Gender	Male		Age	64
Licence Valid	Yes	Total Hours	16306		Total Hours on Type	902	
Total Hours Past 30 Days	25.6		Total Hours on Type Past 90 Days	72

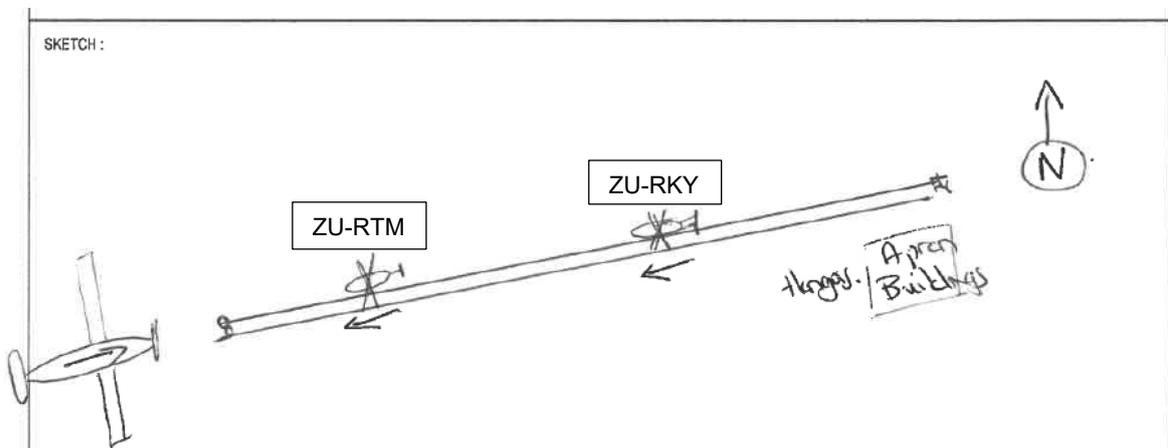
<b>People On-board</b>	3 + 7	<b>Injuries</b>	0	<b>Fatalities</b>	0	<b>Other (on ground)</b>	0
<b>What Happened</b>							
<p>On Sunday morning, 10 August 2025, two pilots on-board their respective Calidus gyrocopters with registrations ZU-RTM and ZU-RKY took off from Runway 27 at Malelane Aerodrome (FAMN) in Mpumalanga province to Kitty Hawk Aerodrome (FAKT) in Gauteng province. The flights were conducted under visual meteorological conditions (VMC) by day and under the provisions of Part 94 of the Civil Aviation Regulations (CAR) 2011 as amended.</p> <p>Meanwhile, another aircraft, a Pilatus PC12/47 with registration ZS-APS had taken off at 0745Z on a planned instrument flight from Wonderboom Aerodrome (FAWB) in Gauteng province; routing directly to FAMN after having requested flight level (FL) 190 (19 000 feet). There were three crew members and seven passengers on-board the aircraft.</p> <p>The lead pilot on-board ZU-RTM broadcasted her intentions on the Malelane Special Rules Area (SRA) frequency 129.35-Megahertz (MHz) and, thereafter, took off. As she rotated, she spotted an aircraft (ZS-APS) on short final approach for Runway 09, which conflicted with Runway 27. She immediately alerted the pilot on-board ZU-RKY to take an evasive action to prevent a midair collision. Therefore, both pilots on-board the gyrocopters took evasive actions as the ZS-APS aircraft remained at low level and maintained the runway heading. The ZS-APS then positioned for a left</p>

downwind and continued to land on Runway 09. The ZU-RTM pilot made several attempts to communicate with the ZS-APS crew. The ZS-APS crew neither broadcasted their intentions on the allocated radio frequency when inbound for FAMN, nor did they follow the unmanned aerodrome joining procedure. Instead, they opted for a straight-in approach for Runway 09.

**Figure 1:** A sketch of the two gyrocopters taking off and the ZS-APS aircraft approaching to land.  
(Source: ZU-RTM pilot)

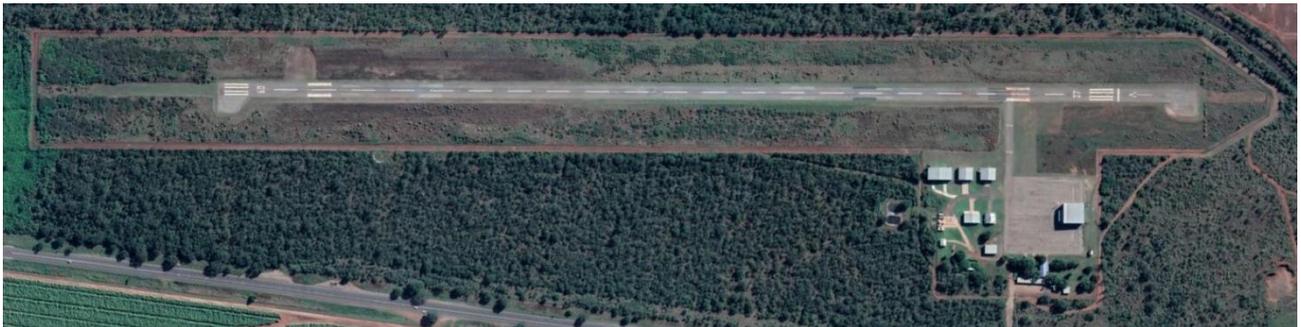
FAMN is a licensed, unmanned aerodrome with a single asphalt runway oriented 09/27. The runway is 1 248 metres (m) long and 18m wide with an elevation of 1 155 ft above mean sea level (AMSL).

**Figure 2:** Overview of FAMN. (Source: Google Earth)

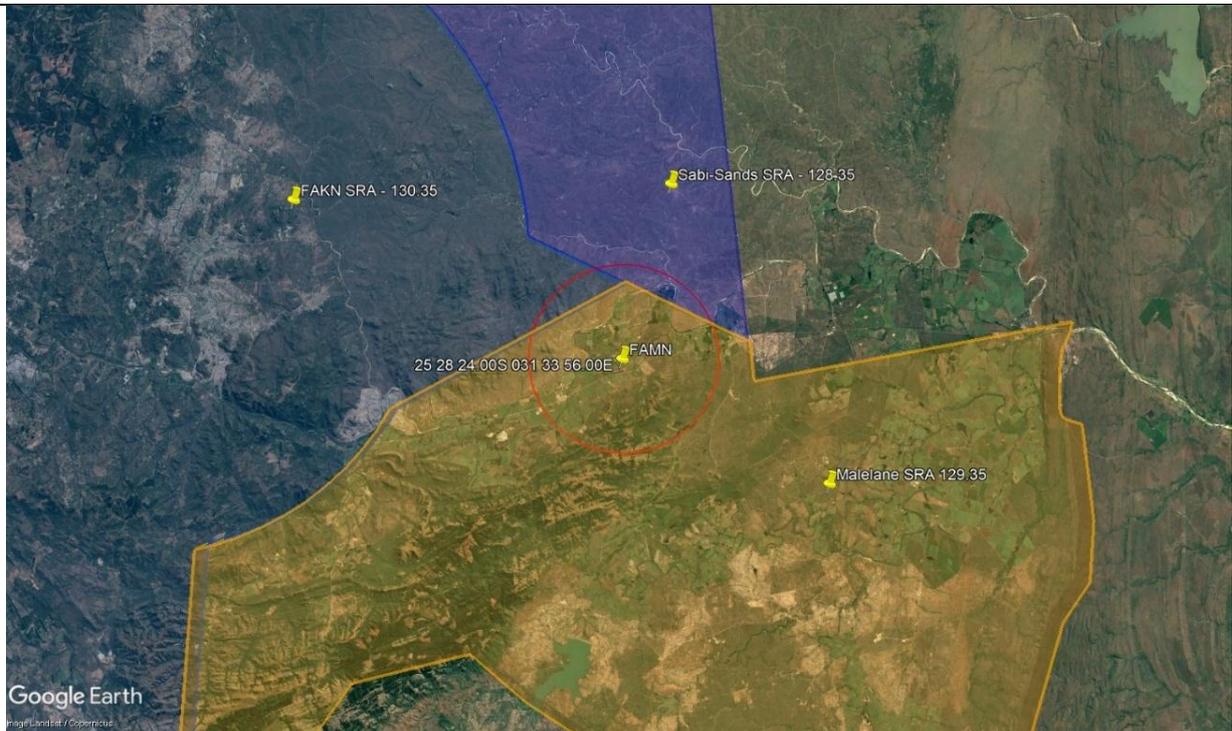
*A portion of the airspace below the Kruger Mpumalanga Terminal Control Area (TMA) F extending eastwards towards the South African and Mozambique International Boundary and southwards along the Matsapha TMA boundary is declared as a Special Rules Area and will be known as the Malelane SRA.*

**Vertical limits:** GND – FL105

**Frequency:** 129.35-MHz

**Figure 3:** Overview indicating Malelane Special Rules Area and FAMN. (Source: Google Earth)

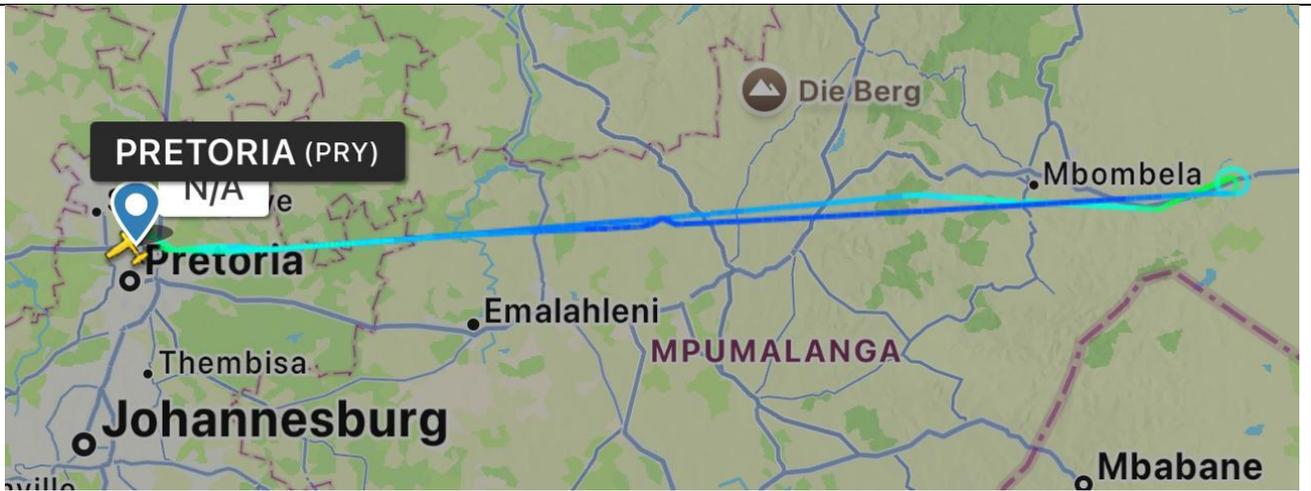
Based on the ZS-APS radar track, the crew departed from FAWB Runway 29 and flew to FAMN (in a straight line). They approached FAMN from the west for a straight-in landing on Runway 09. Only after the pilot of ZU-RTM had broadcasted on the radio that they were in conflict with their take-off direction did the crew abort the approach and flew a circuit, positioning the aircraft on a left downwind for Runway 09.

The inbound flight to FAMN is indicated by the blue line, which changes to light blue and then green as the aircraft approaches FAMN (see Figure 4). Based on the radar track flown by ZS-APS, the aircraft entered the Malelane SRA 13nm west of the aerodrome, but only realised the frequency was muted when they were about to land on Runway 09.

**Figure 4:** The radar track of the inbound and outbound flight of ZS-APS into FAMN.  
 (Source: FlightRadar24.com)

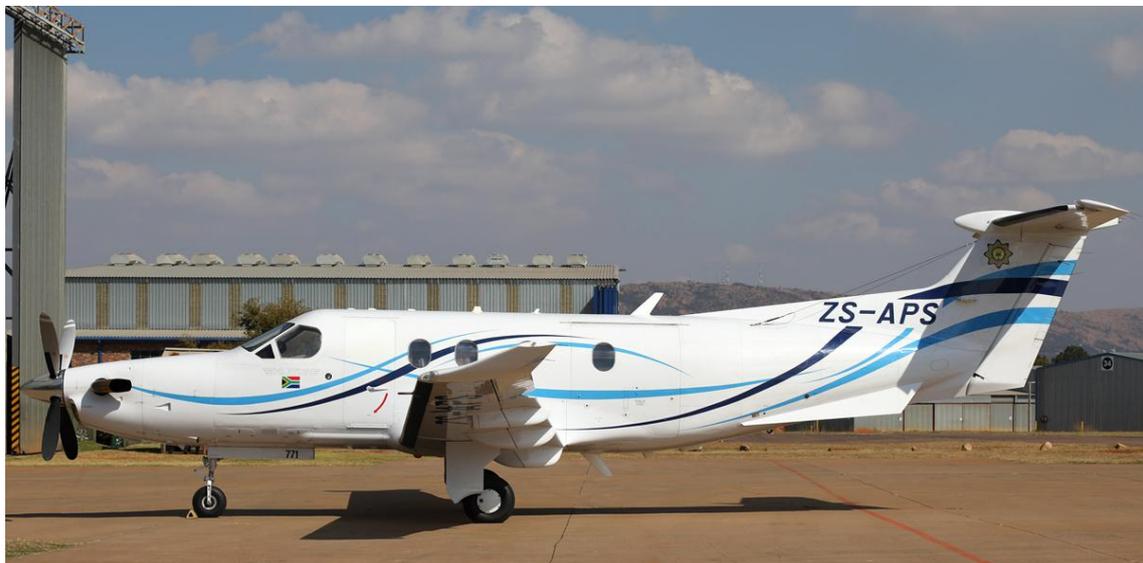
**Figure 5:** The file picture of the ZS-APS aircraft. (Source: [www.jetphotos.com](http://www.jetphotos.com))

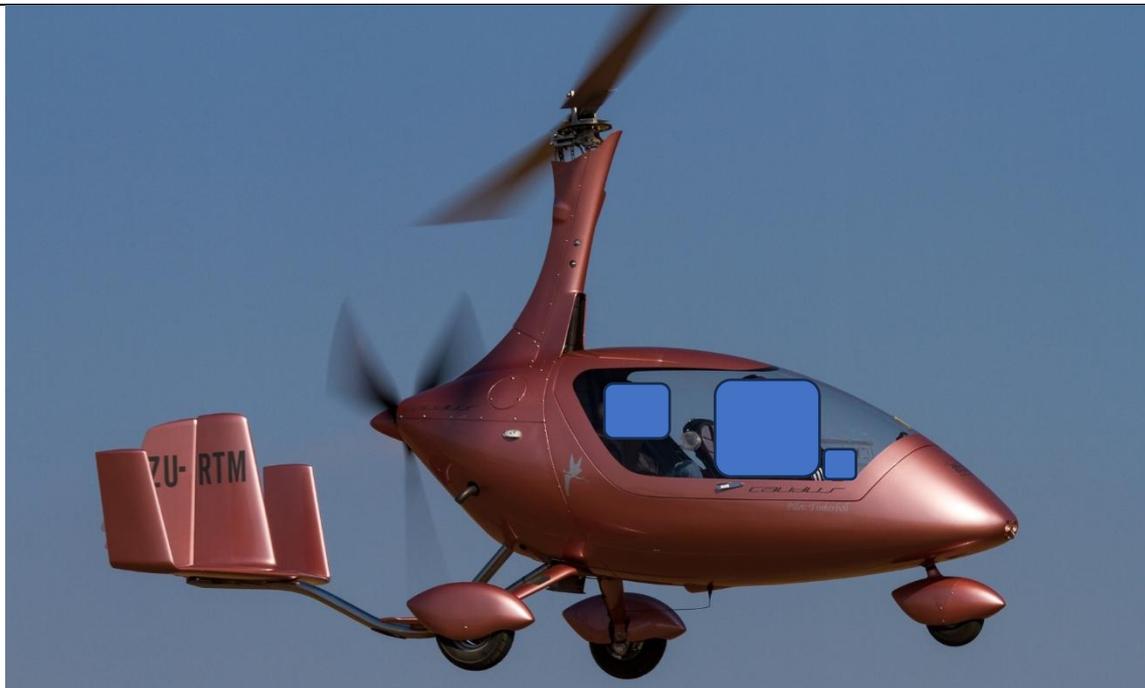
**Figure 6:** The file picture of the ZU-RTM gyrocopter. (Source: Owner/pilot)

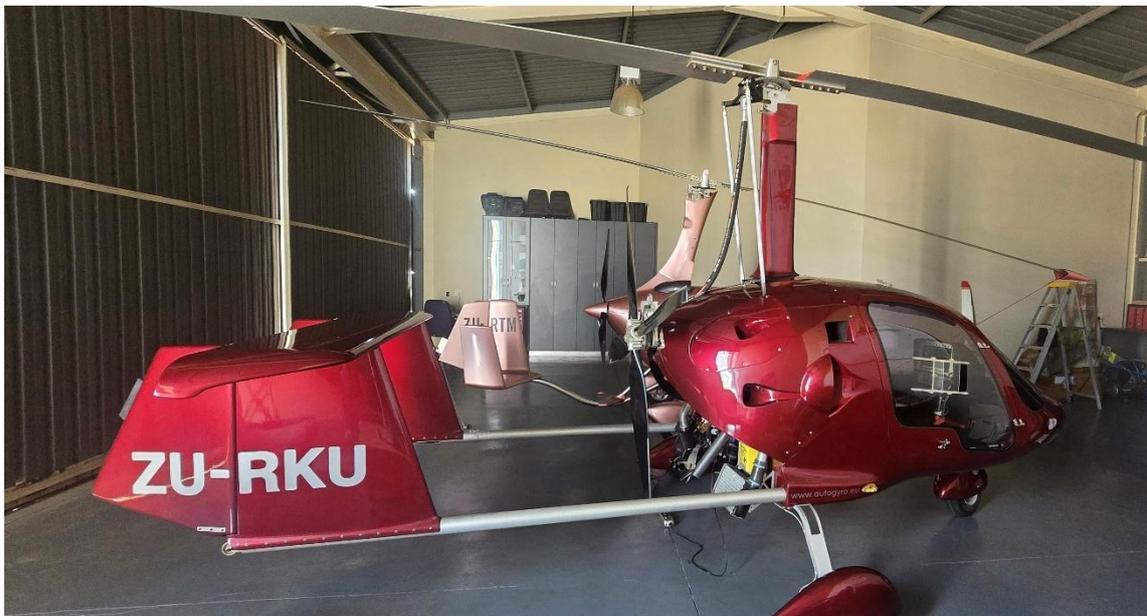
**Figure 7:** The file picture of the ZU-RKU gyrocopter. (Source: Owner)
