PRELIMINARY AIRCRAFT ACCIDENT REPORT

Paraglider Accident
- Preliminary Report -
AIID Ref No: CA18/2/3/10620

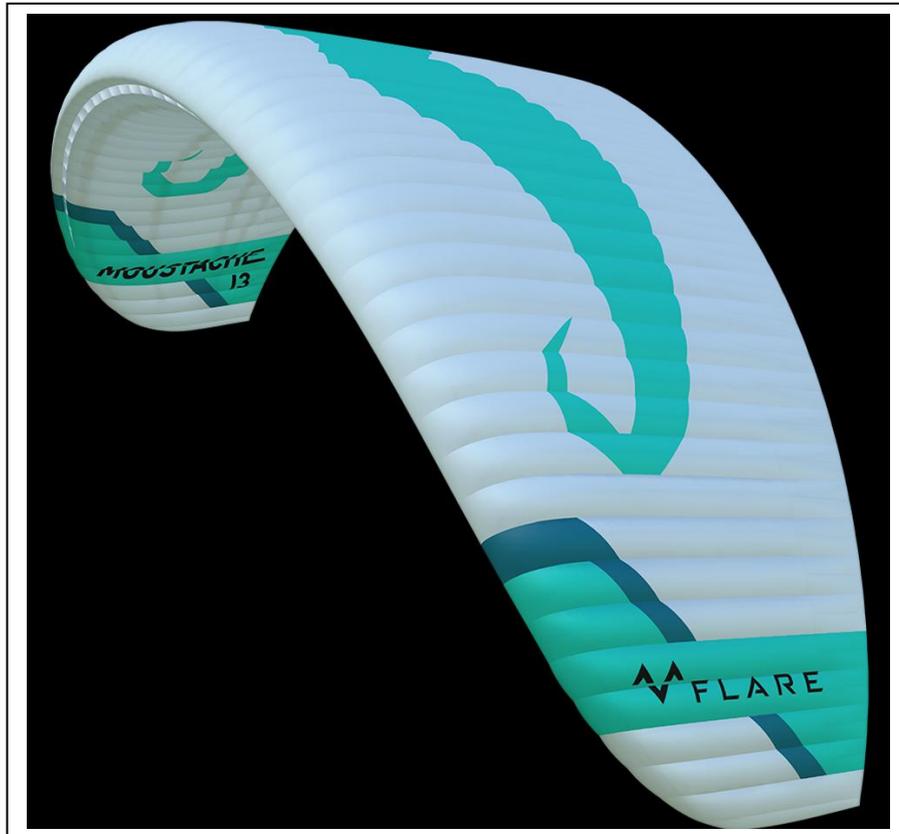
Figure 1: A file picture of an inflated Moustache 13 paraglider. (Source: go-flare.com)

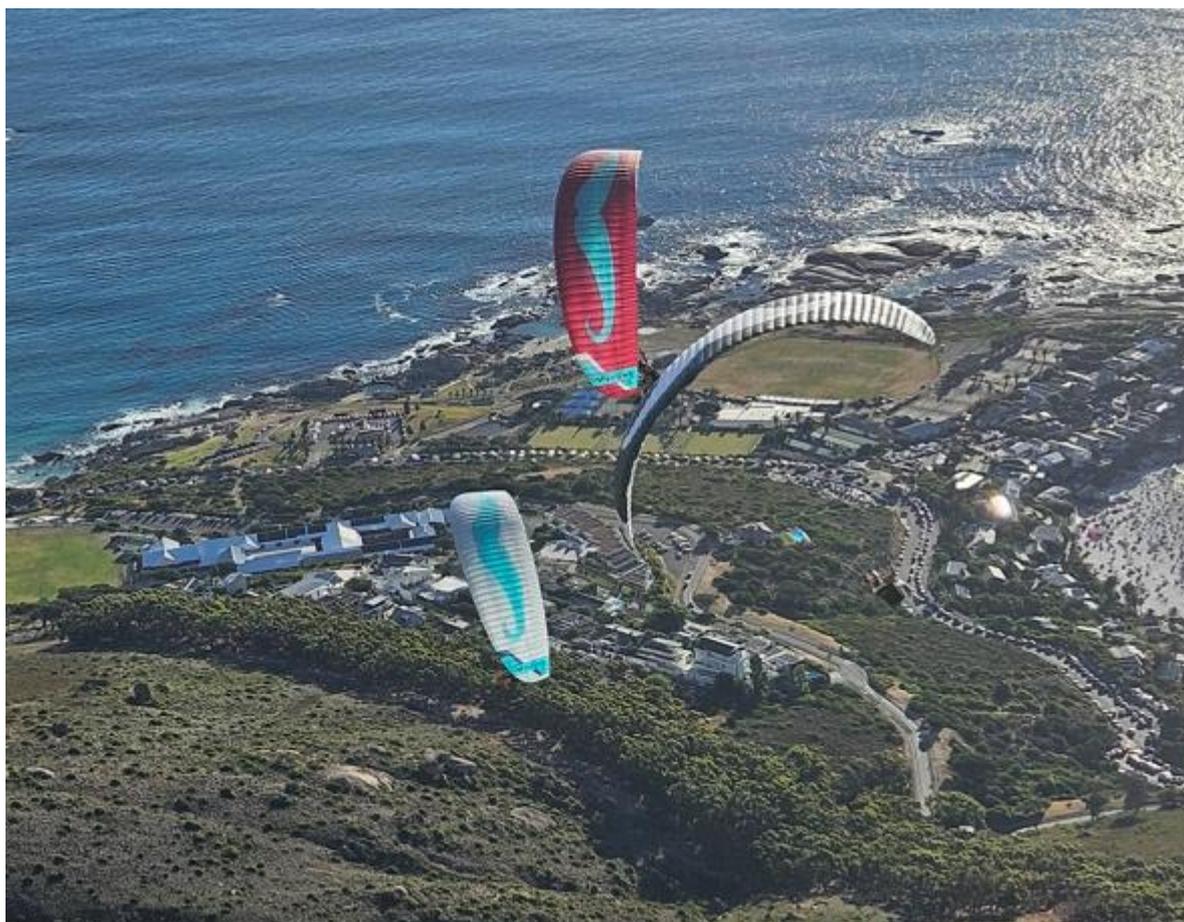
- 1.1.2. Details about the preparation and departure of the subject paraglider are not known; however, a closed-circuit television (CCTV) camera footage was made available to the investigators. The footage showed three paragliders flying in a loose formation after launch. *Figure 2 depicts the turquoise (blue-green) and white Moustache 13, which was the accident paraglider, as well as the other two paragliders after the launch.* Figure 2 image was taken at 1615Z, about 32 minutes before the accident paraglider was located at the accident site.

Figure 2: A still image of the three paragliders before the accident. (Source: SAHPA)

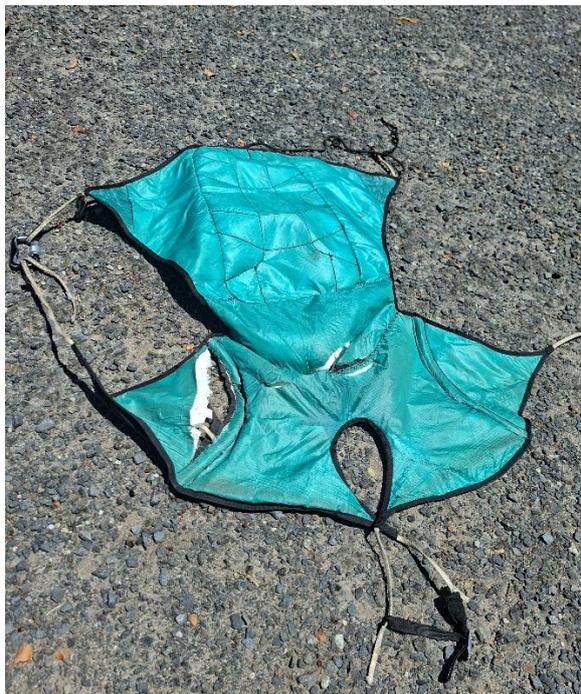
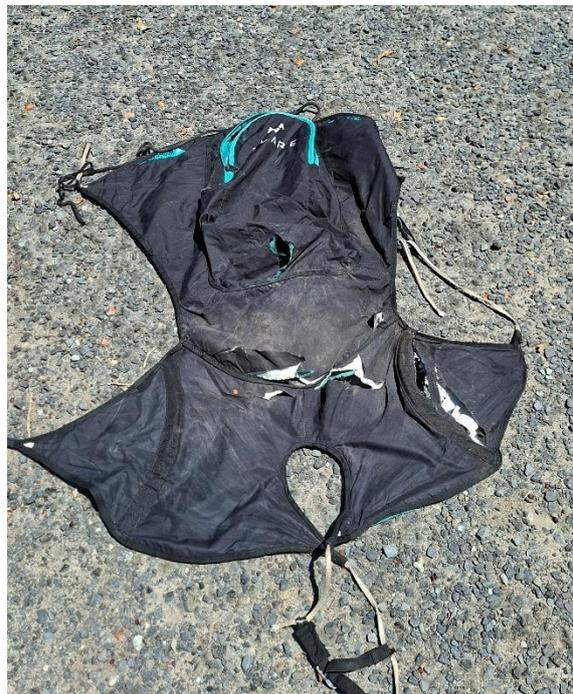
Figures 3 and 4: The teared harness (blue-green on the inside and black on the outside).

1.3.1. The harness had tearing on the lower region of the right-hand side.

- 2.2.6. Some of the harness straps sustained damage during the accident sequence; those that remained intact were cut by the first responders when they freed the pilot to offer medical assistance. The paraglider (structure) and the control lines were not damaged.

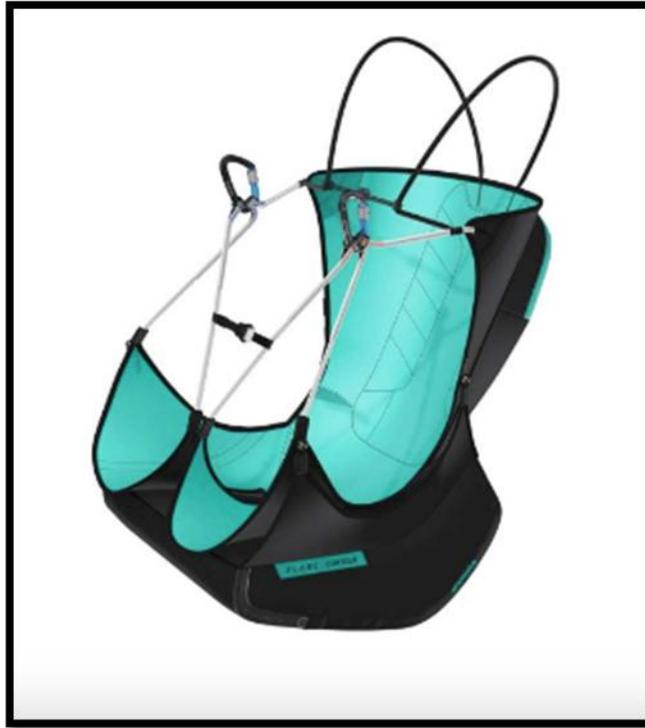
Figure 5: A harness similar to that worn by the pilot. (Source: <https://go-flare.com>)

The Contour eliminates bulky buckles and adjustment straps. The elastic shoulder straps adapt to your size, ensure an optimal fit during the launch phase, and rest comfortably on your shoulders in the air. Red and blue marked seams in the loops improve the overview while small Salewa sling protectors prevent the carabiners from twisting in the straps. In-flight, insulation foam in the complete seat and elastic curved and comfortable tubes on the left and right side of your legs ensure an extremely comfortable fit and counteract the cold.

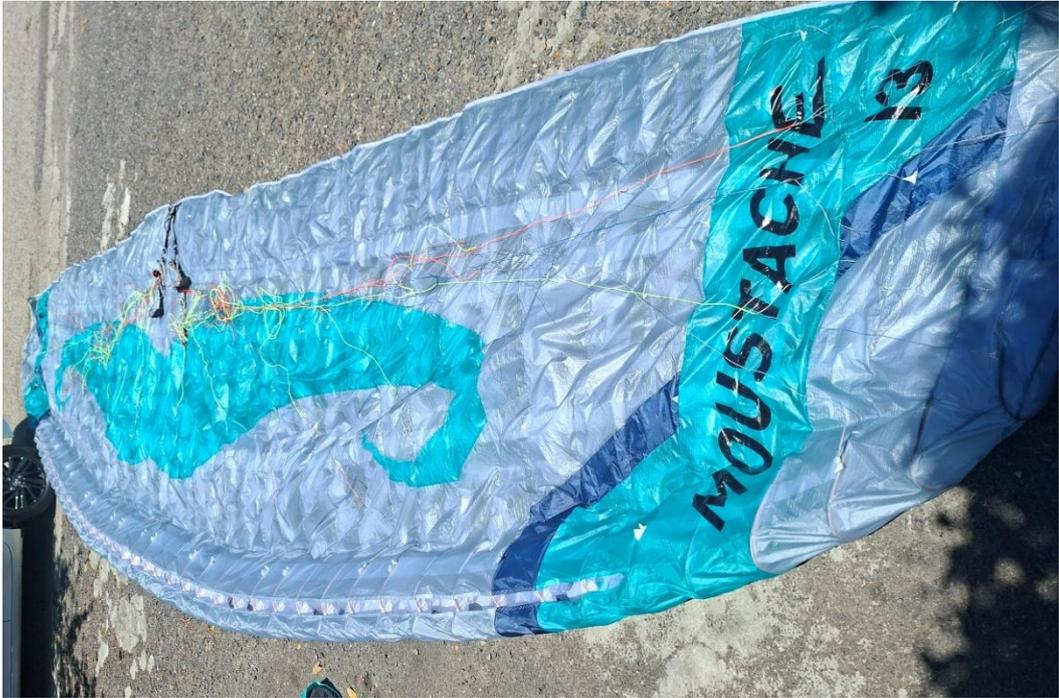
1.11.2. The paraglider impacted the ground near a hiking trail. Two hikers reported that they heard a sound that was made by the paraglider as it scraped against the mountain surface and saw it when it impacted the ground; they went to the accident site to assist the pilot. The paraglider (structure) and the control lines were not damaged during the accident sequence. Some of the harness straps were damaged during the accident sequence. The harness straps that were still intact were cut by the first responders when they arrived at the scene to assist the pilot. The helmet had remained secured to the pilot's head; it sustained minor damage. It was believed that the pilot had an Insta360 camera attached to his helmet; however, it was missing from the accident site.

Figure 6: The paraglider (structure) sustained minor damage.

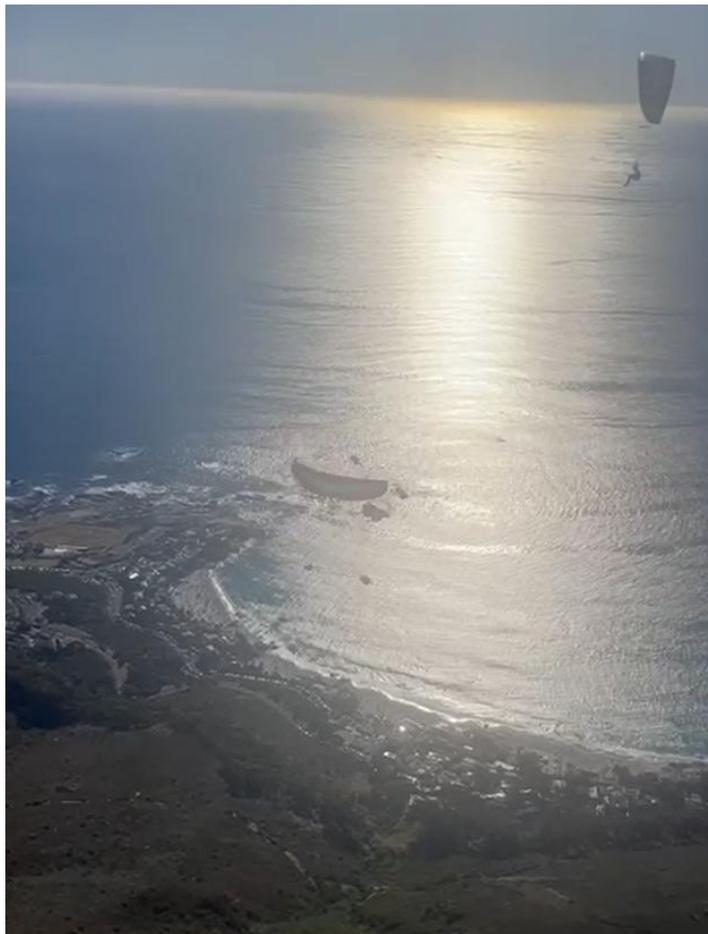
1.11.1. The CCTV footage showed the pilot and two other colleagues flying their paragliders near the mountain; *the duration of the footage is 1 minute and 42 seconds*. Towards the end of the footage, the subject paraglider entered what could be described as a barrel roll in a clockwise direction before the recording ended as the paraglider disappeared below the rocks.

Figure 7: A still image from the CCTV footage which shows the paraglider in a barrel roll.
(Source: SAHPA)

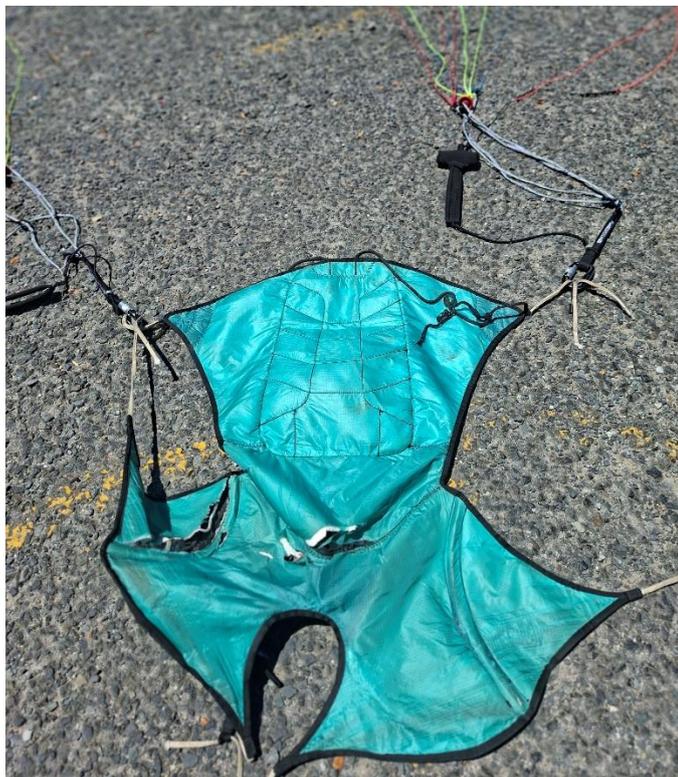
Figure 8: Damage on the harness straps.

- 2.2.7. The paraglider and the harness straps were sent for tests; the results will be discussed in the final report.
- 2.2.8. The paramedics took approximately 1 hour and 15 minutes to reach the accident site.
