PRELIMINARY SERIOUS INCIDENT REPORT

Serious Incident
- Preliminary Report -
AIID Ref No: CA18/3/2/1434

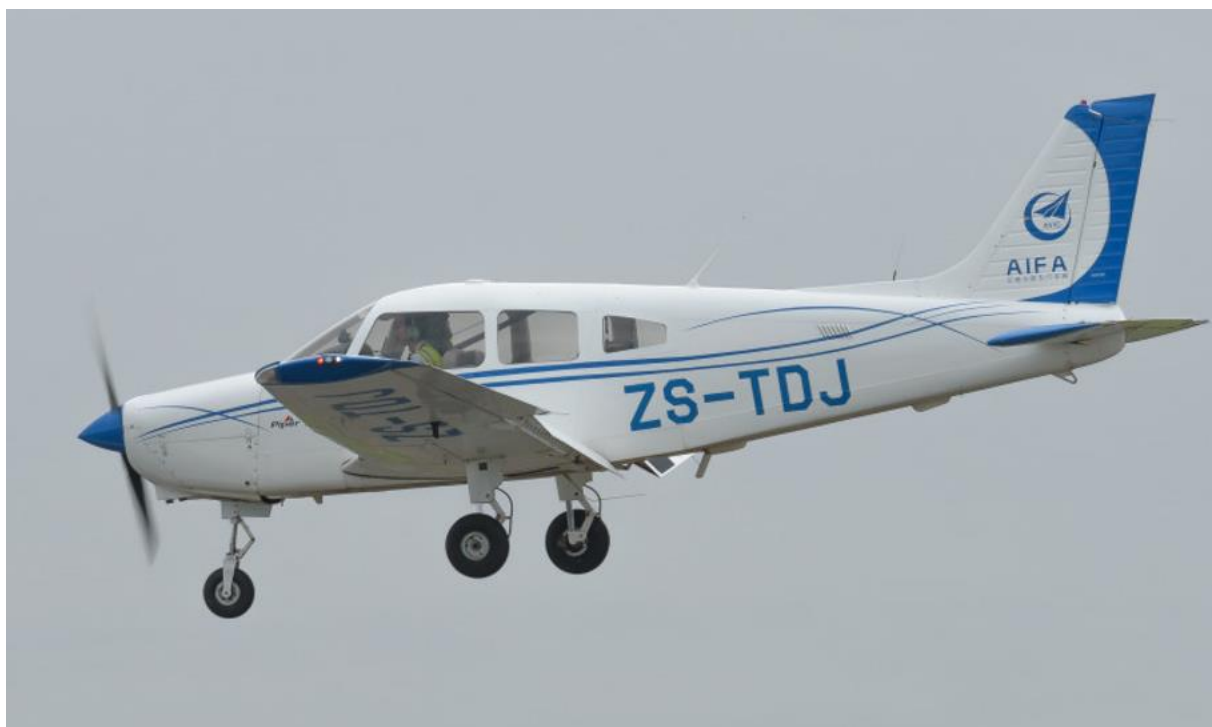
Figure 1: The file picture of the ZS-TDJ aircraft. (Source: Operator)

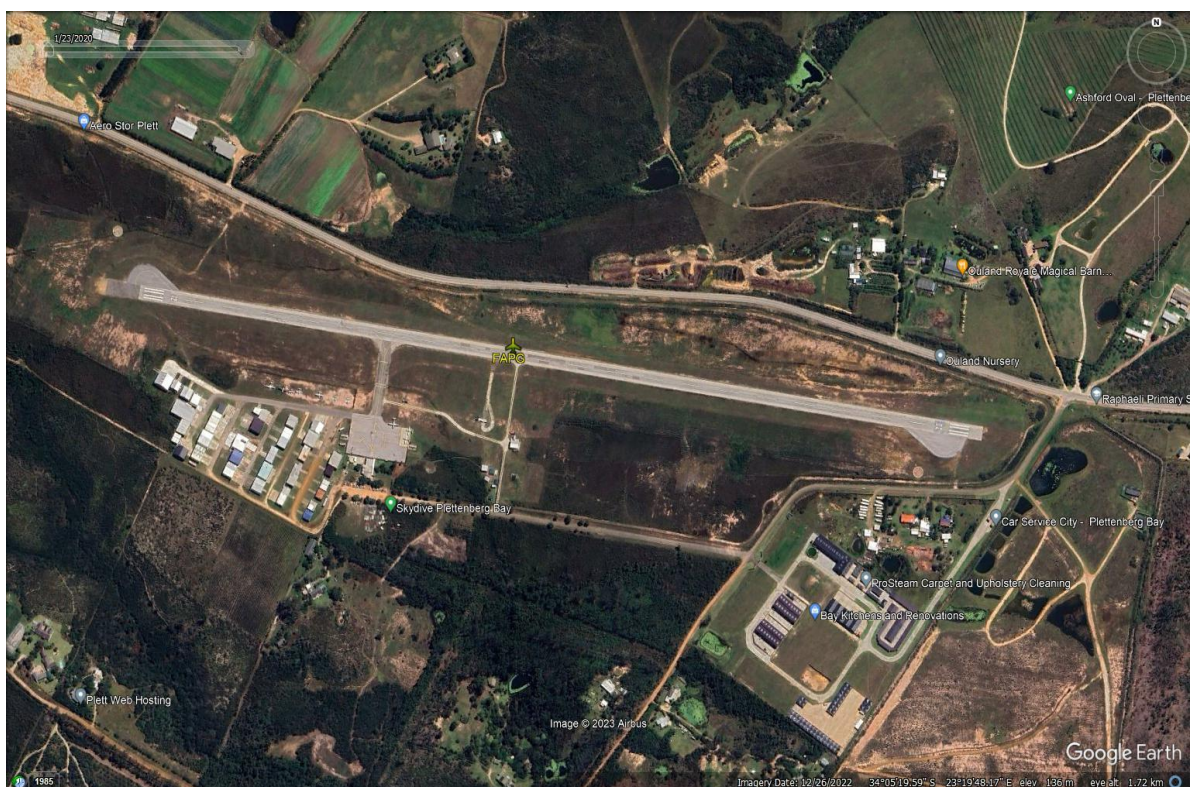
Figure 2: Aerial view of FAPG. (Source: Google Earth)
