LIMITED ACCIDENT INVESTIGATION REPORT

Reference Number	CA18/3/2/10127						
Classification	Accident	Date	26 February 2022	Time	1530Z		
Type of Operation	Private (Part 94)						
Location							
Place of Departure	New Tempe Aerodrome (FATP), Free State Province		Place of Intended Landing	New Tempe Aerodrome (FATP), Free State Province			
Place of Accident	FATP Runway 01						
GPS Co-ordinates	Latitude	S 29°2'44.81"	Longitude	E 26°9'36.90"	Altitude	4441.6 feet (ft)	
Aircraft Information							
Registration	ZU-FAS (Serial Number: CH029)						
Model/Make	Cheetah, Rainbow Aircraft (Pty) Ltd						
Damage to Aircraft	Substantial		Total Aircraft Hours	812.2			
Pilot-in-command							
Licence Type	National Pilot Licence (NPL)	Gender	Male		Age	67	
Licence Valid							
Total Hours on Type	200.6		Total Flying Hours	200.6			
People On-board	1 + 1	Injuries	0	Fatalities	0	Other (on ground)	0
What Happened							
<p>On 26 February 2022 at 1530Z, a pilot and a passenger on-board a Cheetah aircraft with registration mark ZU-FAS were planning to take-off on a sightseeing flight from New Tempe Aerodrome (FATP) with the intention to land back at the same aerodrome. The flight was planned to be conducte

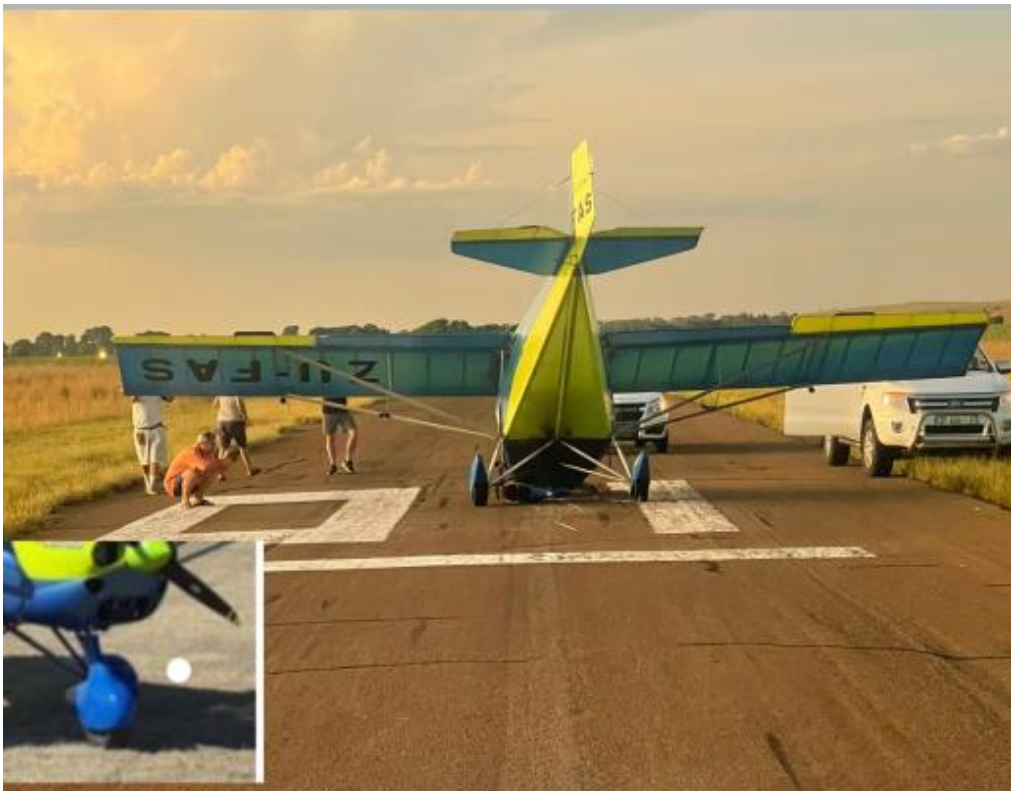
The aircraft sustained substantial damage, however, both occupants were not injured.

Figure 1: The aircraft's nose wheel fork broke off just before the take-off roll.
Inset: The wheel spat/fairing. (Source: Pilot)

The nose gear fork failed due to an undetected crack during the last inspection.

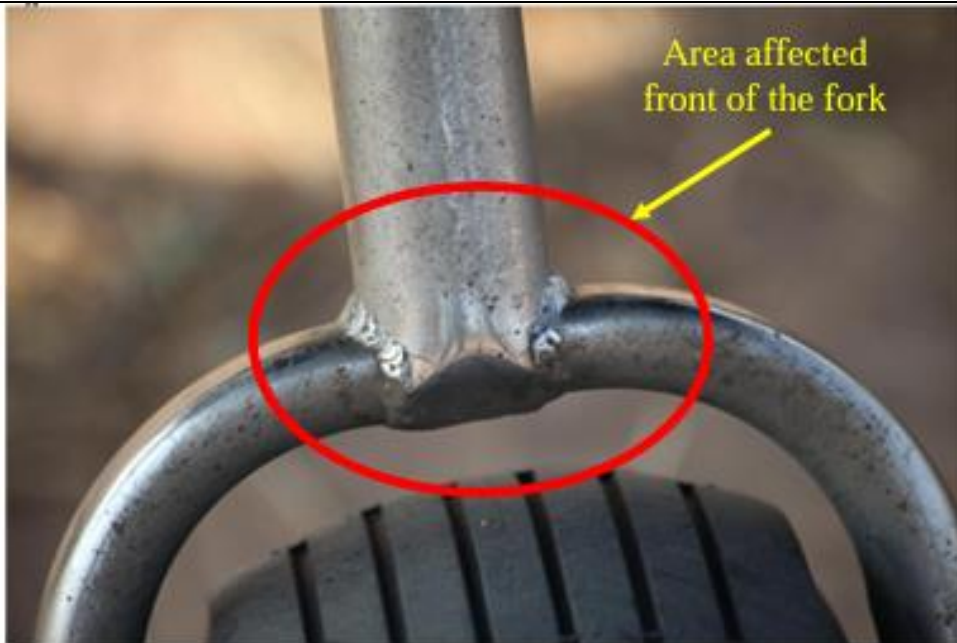
- 1) Remove the front fork Spat (if installed)
- 2) Clean the affected area in order to better the inspection
- 3) Utilising a bright light, inspect the indicated area [see figure 2](#)
- 4) If no cracks were found assemble the removed parts
- 5) Continue further operation
- 6) Inspect every 50 normal landings (with Spats)
- 7) Inspect every time with hard landings (with Spats)
- 8) Include this inspection in your pre-flight if no spats are fitted. This is normally the case with aircraft being utilized as per point 1b

Figure 2: Cheetah SB 004-08-2011 compliance. (Source: fly-skyreach.com)

- The Service Bulletin (Figure 2, bullet point 6) states that “a *visual inspection must be done every 50 normal landings*”; and (bullet point number 7) further states that “an *inspection must be done in cases where a hard landing was experienced*”. The pilot admitted to not counting the landings he made on the aircraft, however, he approximated that he did one landing per hour.

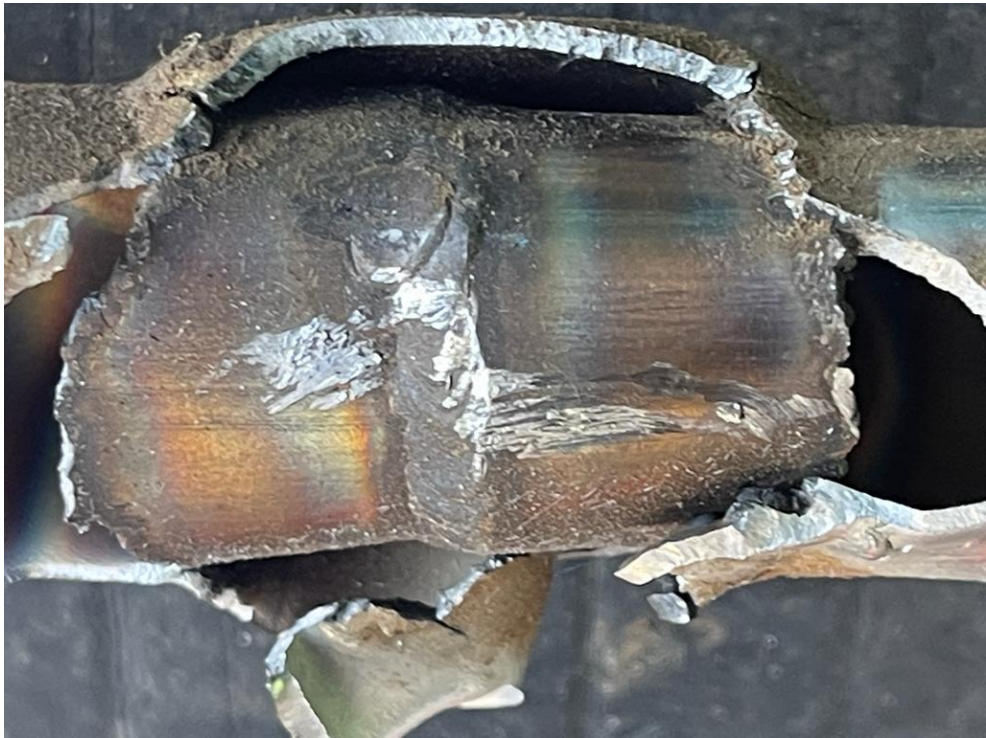
Figure 4: The damage on the nose wheel gear fork. (Source: Owner)

1. Non-recording of landings by the pilot/s and/or operator.
2. Lack of proper maintenance inspection as per the manufacturer's SB.
3. Non-adherence to the 50 landings maintenance inspection as per the manufacturer's SB.

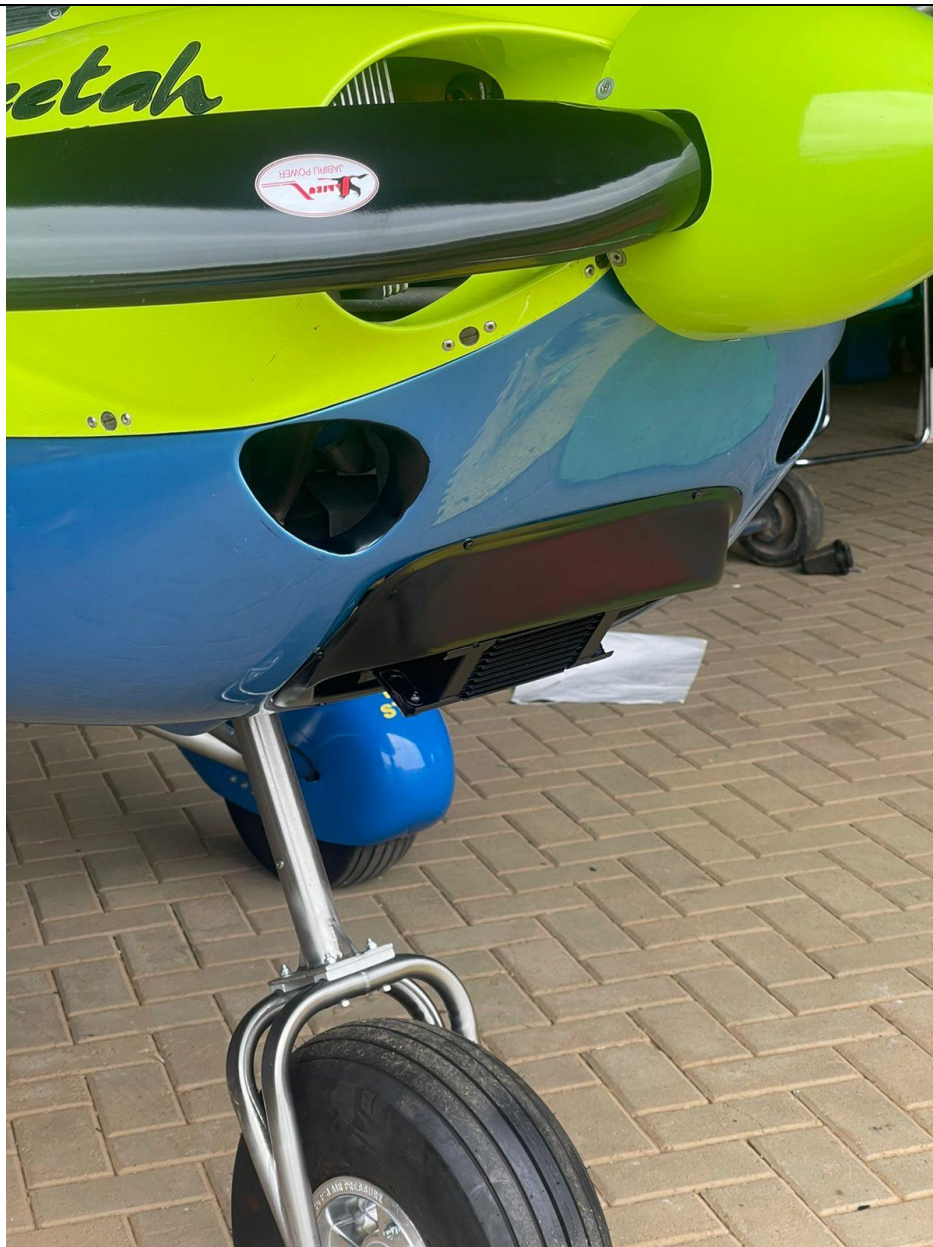
Figure 5: The new nose wheel fork that was installed. (Source: Pilot)

Safety Action	
The owner of the aircraft has since fitted a new nose wheel fork from the aircraft's manufacturer (see Figure 5).	
Safety Message and Safety Recommendations	
<p>Safety message:</p> <ul style="list-style-type: none"> • Pilots and operators must always adhere to the maintenance requirements by the manufacturer, as well as abide by the regulations. <p>Safety recommendations:</p> <ul style="list-style-type: none"> • It is recommended that the nose wheel spat on these aircraft be permanently removed; this would enable pilots to conduct proper pre-flight inspections in the nose wheel strut/fork assembly area, which is known to be susceptible to cracks and possible failure. • It is recommended that the manufacturer considers redesigning the nose wheel strut/fork assembly by making use of durable material as the current strut/fork assembly material appears to be weak for the type of operation.
