LIMITED SERIOUS INCIDENT INVESTIGATION REPORT
--

Reference Number		CA18/3/2/1361					
Classification	Serious Incident	Date	5 August 2021		Time	1039Z	
Type of Operation	Training (Part 141)						
Location							
Place of Departure	Beaufort West Aerodrome (FABW)		Place of Intended Landing	Beaufort West Aerodrome (FABW)			
Place of Occurrence	Runway 26, Beaufort West Aerodrome (FABW), Western Cape province						
GPS Co-ordinates	Latitude	32° 18' 04.57" S	Longitude	022° 40' 07.72" E	Elevation	4 750ft	
Aircraft Information							
Registration	ZS-FIA						
Model/Make	Cessna 172S						
Damage to Aircraft	None		Total Aircraft Hours	5 514.4 hours			
Pilot-in-command							
Licence Valid	Yes		Gender	Male	Age	22	
Licence Type	Student Pilot Licence (SPL) Integrated Course						
Total Hours on Type	26.2 hours		Total Flying Hours	26.2 hours			
People On-Board	1 + 0	Injuries	0	Fatalities	0	Other (on ground)	0
What Happened							
<p>On 5 August 2021 at about 1030Z, a student pilot on-board a Cessna 172S aircraft with registration mark ZS-FIA took off on an initial solo flight from Beaufort West Aerodrome (FABW), Western Cape province, and later landed back at the same aerodrome at about 1039Z. Fi

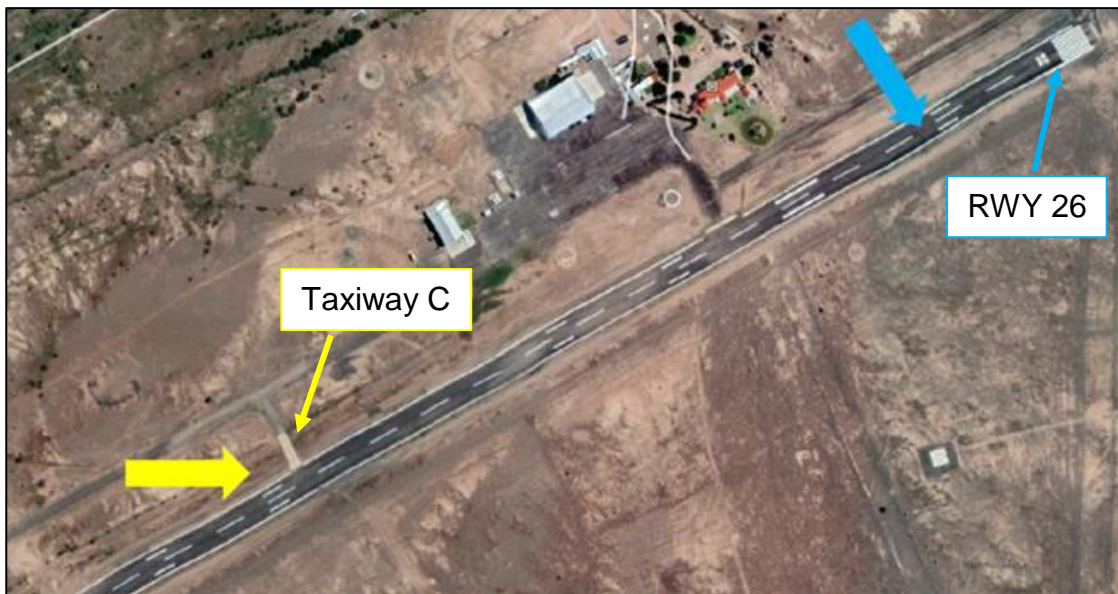
Figure 1: Aerial view of FABW. The blue arrow shows touchdown point; the yellow arrow shows the point where aircraft came to rest. (Source: Google Earth)

During the landing roll, the student pilot increased taxi speed to expedite exiting the runway, which resulted in the aircraft vacating to the left of the taxiway.

Post-incident, the student pilot was debriefed by his instructor as well as his mentor instructor. Subsequently, he flew 2.4 hours solo remedial with no further problems. The student pilot had no previous incidents or concerns prior to the serious incident.
