Safety Information Bulletin

SIB No.: 2018-04R1

Subject: Environmentally Assisted Cracking in certain Aluminium Alloys

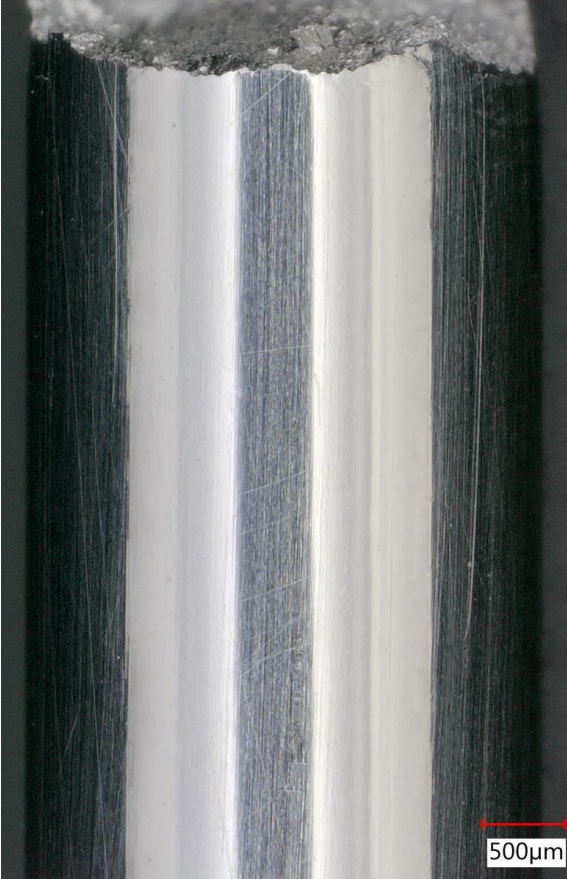
Valid test	Non-valid test due to condensation

<p data-bbox="371 1169 891 1198">Figure 1 – Round smooth bar: not corroded</p>

- A material is considered to have failed the test, and susceptible to EAC, if it shows cracking along the grain boundaries without corrosion attack or oxidation products on sample or fracture surface, as shown on the figures 1,3 and 5 below.
- If obvious through cracking has not occurred, a check for the presence of grain boundary cracking can be made by optical examination with magnification of at least 50x. Presence of grain boundary cracking is also considered a test failure.
- Specimen and fracture surface have to meet the validity requirements as given in Table 1 of this SIB. If the requirements are not met, the test is invalid and should be repeated.

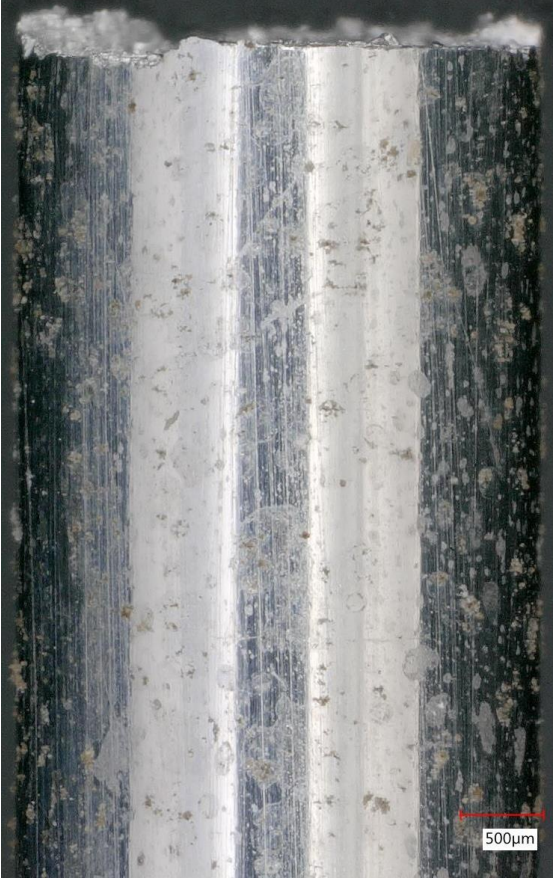
<p data-bbox="1379 1169 1850 1198">Figure 2 – Round smooth bar: corroded</p>

Observation	Requirement for a valid test
Evidence of the presence of condensation on specimen surfaces	Not allowed
Corrosion pitting or corrosion products on specimen surfaces (figures 2, 4 and 6)	Not allowed Surface of a failed sample by light microscopy, level of magnification: 50x Fracture surface and rim of fracture surface by Scanning Electron Microscopy, level of magnification: 2000x
Fracture surface morphology in the case of through fracture	Predominantly intergranular fracture path with little or no evidence of ductile decohesion (see figure 5) Level of magnification for examination by Scanning Electron Microscope: 6000x

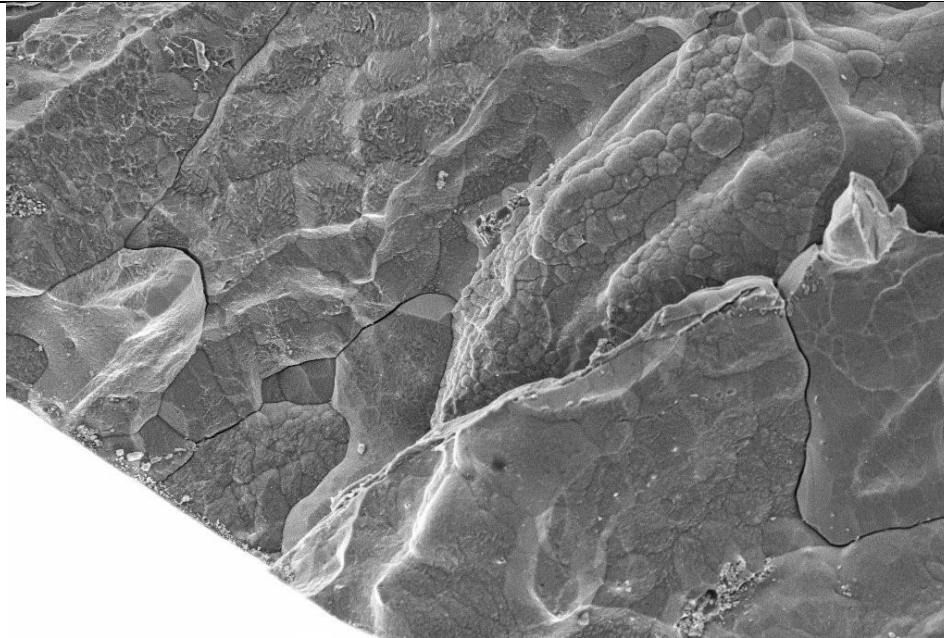
Valid test

Only precipitates on the grain boundaries are visible

Figure 3 – Fracture surface without traces of corrosion

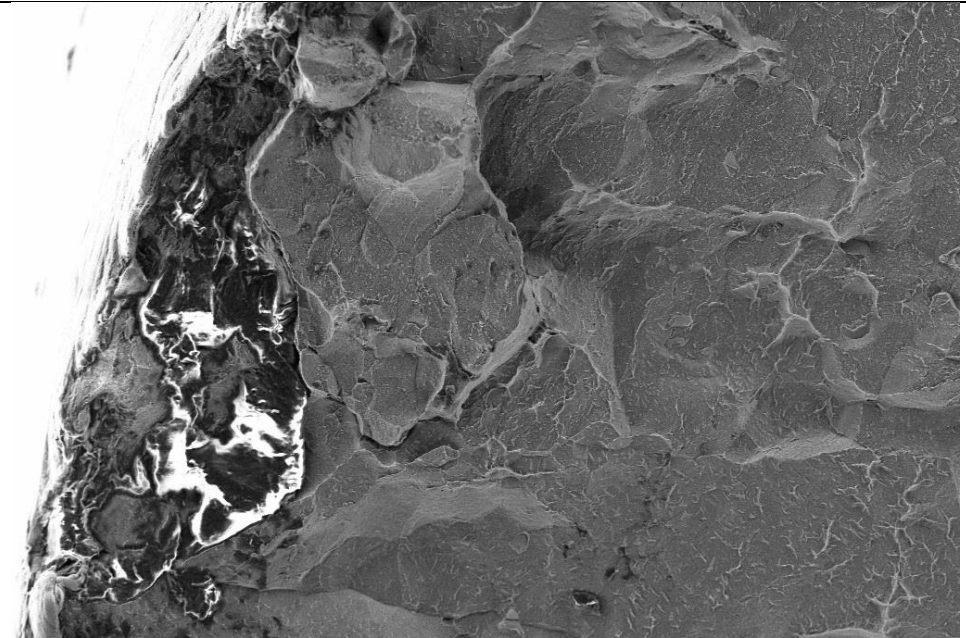
Non-valid test due to corrosion at initiation site

Precipitates & dark oxides on the grain boundaries are visible

Figure 4 – Fracture surface with traces of corrosion

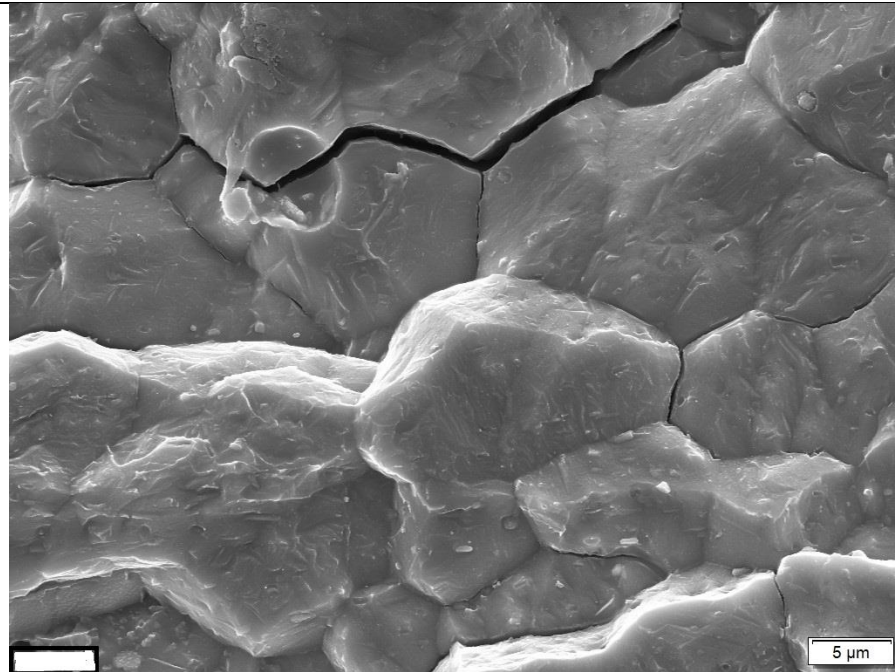
EAC test

Figure 5 – Typical EAC fracture surface

Note 1: The subject of this SIB is EAC caused by hydrogen assisted embrittlement resulting in a decrease of toughness but in absence of an obvious corrosion reaction (see Appendix 1 of this SIB, figure 5). It is different from classical stress corrosion cracking characterised by anodic dissolution with loss of material accompanied with findings of active corrosion like pitting or attack of grain boundaries (see Appendix 1 of this SIB, figure 6).

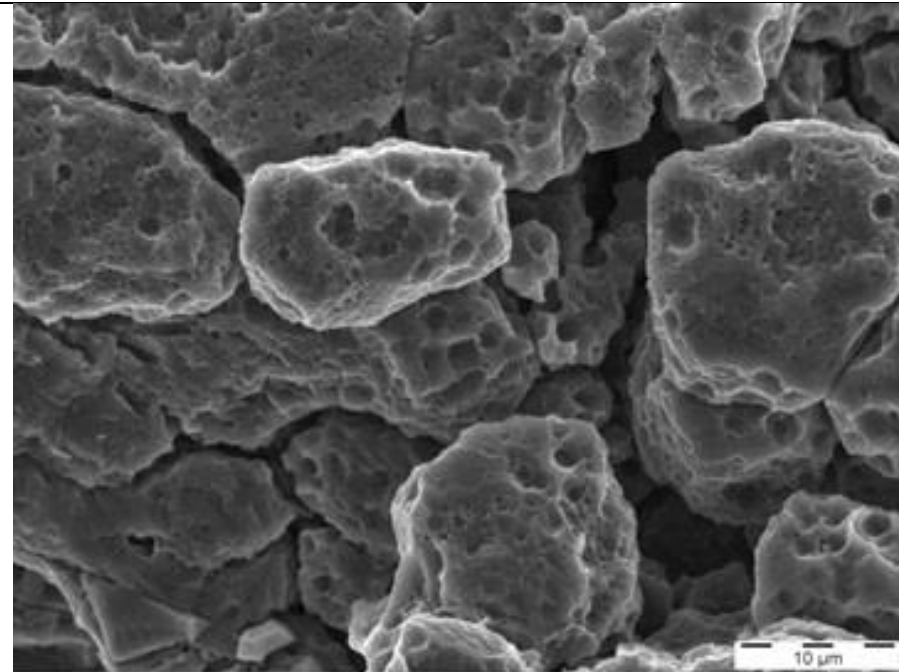
SCC test (ASTM G 47)

Figure 6 – Typical SCC fracture surface
