Subject: Sailplane Rigging – Procedures, Inspections and Training
Ref. Publications:

All sailplanes and powered sailplanes, subject to rigging.

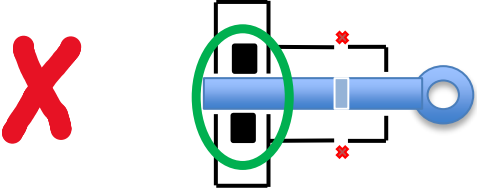
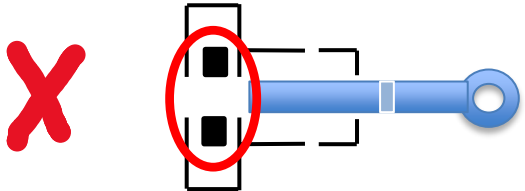
Engaged but <u>not</u> secured.	The bolt moved away from its engaged position, and the control is unconnected.

To engage means e.g. that a bolt is inserted into a bushing. In this condition, the connection is able to transmit forces, but the bolt can move out of the bushing again, therefore the connection is not secure. All connections need to be engaged and secured.

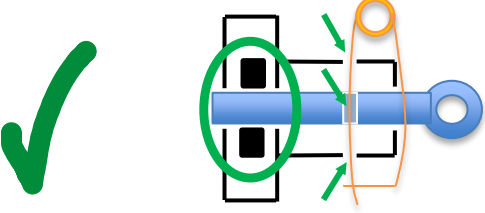
The Fokker-needle needs to be pushed through both holes of the cage and the hole of the bolt.
Engaged and secured.

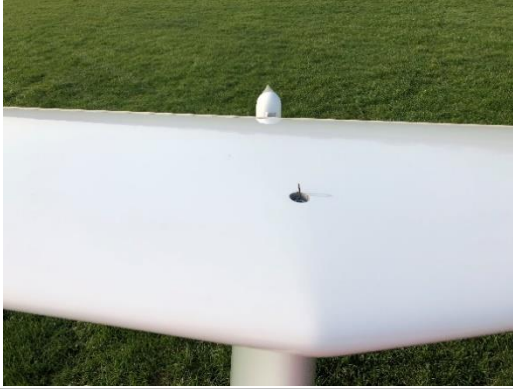
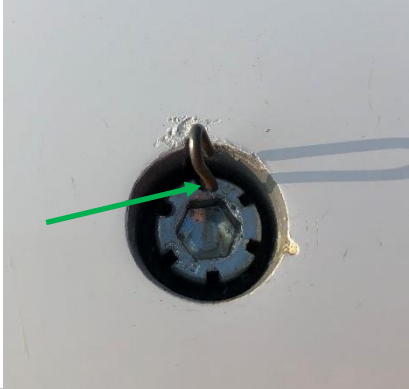
<p>The bolt needs to be engaged and secured against rotation.</p>

Some connections need to be secured against rotation. In most of the cases, this is achieved by the use of a castellated nut and a Fokker-needle. The pin of the needle has to be pushed through two castells and a hole inside the screw.

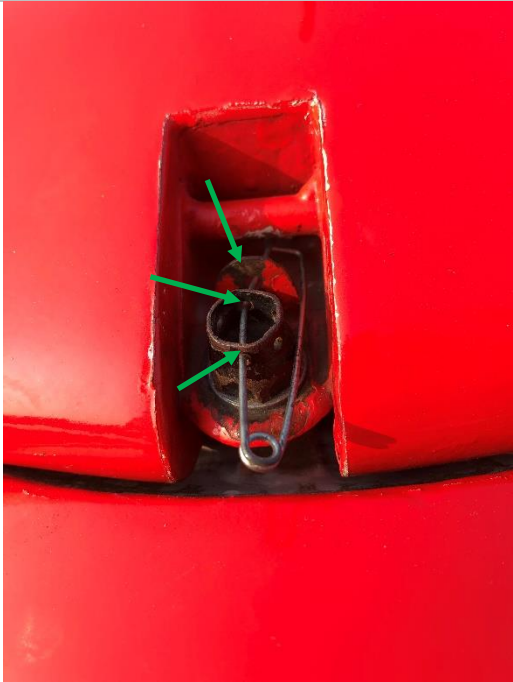
<p>Horizontal stabilizer engaged in its aft fitting but forward fitting not engaged.</p>

Note: All cases of unconnected controls and unconnected horizontal stabilizers can be detected by performing a positive control check. Non-interruption during the rigging helps to prevent forgetting the connections in the first place. The checking of proper securing can be done by a visual inspection only.

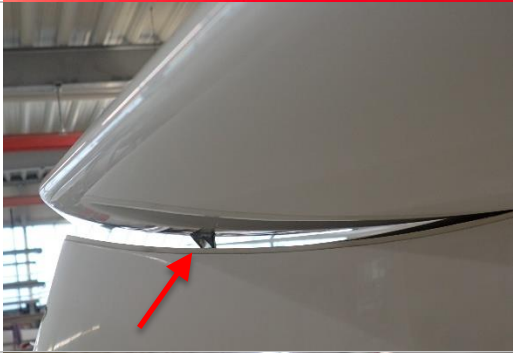
<p>Horizontal stabilizer properly engaged.</p>

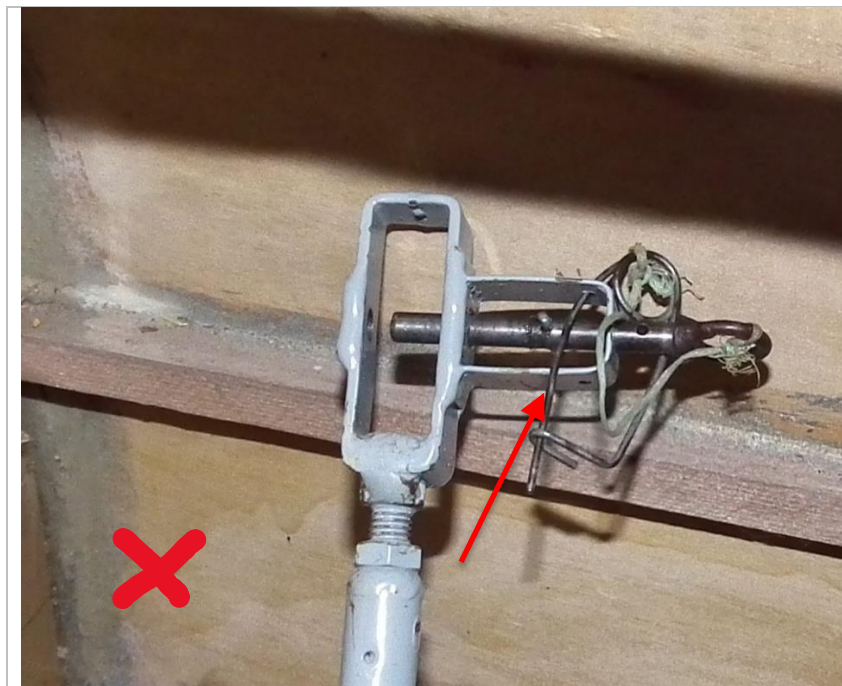
The example below shows an aileron connection, which is typical for old sailplanes with manual control connections. In this case, the connection was engaged during rigging, but not correctly secured. After three flights of short duration, the bolt moved away from its engaged position. The pilot lost control and crashed fatally.

The connection was not secured. The Fokker-needle was put through one hole of the cage only, but not through the bolt and the lower hole of the cage, as well. By this, the bolt could move freely and the control connection could become unconnected.

Note: Connections, which are not properly secured, cannot be detected by positive control checks. The proper securing can be verified only by a manual inspection through turning, pulling, or shaking of the bolt and further visual inspection.

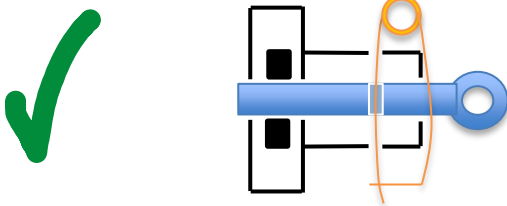
The bolt is secured by pushing the Fokker-needle through all three holes.

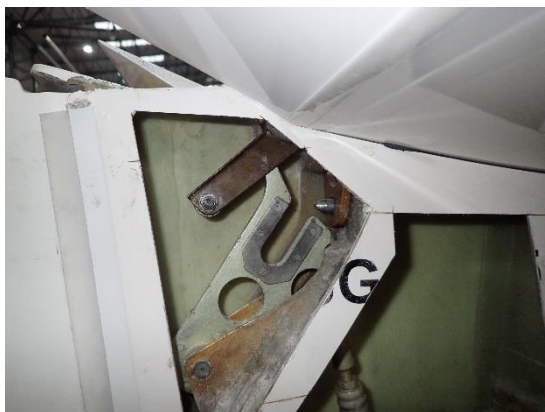
Similar designs can be found for the control connection of the elevator. Pictures below show an example of a mis-rigged vertical stabilizer, which led to a fatal accident. The mis-rigging had its root cause in an unauthorized and apparently unrecorded modification, to make rigging easier.

Disconnected elevator control

Note: Those examples of rigging errors can usually be detected by a proper positive control check as indicated above.

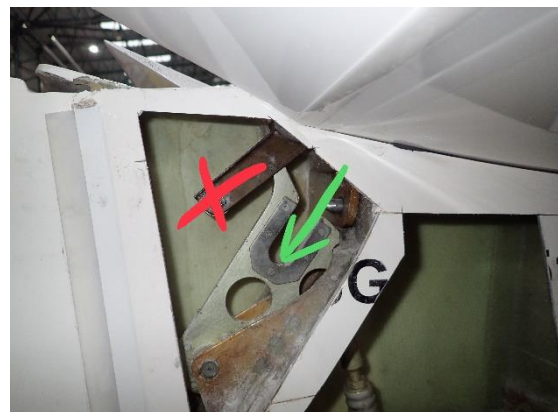
Disconnected elevator control

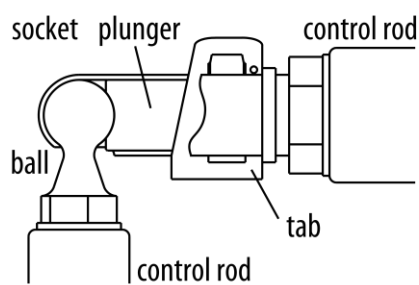
(a) Correct: cut-away shows how tab holds plunger in place

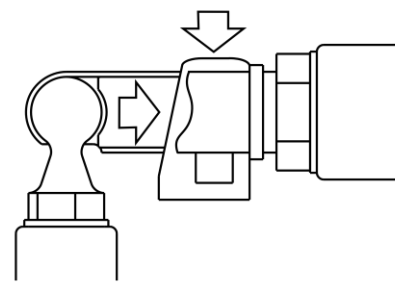
(b) Open: with tab depressed, plunger allows ball to be inserted or removed

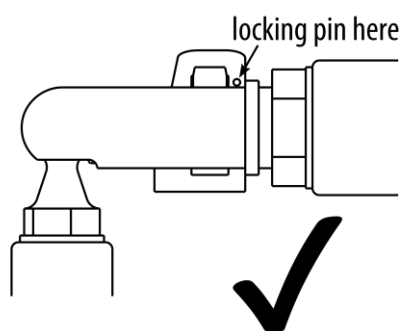
(c) Correct: ball engaged, locking pin may be inserted

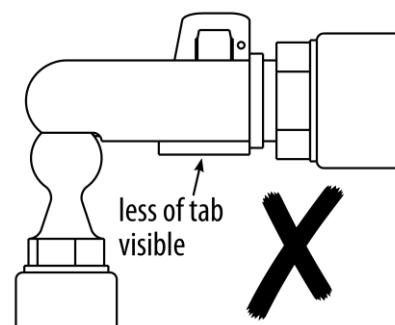
Unfortunately, the tab adopts a similar position when the ball and socket are completely disconnected and, although the ball is then locked out of the socket, it may in some cases engage sufficiently for the controls to seem connected. Being able to insert the locking pin does not guarantee that the connection has been properly made.

(d) Incorrect: ball not engaged, but locking pin may still be inserted

It is crucial to check that the ball and socket are correctly engaged. This can be difficult, if access is tight or illumination poor; a torch and mirror, or telephone camera, can help.

Note: To check the proper engagement of l'Hotellier connectors, a positive control check is strongly recommended.

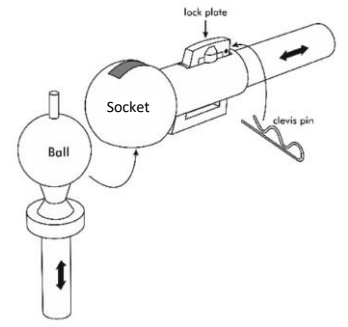
<p>Newer l'Hotellier connectors come with a pin on the top of the ball that becomes visible outside the socket, once the ball and socket are properly engaged. The pin allows also for a tactile inspection. The connection still needs to be secured.</p>

Remark: The maintenance instructions of l'Hotellier, in particular about ball wear need to be respected.

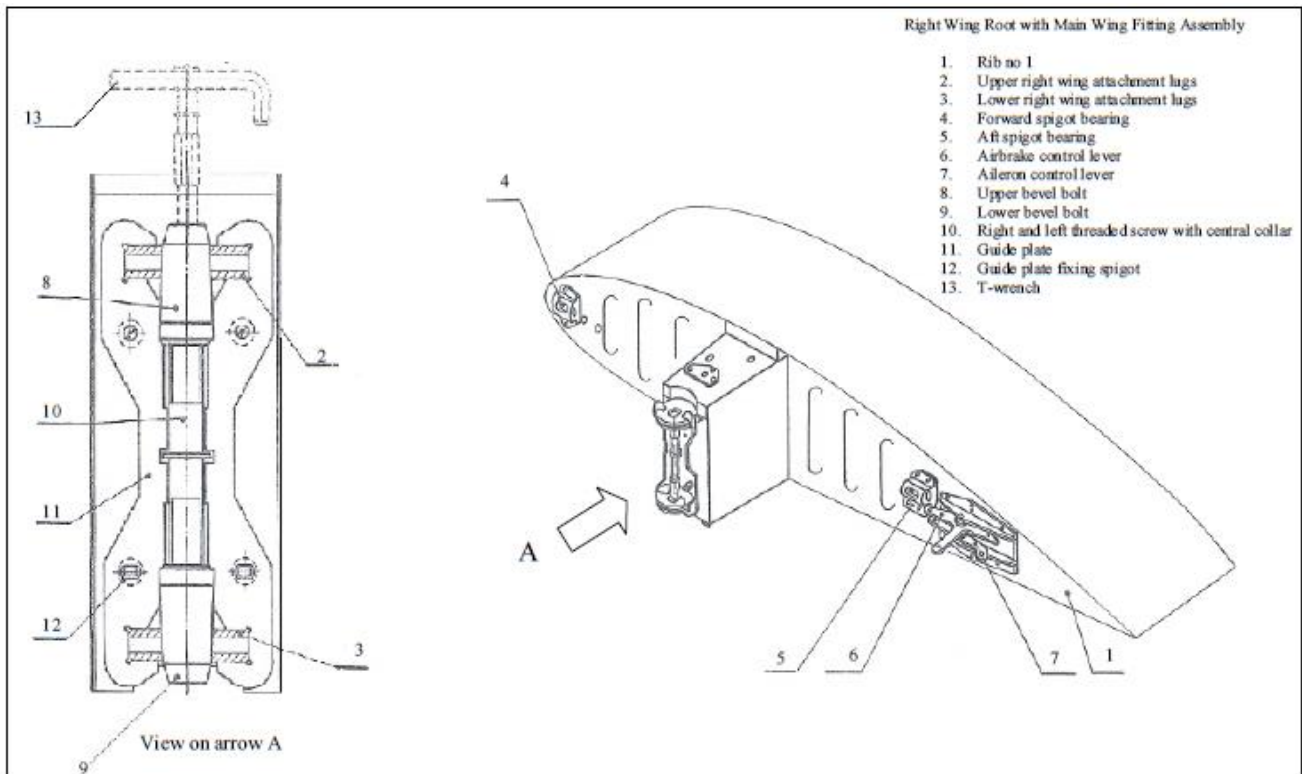
The wing rigging pins for most gliders are smooth cylinders, but those for e.g. the Foka, Cobra, Bocian, Jaskółka, Schempp-Hirth SHK and Austria, consist of expanding pins/cones, which must be fitted exactly in accordance with the instructions of the flight manual. If the pin/cone is not correctly located, the wings can fold up and detach from the fuselage. Unless inspection holes have been cut for the purpose, it can be very difficult in some gliders to see whether the fitting has been assembled correctly.

Example of an expanding main pin wing connection.

Note: In case of sailplanes with expanding main pin wing connections, practice rigging should be carried out under the supervision of someone who is familiar with the sailplane type.
