AIRCRAFT INCIDENT REPORT AND EXECUTIVE SUMMARY

Reference:		CA18/3/2/1185	
Aircraft Registration	ZS-ASW	Date of Accident	8 November 2017		Time of Incident	1738Z	
Type of Aircraft	Avro 146-RJ85A		Type of Operation		International Commercial		
Pilot-in-command Licence Type		Airline Transport Pilot's Licence (ATPL)		Age	36	Licence Valid	Yes
1st Officer Licence Type		ATPL		Age	29	Licence Valid	Yes
Pilot-in-command Flying Experience		Total Flying Hours	8 895.0		Hours on Type	7 035.8	
1st Officer Flying Experience		Total Flying Hours	4 157.1		Hours on Type	81.3	
Last point of departure		Harare International Airport (FVHA), Zimbabwe					
Next point of intended landing		OR Tambo International Airport (FAOR), South Africa					
Location of the accident site with reference to easily defined geographical points (GPS readings if possible)							
During flight at approximately 34 000 ft above mean sea level (AMSL), 240Nm north east of FAOR in the area of UTULI in Limpopo province

AIRCRAFT ACCIDENT REPORT

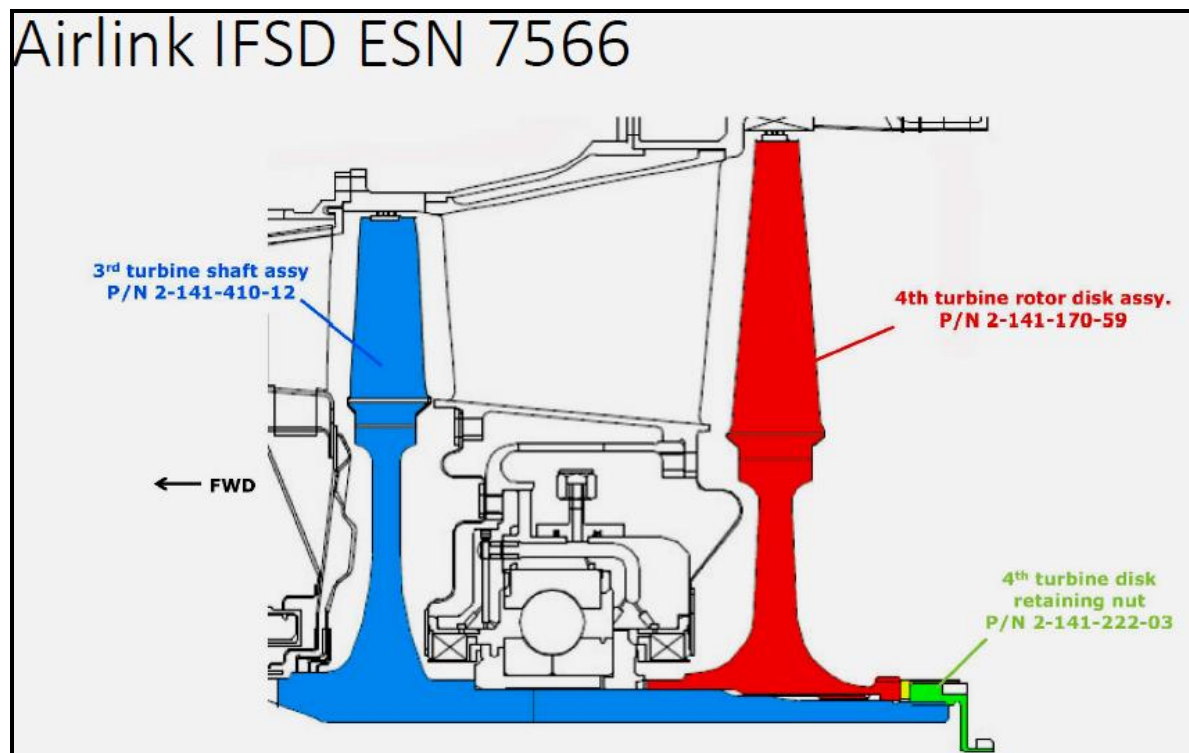
Figure 12: Schematic illustration of the fourth and third turbines

- The fourth-stage PT rotor was replaced on-wing as per the AMM at 320.2 hours, 248 cycles before this event.
- The shaft and nut threads were intact and not sheared, implying the retention nut backed off.
- The fourth-stage PT disk experienced an over-speed as a result of the disk spline disengaging its mating spline on the PT shaft. This led to the release of the fourth-stage PT blades.
- The fourth-stage power rotor is downstream of the control over-speed sensor; as such the over-speed sensor would not have been triggered.

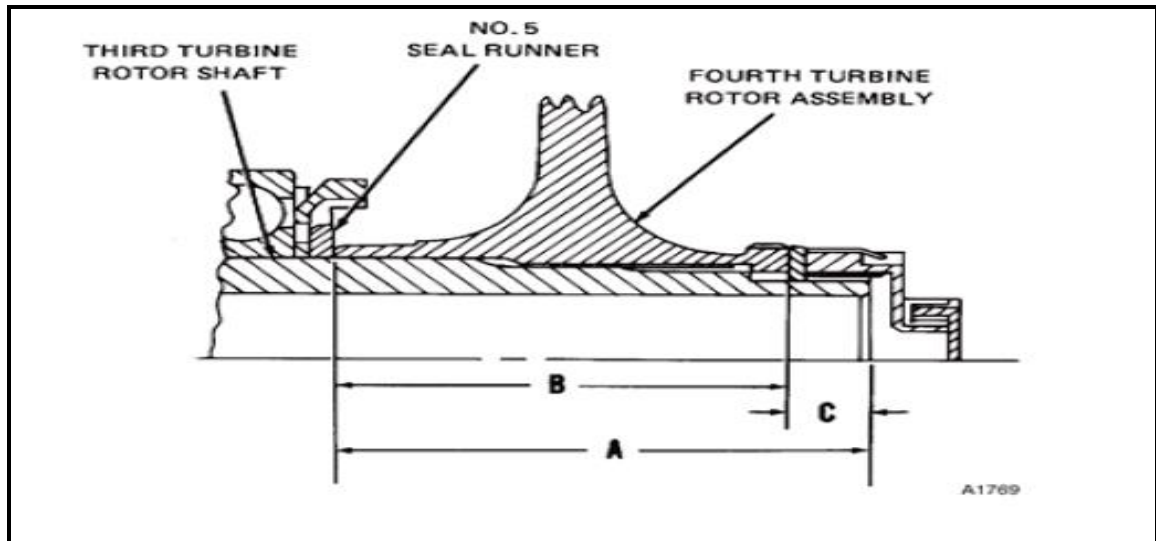
Figure 16: Dimension checks for pre-SB

correspondence with the operator confirmed that the airline used the procedure in the AMM for pre-SB configured engines. The pre-SB procedure is for the fourth-stage turbine disk and pick-up ring that does not have tangs which require alignment during stacking. The use of the pre-SB dimensional check presents an opportunity for errors by not assuring the correct axial placement and engagement of the fourth-stage turbine with the LPT shaft.

- According to the AMO's email correspondence, AMM 72-52-01 page 406 step (12) was followed during the maintenance procedure.

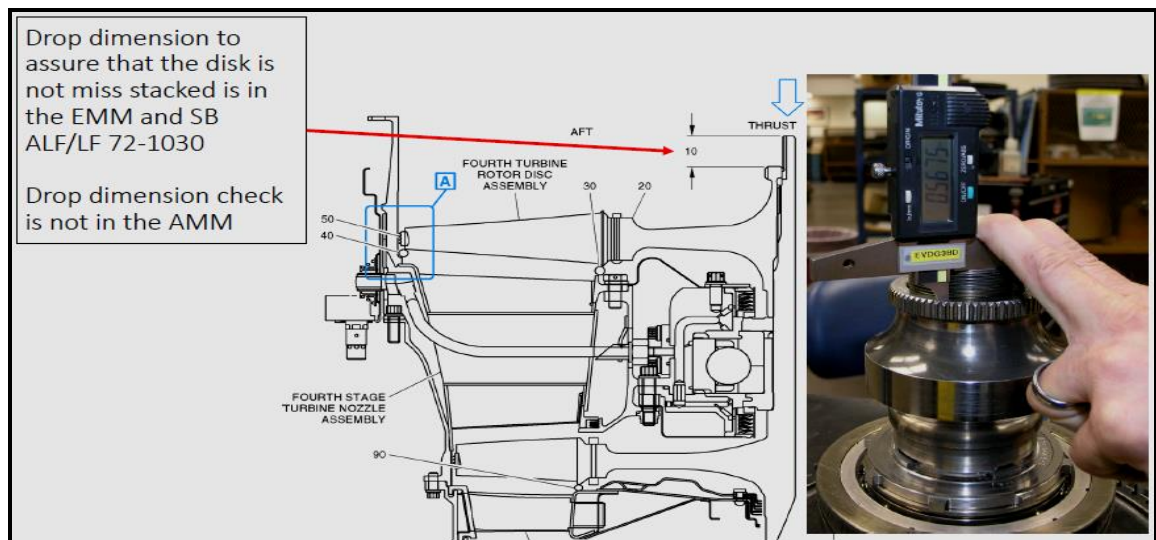
Figure 17: The anti-rotor tangs and slots

- The below dimension check is contained in the EMM for the post-SB configuration procedure.

- As stated in the EMM: "Apply alignment mark on the end of the fourth turbine rotor disc assembly that is directly in line with the centre of any slot on the forward end of disc."
- AMM assembly procedure did not have a drop dimension check to ensure that the fourth-stage disk is not mis-staked. The AMM stated to check within limits without referencing a sketch or numerical limits or the engine maintenance manual, which lists numerical limits.
