CA18/2/3/7510					
		SOUTH AFRICAN CIVIL AVIATION AUTHORITY ACCIDENT REPORT – EXECUTIVE SUMMARY					
Aircraft Registration	ZS-OJU	Date of Accident	01/06/2002		Time of Accident	0515Z	
Type of Aircraft	HAWKER SIDDELEY 748		Type of Operation		Scheduled Freight		
Pilot-in-command Licence Type		Airline Transport	Age	69	Licence Valid	Yes	
Pilot-in-command Flying Experience		Total Flying Hours	20963.8 hrs		Hours on Type	1819.3 hrs	
Last point of departure		Bloemfontein Aerodrome					
Next point of intended landing		George Aerodrome					
Location of the accident site with reference to easily defined geographical points (GPS readings if possible)							
In Vandalenskloof, 7.6 nm from GGV on a bearing 065° Magnetic at a position S33° 54' 42" E022° 28' 33.6"							
Meteorological Information		Poor weather conditions with low cloud and rain.					
Number of people on board	2 + 1	No. of people injured	Nil		No. of people killed	2 + 1

AIRCRAFT ACCIDENT REPORT

Name of Owner : AirQuarius Contracts (PTY) LTD
Name of Operator : AirQuarius Air Charter (PTY) LTD trading as Airquarius Aviation
Manufacturer : Hawker Siddeley
Model : HS-748 2B
Nationality : South African
Registration Marks : ZS-OJU
Place

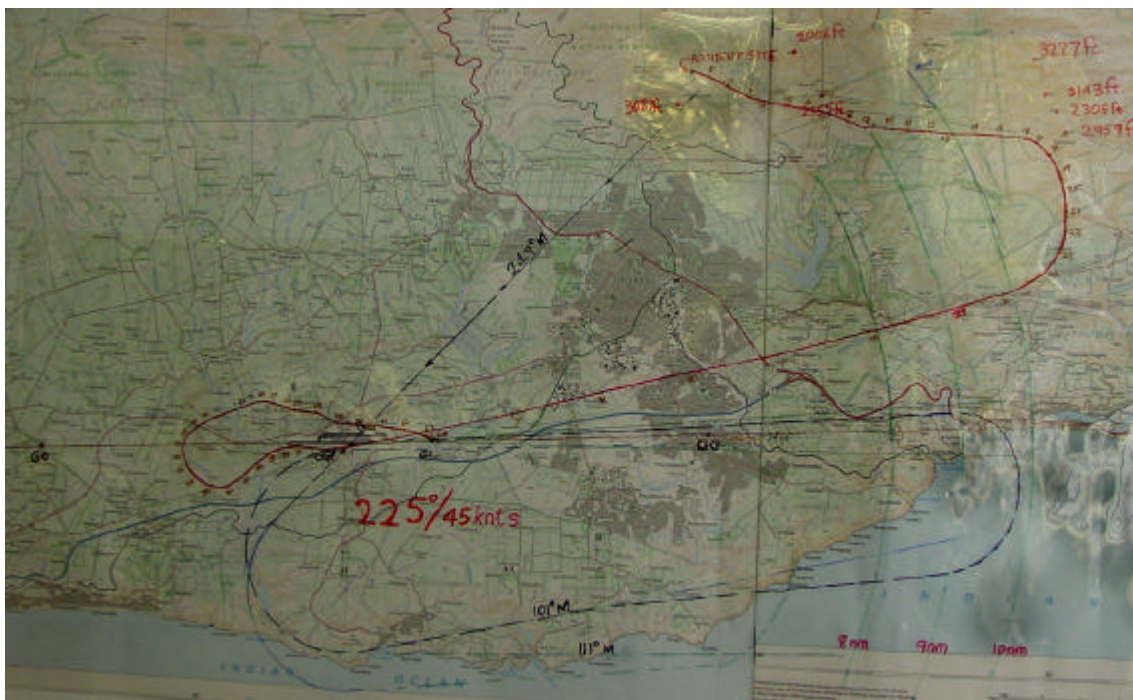
- 1.1.11 A further attempt to plot the flight path of the aircraft from where the missed approach was initiated was attempted by using the FDR data. The surface wind was recorded at George Aerodrome as 270°/13knots, but the winds at higher altitudes was not available. The investigator used the comment of the pilot-flying during the one outbound leg, that they were tracking 101° (he probably obtained this information from the Garmin GPS100, Global Positioning System (GPS) fitted to the aircraft), while the FDR recorded a heading of about 111°. The wind factor was calculated using this information and was determined as 224°/38knots. Using this wind factor a probable flight path from the accident site as a known point was plotted. In this plot the probable flight path did not pass over the aerodrome as one would expect when the missed approach was initiated. There were several witnesses that heard or saw the aircraft passing typically over the aerodrome during the missed approach. Several different wind factors were used to plot probable flight paths, but the flight path with an average wind factor of 225°/45knots was the most acceptable. The flight path was plotted from the accident site position and ended at the GL Non-directional Beacon (NDB), which was the most probable point from which a missed approach would be initiated and appeared as follows:

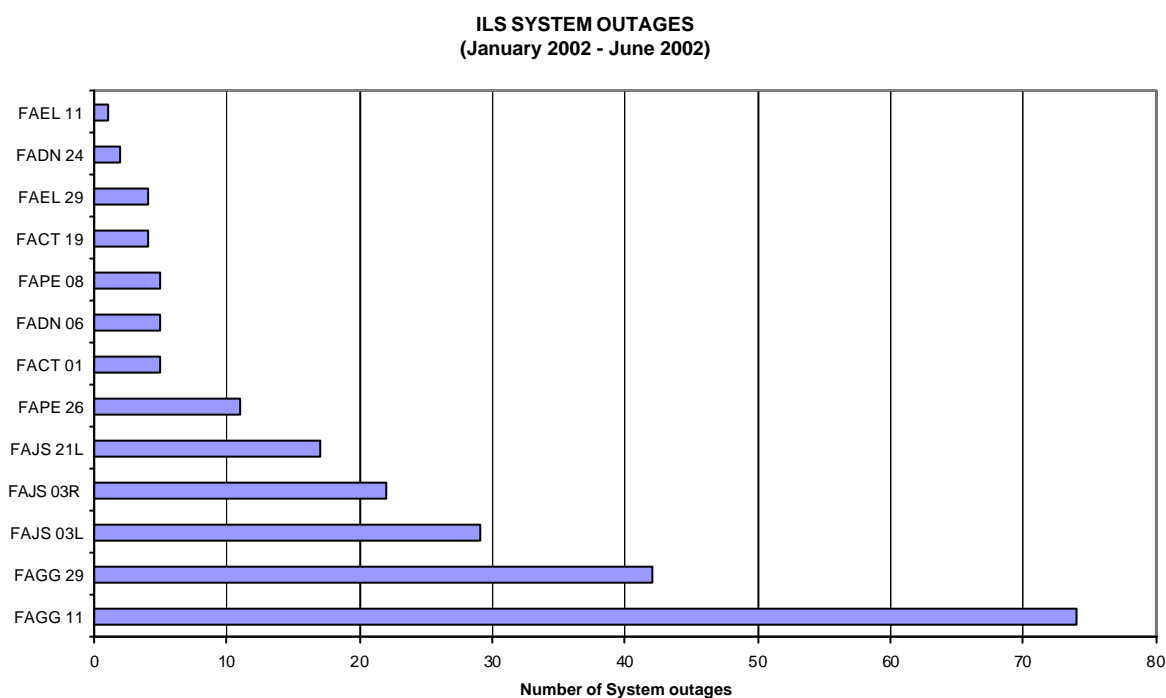
1.8.20 A report was requested from ATNS about the maintenance history of the ILS's at George Aerodrome and it was requested that the performance of these ILS's be related to some of the other similar ILS's in South Africa in the period from January 2002 to June 2002. There were several criteria that may be used to relate the different ILS's to each other. The criteria used in the ATNS report were number of system outages, availability, number of adjustments performed on the ILS's over the last four consecutive flight inspections and the age of the equipment. If the number of outages were considered the following graph illustrates how the different ILS's related to each other:

From this graphic illustration one can see that the two ILS's at George Aerodrome FAGG suffered by far the most outages. The ILS of Runway 29 at George was a Thompson 371 model and the same model ILS was installed at Johannesburg International Aerodrome's Runway 03L also in 1973. This ILS was the third worst performer considering outages. The same model ILS was installed on both runways at East London Aerodrome in 1978 and 1979 respectively. These two ILS's on the other hand performed very well in relation to the other ILS's considered.

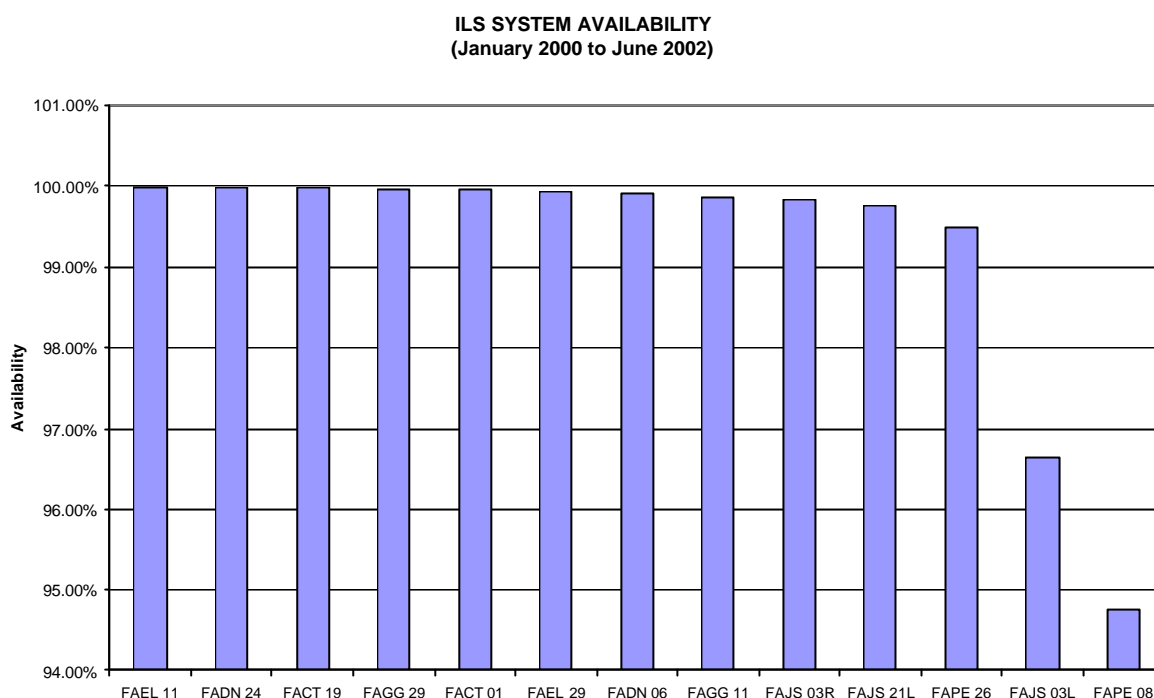
1.8.21 If the availability of the ILS's were considered the following graph was presented:

In this case the ILS's at George Aerodrome performed much better than several of the other ILS's, with the ILS at Port Elizabeth's Runway 08 being the worst performer and thereafter the ILS at Johannesburg International Aerodrome's Runway 03L. In the ICAO Annex 10, Volume 1 – Attachment F (Guidance material concerning reliability and availability of radio communications and navigation aids) it indicates that equipment reliabilities of 1000 hours or more have been consistently achieved. The document suggests that this reliability could be translated to 97.5% reliability in a 24-hour period, thus the likelihood of facility failure of about 2.5% during a 24 hour period. The only ILS that was below these criteria at that time was the ILS at Port Elizabeth's Runway 08.

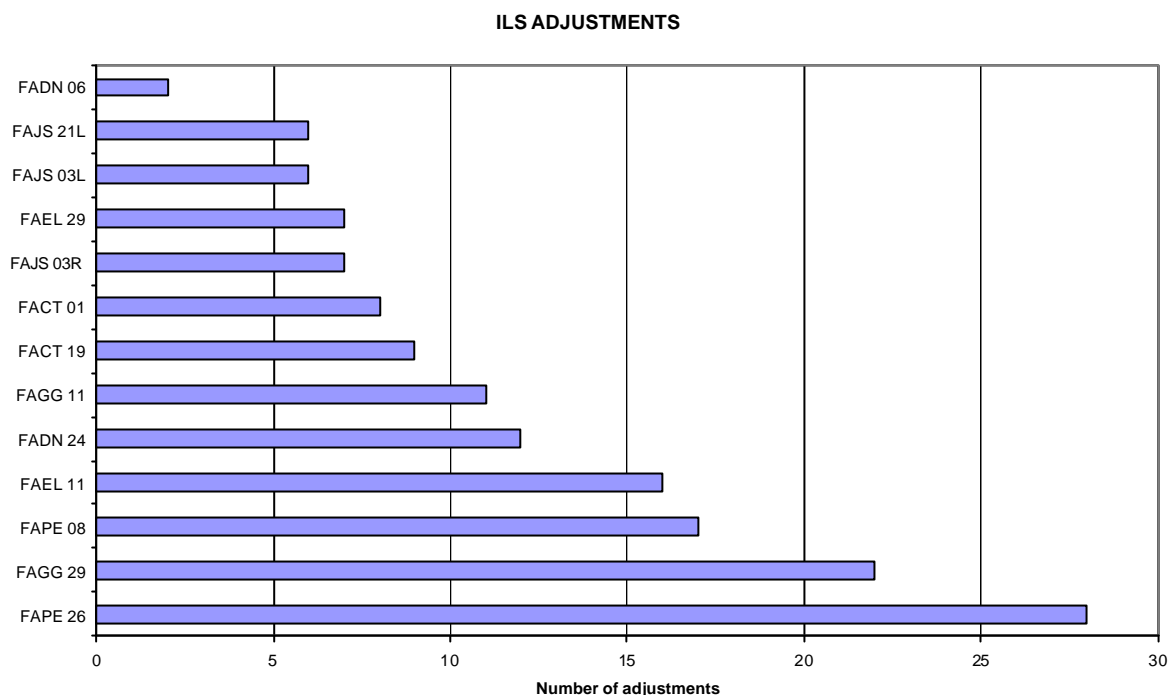
1.8.22 The next parameter considered to relate the ILS's to each other was the number of adjustments performed to the ILS's over the last four consecutive periodic flight inspections. The graphical presentation of the number of adjustments was as follows:

Considering the above information it is apparent that the ILS at Port Elizabeth's Runway 26 needed to be adjusted the most times, but the ILS of George's Runway 29 was adjusted the second most times. Interesting enough the ILS of George's Runway 11 did not need as many adjustments as the ILS on Runway 29 although the ILS of Runway 11 had more outings as the ILS of Runway 29.

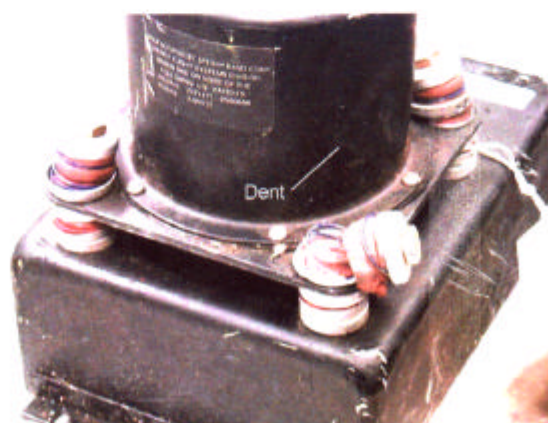
Figure 1: C14A Directional Gyroscope

The C-14A, P/N 2587193-43, S/N 84108500, is shown as received in Figure 1.

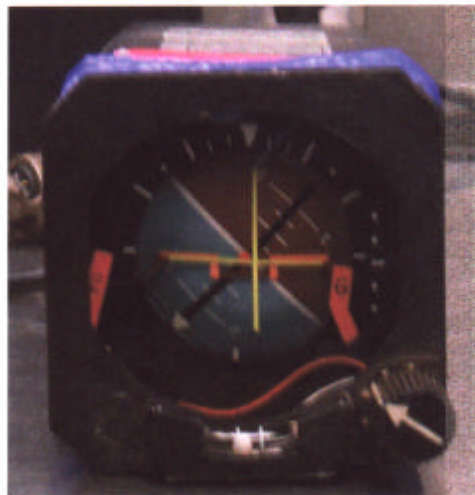
Figure 4: GH-14 Front

The GH-14, P/N 4020531-534, S/N 79060594, is shown as received in Figure 4 and Figure 5.

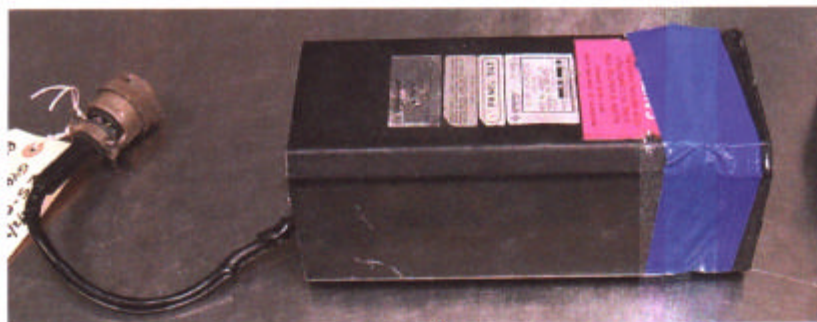
Figure 5: GH-14 Top

- Front faceplate glass is missing
- The gyro flag is in view and the flight director flag is half in view. These flags are held out of view when a 28V valid is received from the flight director or from the internal gyroscope. They are spring loaded to return to view when the 28V signal is lost. It is not possible to tell ~~when these flags are free to move (as they are in this instrument)~~ whether the flags were in or out of view at the time of the impact and loss of power.

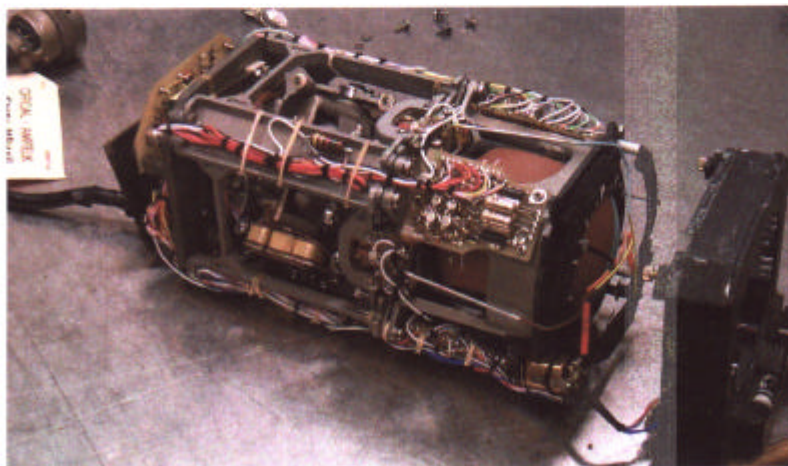
Figure 6: GH-14 with case opened

- The cord tying the attitude sphere to the gyro assembly was broken loose, allowing the sphere to rotate in pitch.
- The attitude sphere displayed pitch was approximately 80° off from the pitch attitude of the gyro assembly
- The gyro was out of balance despite the presence of a large number of balance weights
- The "Valid Interlock" relay had broken loose
- The movement of the localizer ~~motor~~ meter movement seemed un-impeded
- The movement of the glideslope ~~motor~~ meter movement seemed un-impeded.
- There is an impact mark on the attitude sphere and corresponding blue paint on the indicator frame (Figure 7).
- Aligning these marks gives an attitude of 25° pitch up and 67° right bank.

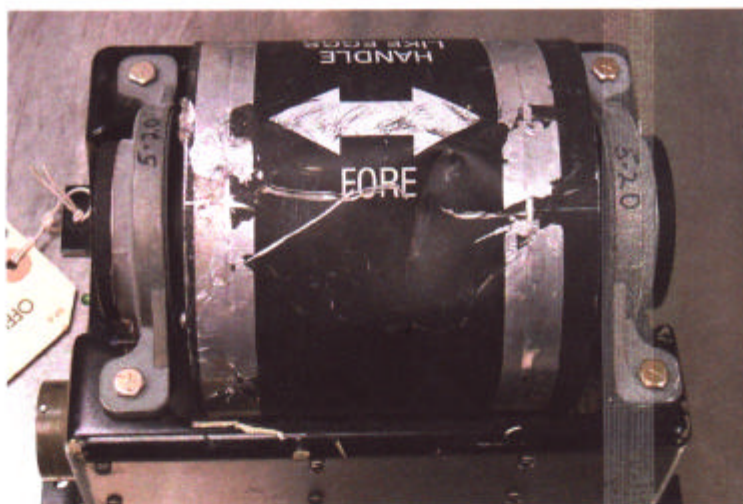
Figure 9: VG-14A

- Unit was a VG-14A vertical gyroscope, P/N 7000622-901, S/N 86055592, MOD A.B.C.D.E.F.
- Unit had a Honeywell repair sticker indicating repair and modification at a Honeywell shop on May 22, 1992.
- Unit had a sticker from "Field Aviation Accessories Limited" dated May 29, 1992.
- Unit had a dent in the gyro can approximately 1/4 inch deep under the "FORE" label (see Figure 9).
- The Honeywell seal on the gyroscope can was intact.

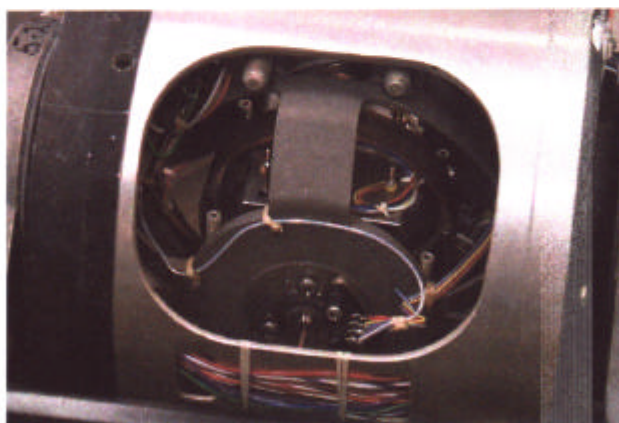
Figure 10: VG-14A Internal Components

- No apparent internal damage
- Gimbals were free to move
- Gyroscope slightly off balance – corresponding to a 45° bank with power off

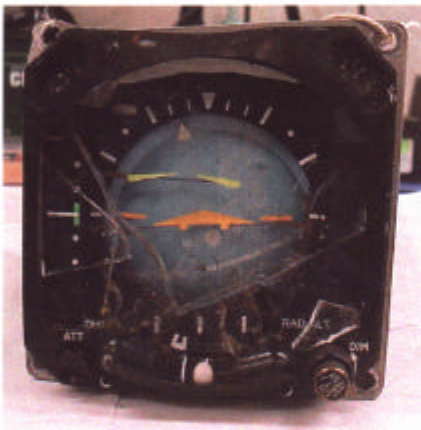
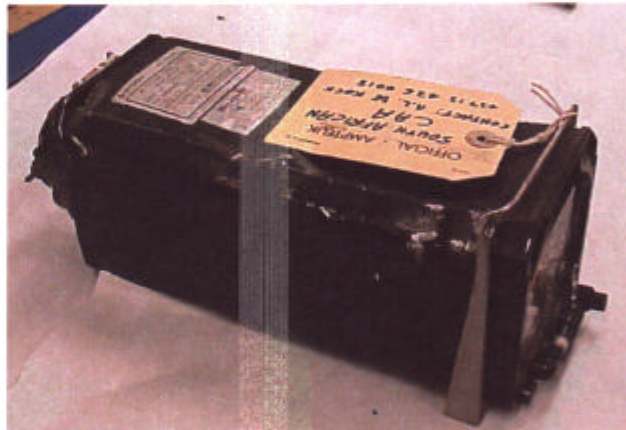
- The unit was P/N 7001182-904, S/N 82080280, MOD A and C.
- Unit had a Honeywell shop repair sticker showing repair on April 7, 1995.
- Honeywell shop seals are broken.
- No Flags in view
- Attitude is approximately 90°+ nose up, slight right bank (this differs from pictures taken at the crash site which show approximately 5° nose up with a slight right bank.)
- DH and Go-Around annunciator lights (in top corners of ADI case) are missing
- Glideslope pointer on the left is centered and not flagged
- Flight Director command bars are pitched up with a slight right bank. Bars are displaced slightly to left of ADI center-line.
- Fixed aircraft symbol is slightly out of position
- Inclinator is not damaged and operating properly.
- Glass faceplate is cracked.
- DH set control, digit dim control, and ATT test controls are jammed.

- The Flight Director flag was found loose in the case.
- The attitude sphere was jammed
- The Glideslope pointer had moved to the top of the scale (spring loaded to bias out of view)
- The CCA A4 showed substandard repair
- The mechanical components were significantly mis-aligned.

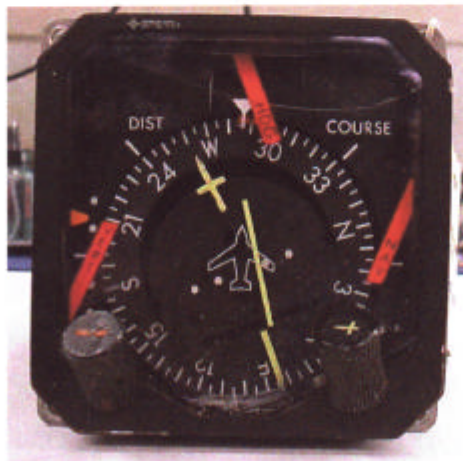
Figure 14: RD-550 Front View

- Unit is P/N 7001179-916, S/N 81110729, MOD A,B,C, and D.
- Unit has a Sperry shop repair sticker showing repair on October 24, 1985.
- Sperry (Honeywell) shop seals are missing.
- Flags are in view.
- Heading is approximately 286°.
- Selected course pointer is 262° for the head and 84° for the tail.
- Glideslope pointer is about 1.25 dots above reference.
- Course Deviation Indicator is twisted, indicating about .2 dots at tail end (connection to meter movement) and about 1.5 dots at head end.
- Compass sync indicator is in the middle.
- Front glass is undamaged.
- Parts are loose inside case.

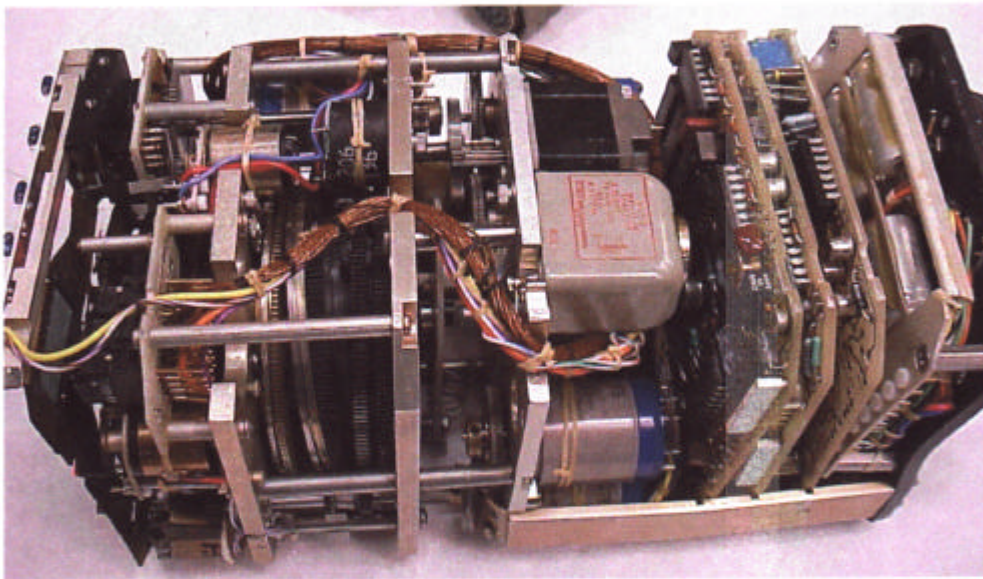
Figure 15: Interior of RD-550

- Three loose screws and a loose board retainer were found.
- The heading flag was broken off from the heading flag motor.
- The glideslope motor was free to move, but the pointer was slightly bent upward.
- The compass sync (X-O) motor was free to move.
- A broken IC and a replaced IC, which doesn't appear to be a Honeywell part, were found on CCA A2 (Figure 16). The quality of repair on A2 appears substandard.
- A broken IC was found on CCA A3.

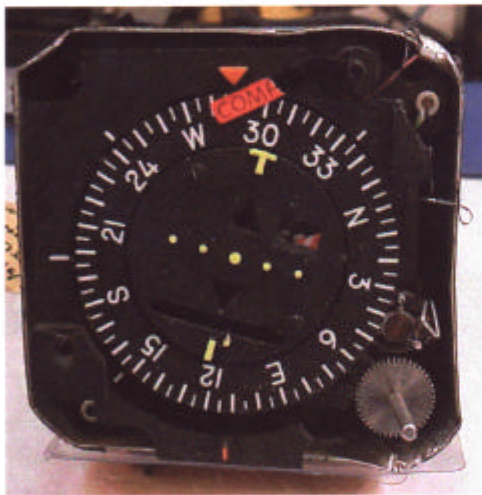
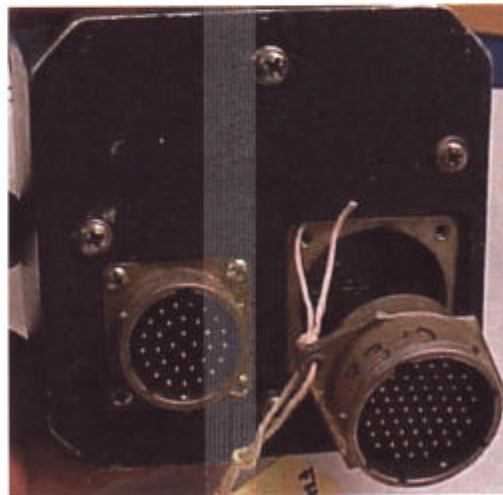
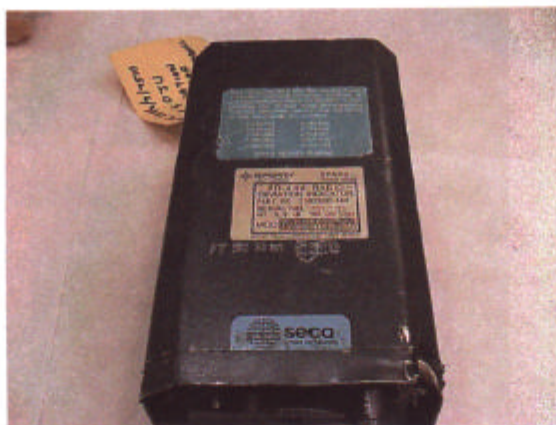
- Unit is P/N 2592920-444, S/N 77122395, MOD A, B, C, D,E,F,G,J,K, and L.
- Unit has a partial "Acrospatiale SECA" repair sticker, broken at the intersection of the bezel and case.
- Compass flag is in view.
- Front glass and bezel are missing.
- Heading is 288°.
- Course pointer head is 304°, tail is 124°.
- The Course Deviation Indicator is missing.
- The Glideslope pointer is missing.
- There is no To./From display.
- There is no Selected Heading Bug.
- Course select knob is missing.
- One rear connector is loose (Figure 18).
- Compass sync indicator is missing.
- NAV flag is approximately 10% in view.

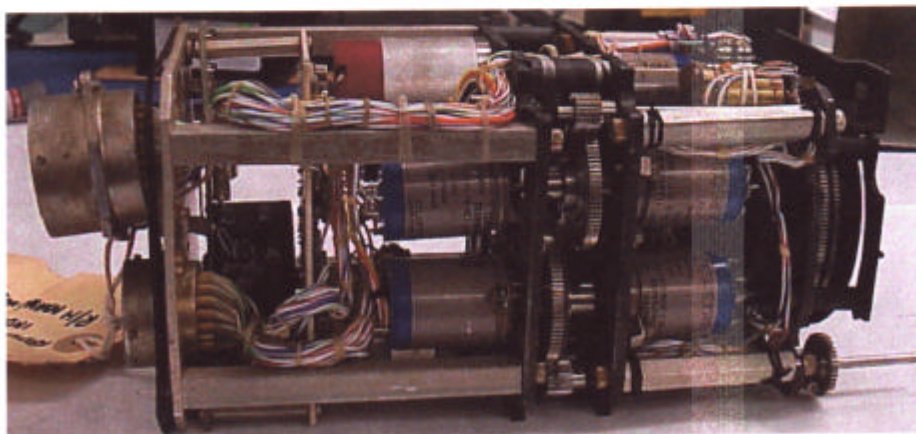
Figure 20: RD-444 Interior

- No loose parts.
- Glideslope pointer broken off from meter movement.

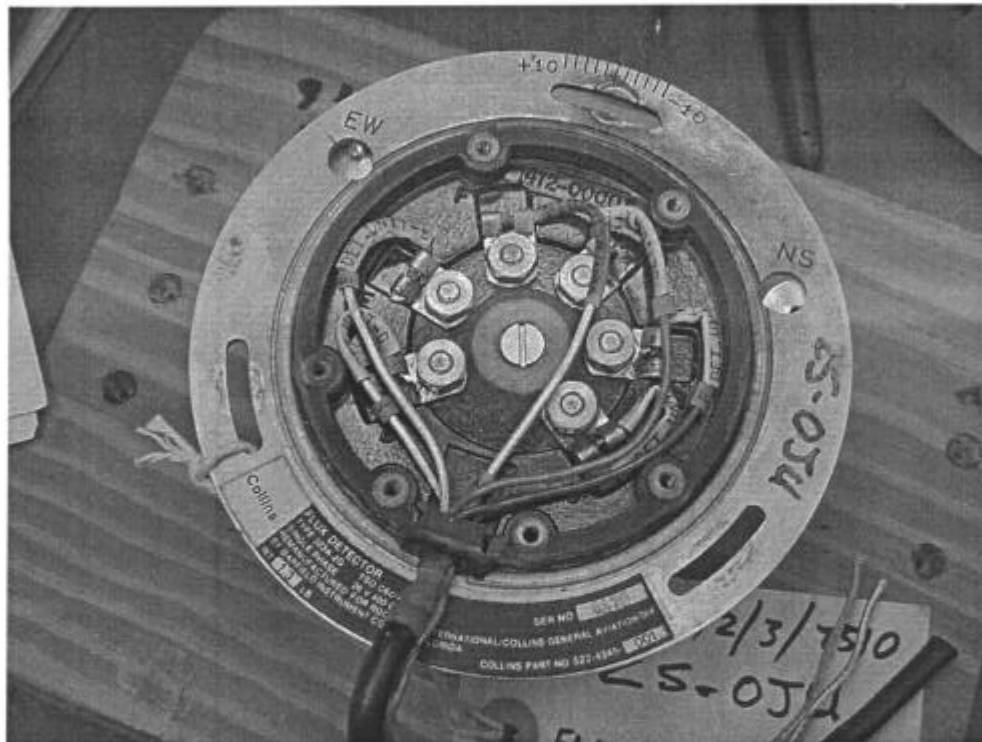
Figure 2 - Flux Detector with cover plate removed showing original aircraft wiring

The 323A-2G unit was removed from the airplane by cutting the interconnecting cable. To facilitate testing, the unit cover plate was opened to access the mounting terminals. The original wiring was inspected and looked to be in good condition. Some solder flux residue was observed in and around the solder joints on the lugs. The cut cable was then removed and replaced with a Collins made interconnecting cable and connector.

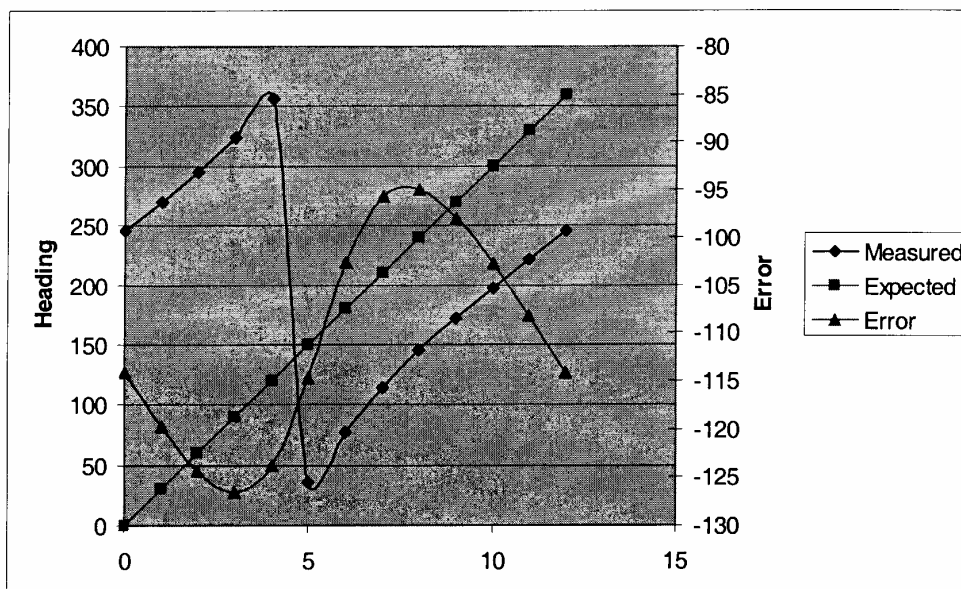
A 12-point check swing was performed on the index stand. The starting point of the swing was approximately north, but the flux detector read 245.9 degrees.

Step	Measured	Expected	Error
0	245.9	0	-114.1
1	270.18	30	-119.82
2	295.57	60	-124.43
3	323.39	90	-126.61
4	356.23	120	-123.77
5	35.31	150	-114.69
6	77.44	180	-102.56
7	114.36	210	-95.64
8	145.08	240	-94.92
9	172.04	270	-97.96
10	197.18	300	-102.82
11	221.7	330	-108.3
12	245.9	360	-114.1
