CA18/2/3/8017			
		SOUTH AFRICAN CIVIL AVIATION AUTHORITY ACCIDENT REPORT – EXECUTIVE SUMMARY			
Aircraft Registration	ZS-RMR	Date of Accident	2 October 2005	Time of Accident	1830Z
Type of Aircraft	Messerschmitt Bolkow Blohm GMBH MBB BO 105-S		Type of Operation	Medivac	
Pilot-in-command Licence Type	Commercial	Age	35	Licence Valid	Yes
Pilot-in-command Flying Experience	Total Flying Hours	1779.42	Hours on Type	4.6	
Last point of departure	GPS position S 33° 43.645' E023° 19.355', near the town of Haarlem				
Next point of intended landing	FAGG				
Location of the accident site with reference to easily defined geographical points (GPS readings if possible)					
GPS position S 33° 47.56' E023° 19.97', near the town of Haarlem					
Meteorological Information	According to the official weather report, partly cloudy conditions, with isolated thunderstorms which were most likely at the time and place of the accident.

AIRCRAFT ACCIDENT REPORT

Name of Owner/Operator : Air Ambulance Service (Red Cross)
Manufacturer : Messerschmitt Bolkow Blohm
Model : GMBH MBB BO 105-S
Nationality : South African
Registration Marks : ZS-RMR
Place : Haarlem
Date : 2 October 2005
Time : 1830Z

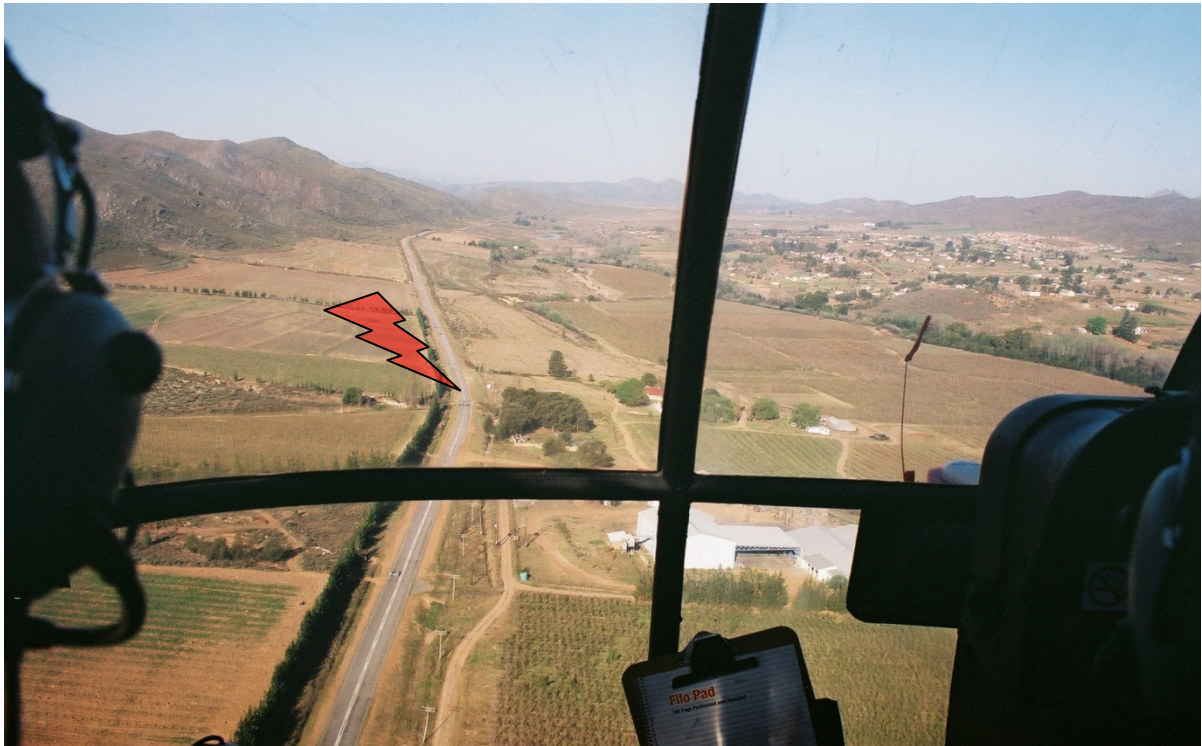
The RED arrow indicates the position of the road accident from where the helicopter took off. Position S33° 43.645' E023° 19.355 @ an elevation of 2500 ft AMSL.

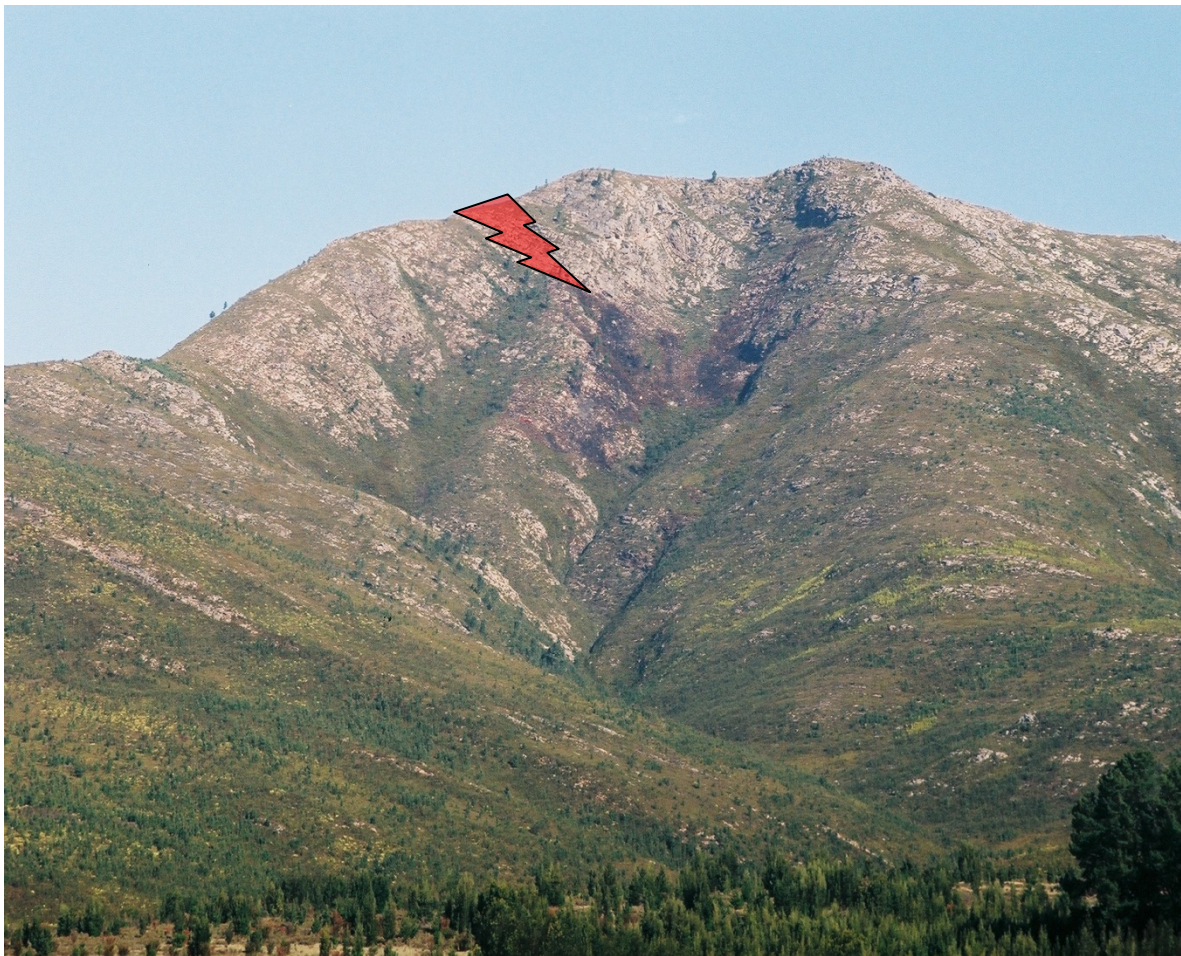
The arrow indicates the position of the helicopter accident. Position S33° 47.56' E023° 19.97' @ an elevation of 4600 ft AMSL

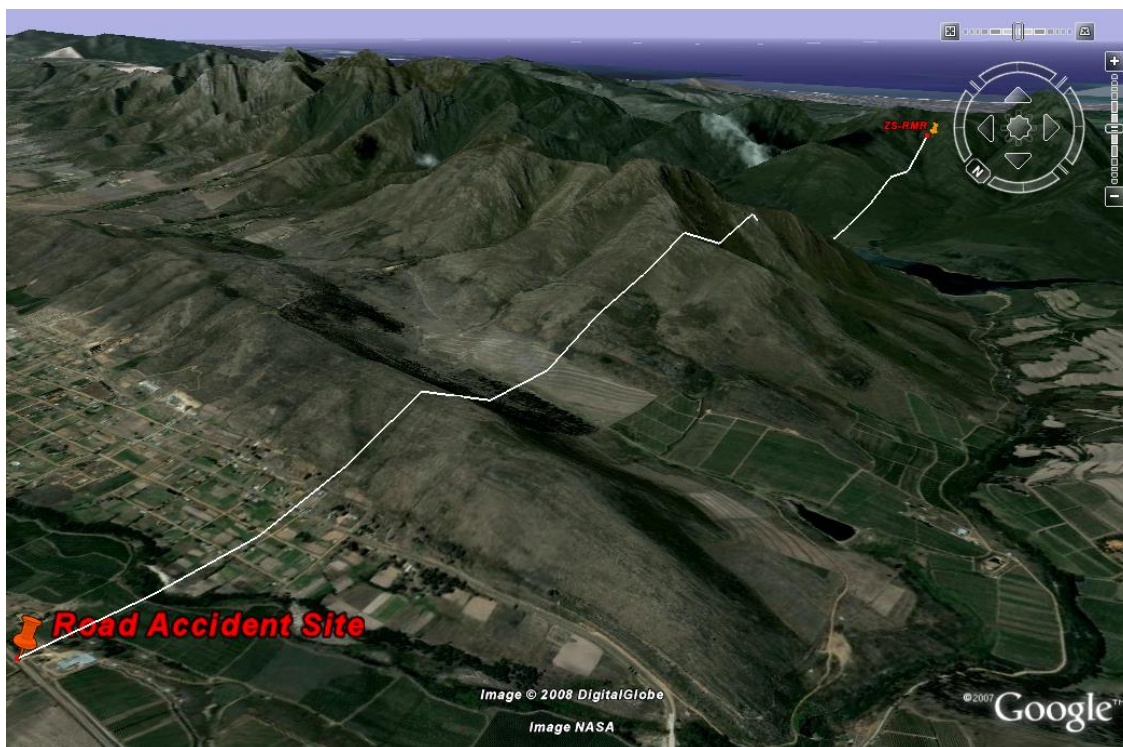
The picture below shows the take-off position at the road accident site and the ground profile (Ground track) to the aircraft accident site. In the background (top right hand corner), Plettenberg Bay can be seen.

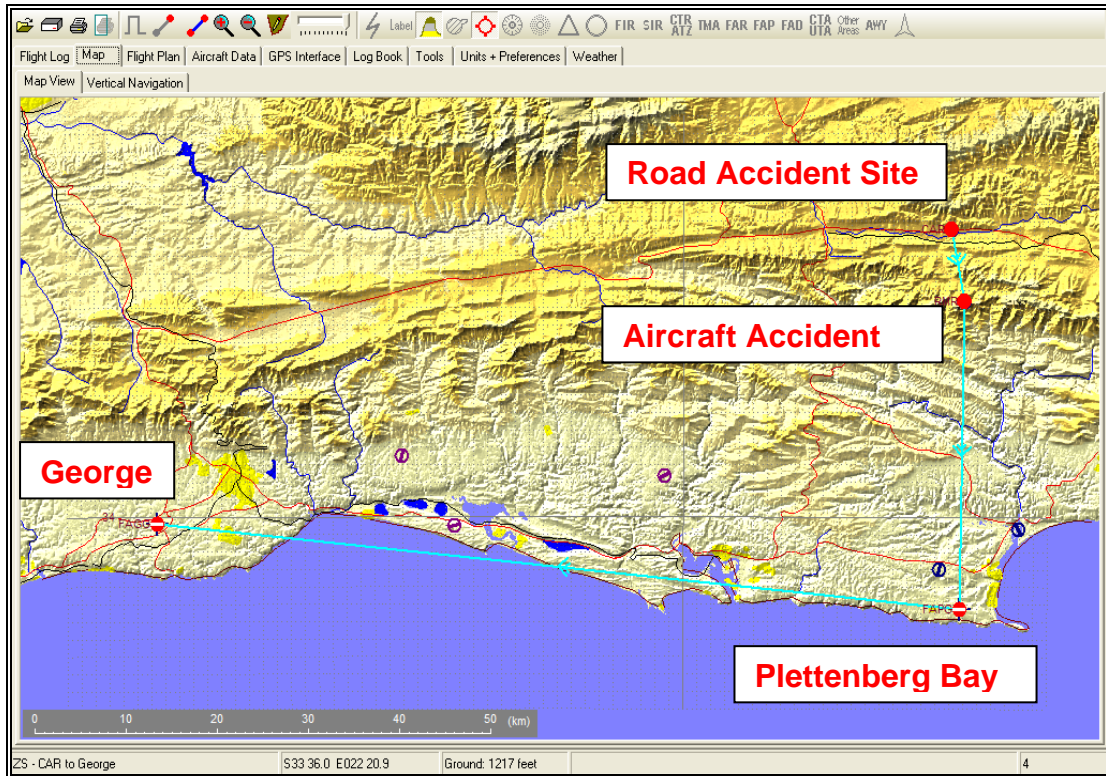
1.19.1 Map & Vertical Navigation Profile:

- 1.19.1.1 A computer program (*EASYPLAN, Version 3.047*) was used to create the intended flight details from the position where the aircraft took off to the accident site, continuing to George, via Plettenberg Bay as illustrated below.
