EXECUTIVE SUMMARY AND AIRCRAFT ACCIDENT REPORT

Reference:	CA18/2/3/8142	
Aircraft Registration	ZU-DYF	Date of Accident	16 June 2006		Time of Accident	0935Z
Type of Aircraft	Dragonfly MK3		Type of Operation		Ferry Flight	
Pilot-in-command Licence Type		Airline Transport	Age	27	Licence Valid	Yes
Pilot-in-command Flying Experience		Total Flying Hours	3500.0		Hours on Type	2.0
Last point of departure		Virginia Aerodrome. (FAVG)				
Next point of intended landing		East London Aerodrome. (FAEL)				
Location of the accident site with reference to easily defined geographical points (GPS readings if possible)						
In the Sawoti area approximately 35 nm south-west of Durban (GPS position: S30° 16'09" E030° 31'31").						
Meteorological Information		Surface wind: Light and Variable, Temperature: 19°C, Visibility: CAVOK				
Number of people on board	1 + 0	No. of people injured	1 + 0	No. of people killed	0	
Synopsis						
<p>The pilot, as the sole occupant, departed from Virginia Aerodrome on a ferry flight to East London via Cato Ridge. The pilot avoided FADN Terminal Control Area (TMA) en-route to East London and climbed to 5500ft AMSL at an indicated air speed of 145kt. At that stage, the

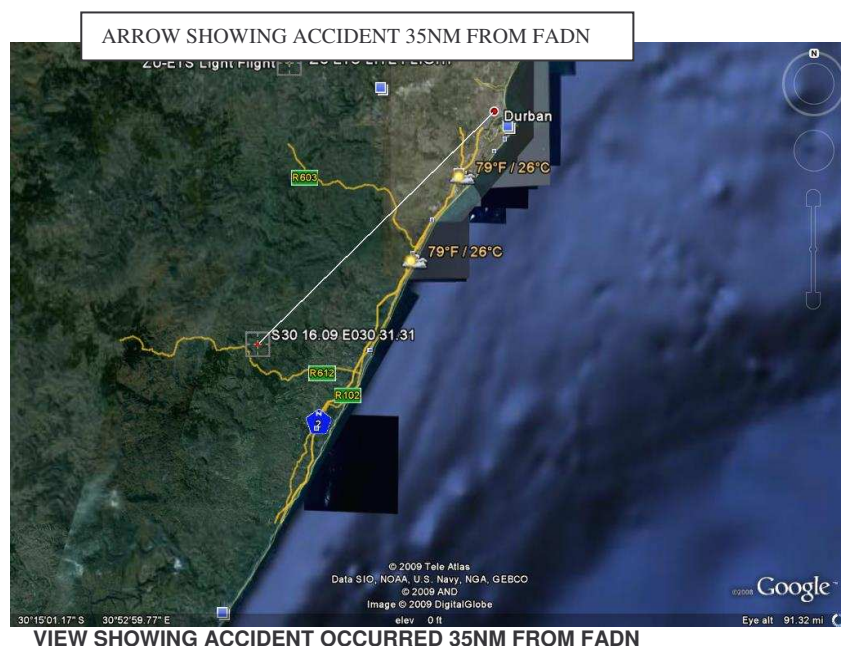
- 2.5.1 The accident did not occur at an aerodrome but in a harvested cane field, 35nm south-west of Durban at a GPS position S30°16'09" E030°31'31".

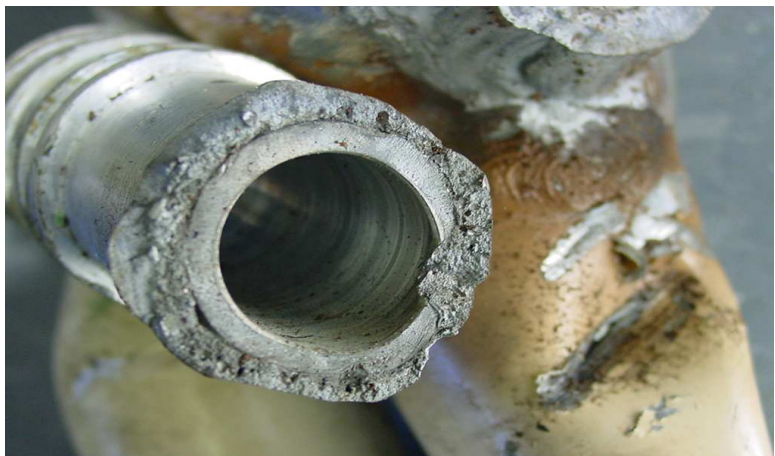
1.16.2 A general inspection of the engine revealed that damage was caused to the lower surfaces of the engine during the impact. The exhaust system, as well as the accessories mounted to the bottom of the engine suffered impact damage. It was noted that during the impact sequence the engine-mounting frame was deformed and caused the upper right-hand mounting point to impact a coolant receptacle welded to the intake manifold for that side. The failed welded joint appeared to be a poorly welded joint, as the aluminium welding material did not flow properly and had a porous appearance. A similar weld was noted on the left-hand side intake manifold.

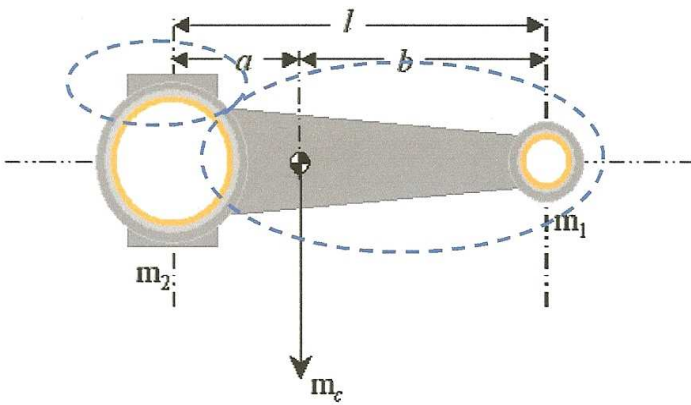
Diagram 1: Con-rod construction, only sections encircled in blue was retrieved for investigation purposes.
