# AIRCRAFT ACCIDENT REPORT AND EXECUTIVE SUMMARY

| | | | | Reference: | CA18/2/3/8768 | |
| <b>Aircraft Registration</b> | <b>ZS-HFG</b> | <b>Date of Accident</b> | 12 March 2010 | | <b>Time of Accident</b> | 1200Z |
| <b>Type of Aircraft</b> | Bell Jet Ranger 206B (Helicopter) | | <b>Type of Operation</b> | | Private | |

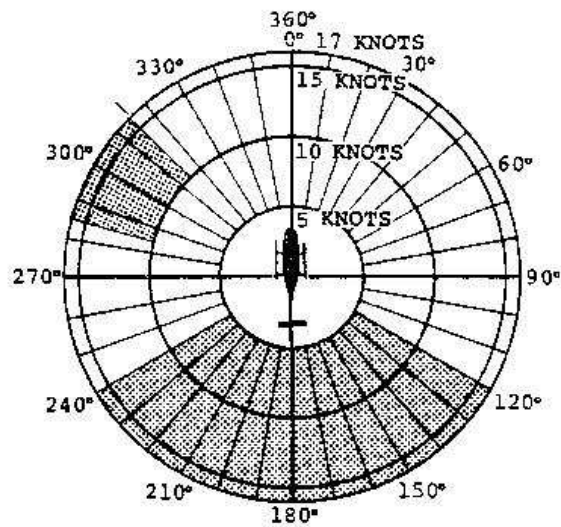
## RELATIVE WIND CHART

An unanticipated right yaw may occur when operating in the shaded areas of the chart.

This chart refers to unanticipated right yaw and does not replace the critical relative wind azimuth chart in the performance section of the flight manual which refers to tail rotor control margin.

- BE AWARE THAT IF A CONSIDERABLE AMOUNT OF LEFT PEDAL IS BEING MAINTAINED, THAT A SUFFICIENT AMOUNT OF LEFT PEDAL MAY NOT BE AVAILABLE TO COUNTERACT AN UNANTICIPATED RIGHT YAW.
- BE ALERT TO CHANGING AIRCRAFT FLIGHT AND WIND CONDITIONS SUCH AS EXPERIENCED WHEN FLYING ALONG RIDGE LINES AND AROUND BUILDINGS.
- OBSERVE THE RELATIVE WIND CONDITIONS SET OUT IN THE ATTACHED CHART.
- IF A SUDDEN UNANTICIPATED RIGHT YAW OCCURS THE RECOMMENDED RECOVERY TECHNIQUE IS:
  1. APPLY FULL LEFT PEDAL.
  2. APPLY FORWARD CYCLIC, AND RECOVER.
  3. IF ALTITUDE PERMITS, REDUCE POWER.
