AIRCRAFT ACCIDENT REPORT AND EXECUTIVE SUMMARY

Reference:	CA18/2/3/8789	
Aircraft Registration	ZU-VDW	Date of Accident	29/05/2010		Time of Accident	1030Z
Type of Aircraft	Aveko S.R.O. VL3A1 Flamingo		Type of Operation		Private (Air race)	
Pilot-in-command Licence Type		Commercial	Age	39	Licence Valid	Yes
Pilot-in-command Flying Experience		Total Flying Hours	1706,4		Hours on Type	16,2
Last point of departure		FARG (Rustenburg)				
Next point of intended landing		FARG (Rustenburg)				
Location of the accident site with reference to easily defined geographical points (GPS readings if possible)						
Near Bela-Bela at GPS position S 24° 54' 27.00" & E028° 14' 54.00" at an elevation of 3674 ft / 1120 m AMSL						
Meteorological Information		Fine weather conditions prevailed at the time of the accident with a light south-westerly wind, mild temperature and no cloud.				
Number of people on board	1+1	No. of people injured	0	No. of people killed	1+1

Synopsis		<p>On 29 May 2010, the aircraft (ZU-VDW) took part in the President's Trophy race.</p> <p>During descent the left wing failed as a result of flutter. The aircraft crashed at approximately 1030Z in clear daytime conditions near Bela

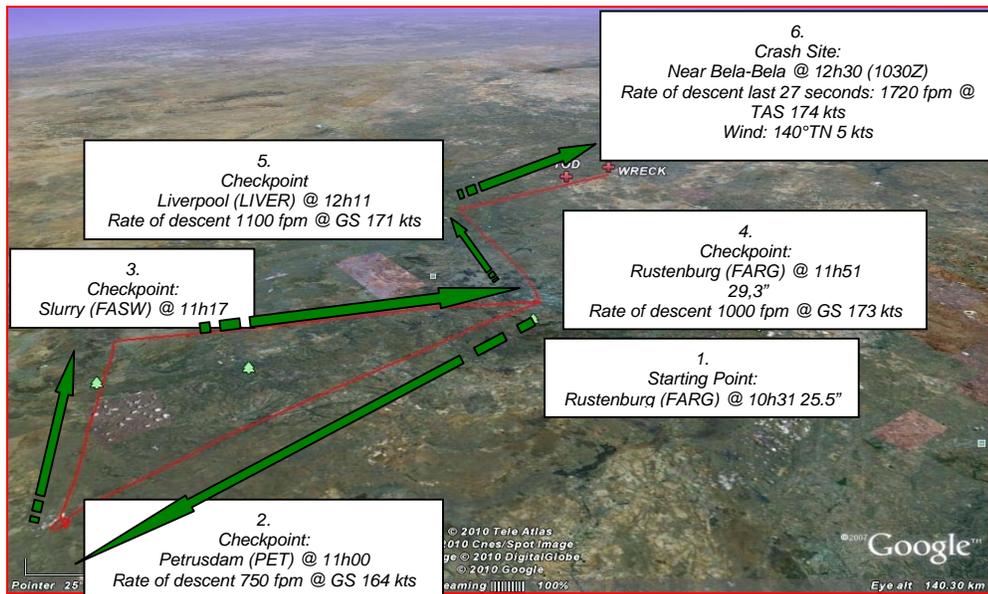
Figure 1: Route details according to the GPS logging device on board

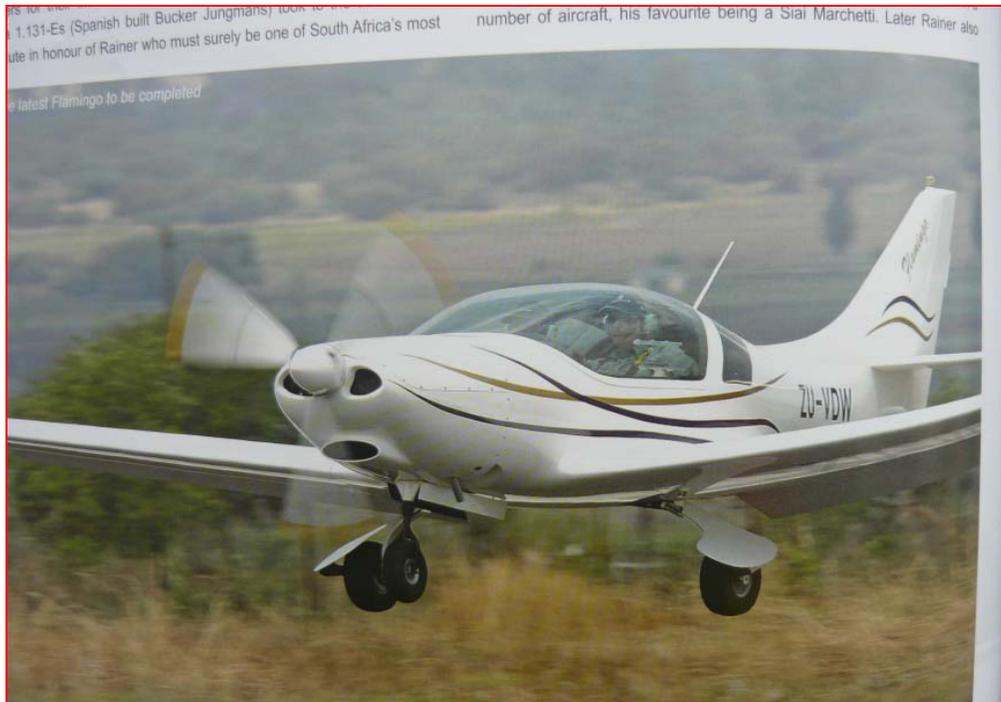
Figure 4: The accident aircraft before the accident

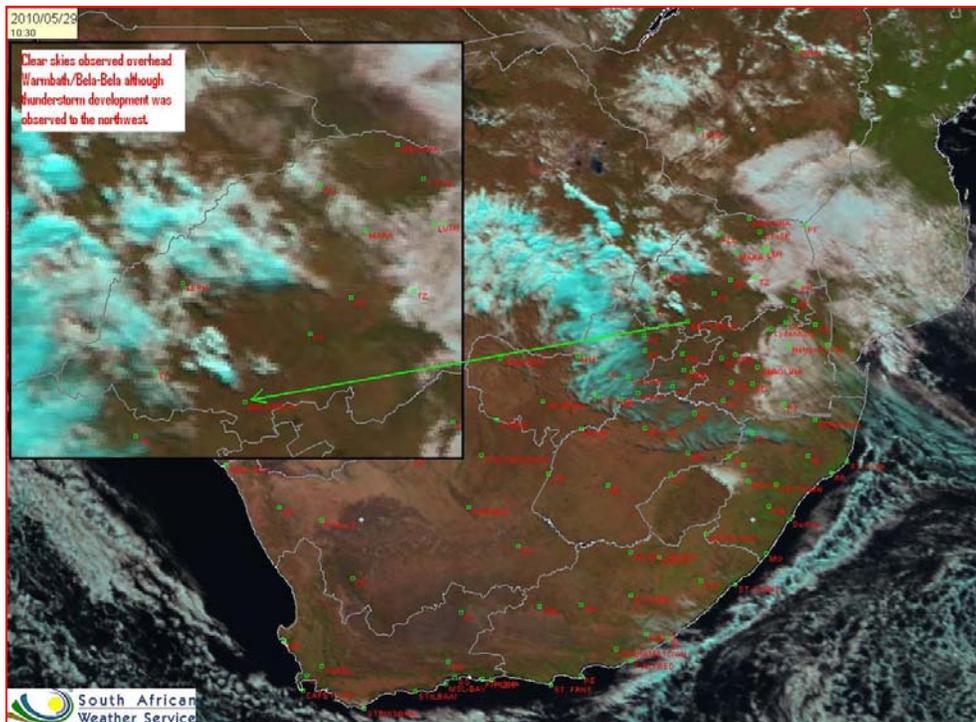
Figure 4: Satellite image at 1200Z on 29 May 2010 showing thunderstorm development over the north-western parts of Limpopo up to the area to the immediate north-west of Bela-Bela

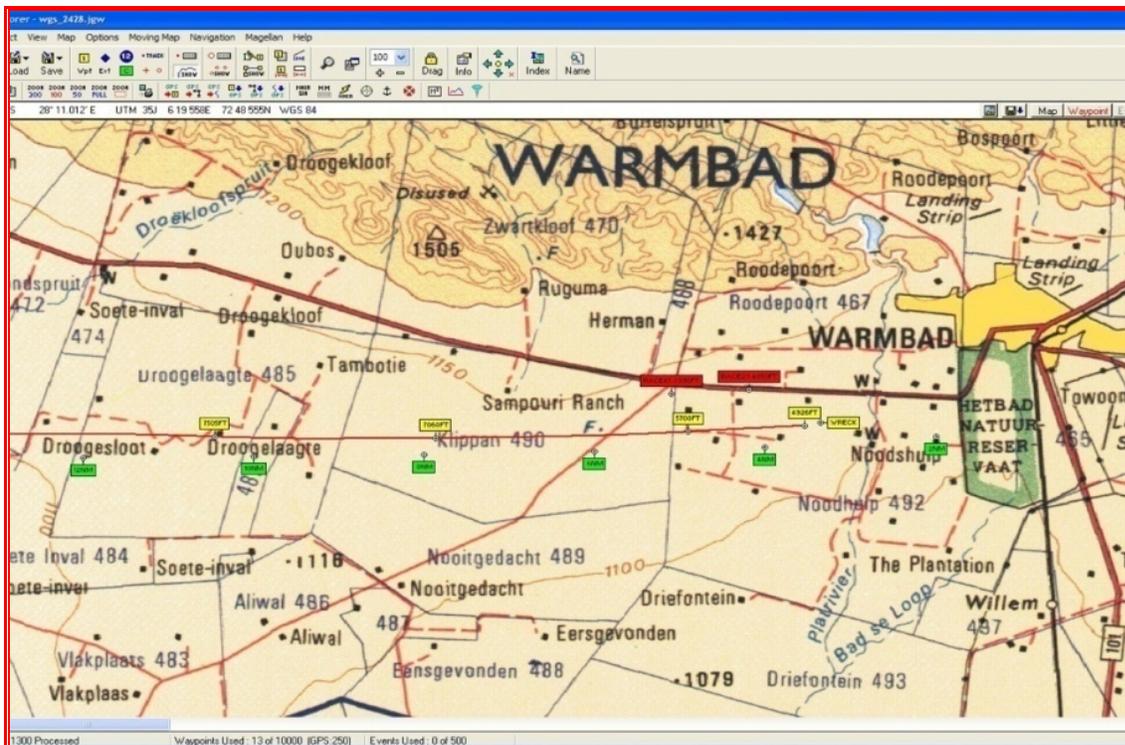
At TOD the aircraft was 10,46 nm west of the Bela-Bela turning point at 7505 ft AMSL (3845 ft AGL). Assuming the pilot intended flying over the turning point at 200 ft AGL, he was 3645 feet above his target altitude. Further assuming a ground speed of 152 kts, he would have had to descend at 860 feet per minute to reach his target altitude.

Figure 14: Map of the Warmbaths (Bela-Bela) area

From the logger it was determined that he descended at 445 ft / min during the 1st minute after commencing the descent. During the 2nd minute after commencing the descent he descended at 1360 ft / min and at 774 ft / min during the last 27 seconds recorded.
