AIRCRAFT ACCIDENT REPORT AND EXECUTIVE SUMMARY

Reference:		CA18/2/3/8995	
Aircraft Registration	ZU-AKW	Date of Accident	14 December 2011		Time of Accident	1625Z	
Type of Aircraft	Koala Super Special		Type of Operation		Private		
Pilot-in-command Licence Type		Commercial	Age	27	Licence Valid	Yes	
Pilot-in-command Flying Experience		Total Flying Hours	+289,4		Hours on Type	5,4	
Last point of departure		Swartkops Aerodrome (FASK) (Gauteng)					
Next point of intended landing		Swartkops Aerodrome (FASK) (Gauteng)					
Location of the accident site with reference to easily defined geographical points (GPS readings if possible)							
On the R55 tar road near Laudium, 5 nm south-west of Pretoria							
Wind: Visibility: Temperature: Dew point: Cloud cover: Cloud base:		Weather was fine; Surface Wind: light/03 kt, Visibility: 10 000 m,					
Number of people on board	1+1	No. of people injured	0	No. of people killed	1 + 1		
Synopsis							
<p>The pilot and a passenger who was the future owner of the aircraft, departed from Swartkops Aerodrome (FASK) on a local private flight to the General Flying Area. A witness observed the aircraft flying overhead his house in a slightly south-westerly d

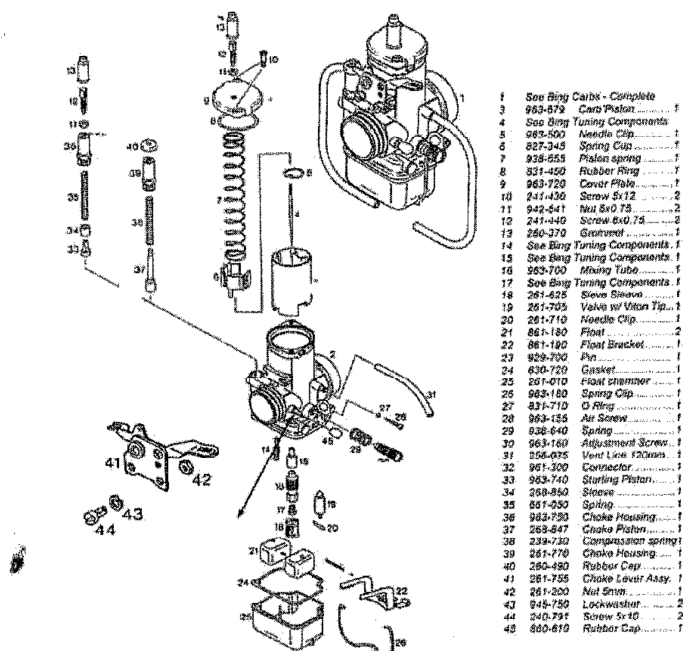
Diagram 3: Bing Type 54 Carburettor Illustrated Parts List

The float chamber (25) was severed on impact leaving the gasket (24) slightly damaged but in position (Photo 18, green arrow).

The main jet (17) was removed indicating size number 158 (Photo 18, blue arrow). Some post-impact induced foreign matter was noted but no clear indications of carbon build-up or other.

The idle jet (14) with size number 55 (Photo 18, yellow arrow) was removed but revealed no obstruction or other.

The pin was removed (Photo 18, red arrow) in order to release the float arm bracket (22), spring clip (19) and float needle (20). All parts proved to be in good condition with no obstruction or stickiness.

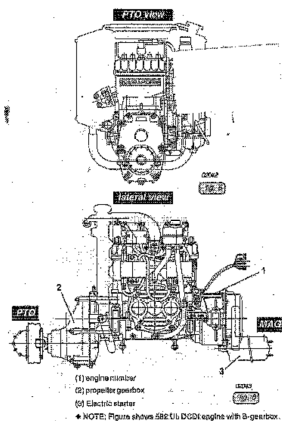
Diagram 4: Rotax 582UL engine layout

6.3.2. Engine. The Rotax 582 two-stroke engine (Diagram 4) was fitted in the inverted configuration on ZU-AKW (Photo 28).

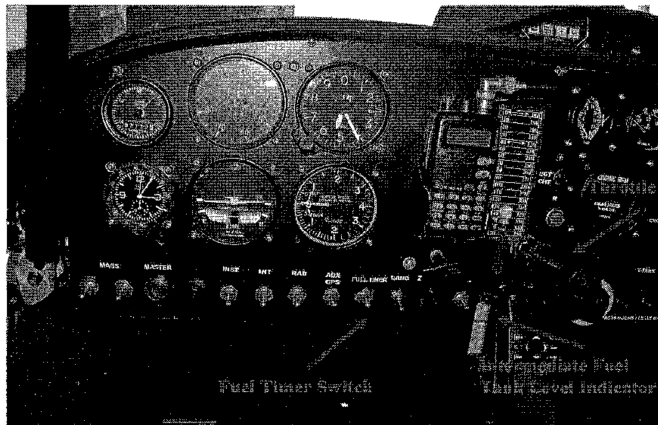
Photo 42: ZU-AKW cockpit layout (courtesy Francois Haarhoff Trust)

6.4.1. Main Electrical Supply Selectors. The Master Switch and Mags 1 and 2 were destroyed and presumed to be in the "ON" position on impact.

Note: During flight the crew are responsible to transfer fuel from the two aft main tanks to the intermediate tank by means of one, or both, of the in-line electrical fuel transfer pumps. For the primary (dual) pump no 1 to operate, the Fuel Timer switch (Photo 42) must be selected "ON" and the Timer (Photo 43) at the "0 minutes" position, and/or, the Manual Switch must be set on "Pump 1" (Photo 43).

The Fuel Timer switch (Photo 42) was not recovered. The Timer switch was found at the "0 minutes" position (Photo 44 red arrow). All indications are that the Timer switch was fitted at later time as it partially obscures the Manual Pump switch insignia. The Manual Pump Switch was found jammed behind the GPS bracket (yellow arrow) and at the "Pump 1" position (blue arrow).
