## AIRCRAFT ACCIDENT REPORT AND EXECUTIVE SUMMARY

Reference:	CA18/2/3/9120	
<b>Aircraft Registration</b>	ZU-EFY	<b>Date of Accident</b>	06 January 2013		<b>Time of Accident</b>	1035Z
<b>Type of Aircraft</b>	Bantam B22J		<b>Type of Operation</b>		Private	
<b>Pilot-in-command Licence Type</b>		National Pilot License	<b>Age</b>	53	<b>Licence Valid</b>	Yes
<b>Pilot-in-command Flying Experience</b>		Total Flying Hours	50.7		Hours on Type	50.7
<b>Last point of departure</b>		Hazyview Airfield, (Mpumalanga Province)				
<b>Next point of intended landing</b>		Hazyview Airfield, (Mpumalanga Province)				
<b>Location of the accidentsite with reference to easily defined geographical points (GPS readings if possible)</b>						
GPS co-ordinates S25 05.539' E030 42.415' (Sabie area, Mpumalanga Province)						
<b>Meteorological Information</b>		Temperature: 24 °C Dewpoint: 17 °C Visibility: >10k m Cloud: Sky Clear Surface wind 100/11kts				
<b>Number of people on board</b>	1+1	<b>No. of people injured</b>	1+1	<b>No. of people killed</b>	0

## AIRCRAFT ACCIDENT REPORT

**Name of Owner/Operator** : P G Eksteen  
**Manufacturer** : MicroAviation New Zealand LTD  
**Model** : Bantam B22J  
**Nationa

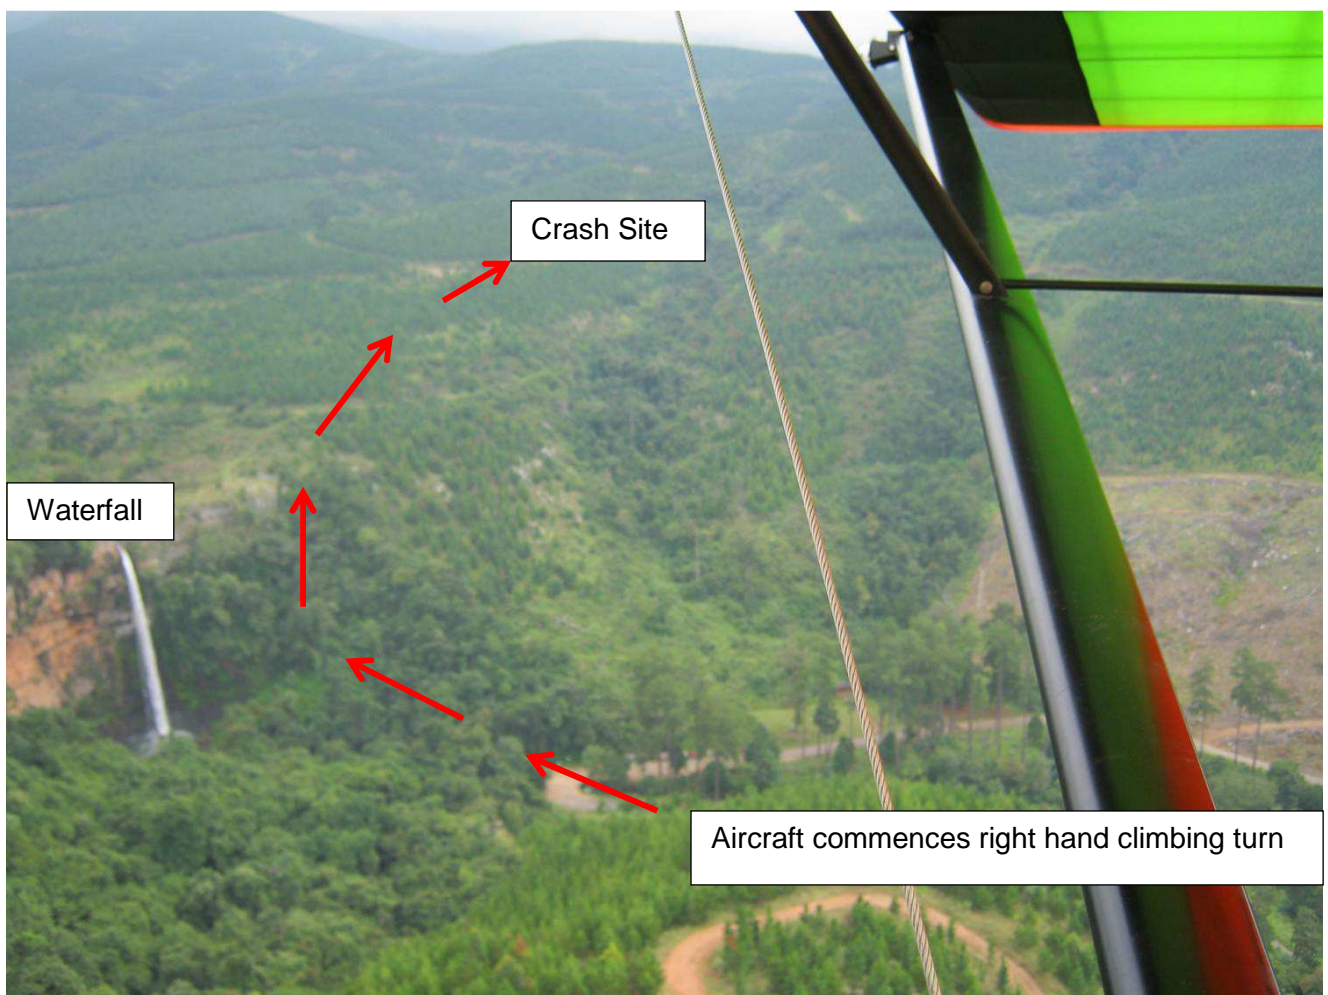
*Figure 1: Flight path of aircraft prior to impact.*

- 1.1.3 Whilst completing a climbing turn to the right the air craft maintained a positive rate of climb temporarily thereafter he noticed that the aircraft started to descend. The pilot confirmed he had a full power setting but the aircraft continued to descend towards the tall vegetation in the surrounding area.
- 1.1.4 The pilot spotted a plantation service road and attempted to execute an emergency landing on the road, however during the emergency landing the left hand wing impacted with the tree tops first, causing the pilot to lose control of the aircraft.
- 1.1.5 The aircraft came to rest on an embankment (elevation 4030ft AMSL) and the pilot and his wife evacuated the aircraft without assistance.

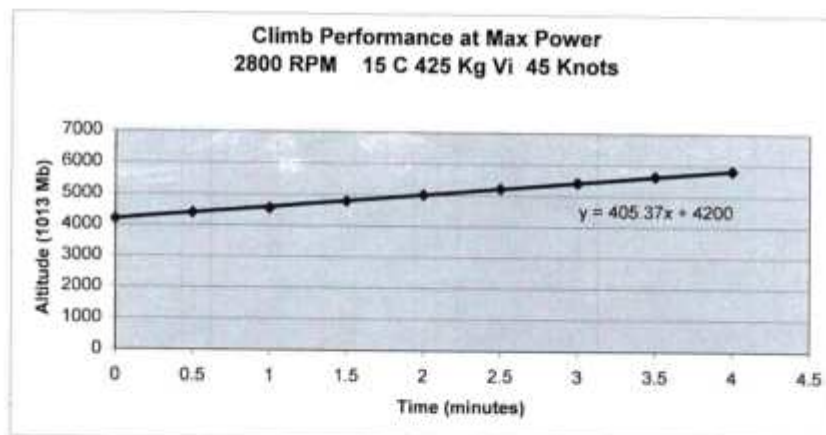
The forces on the controls were light and the movements needed on the control stick were conventional. The stability of the aircraft was stable and conventional. The throttle remained in position and the trim authority was enough to maintain the attitude of the aircraft. No performance graphs were provided in the manual but the following graph was drawn from data recorded during the climb:

The rate of climb was 405 ft/min at the average pressure altitude of 5000 feet at 15°C. the maximum power obtained was 2800 RPM at full throttle. The average mass during the climb was 425 kg. The engine temperatures stabilized after 1 min in the climb. The oil temperature was 80° and the CHT was stable at 240°F.
