COMPILED BY:  	Crash <small>Aviation Accident Investigation & Medalsburg</small> LAB	PAGE 1 OF 12	
COMPILED FOR: A.A.S.	INVESTIGATION REPORT: PROPELLER FAILURE, BANTAM LIGHT SPORT A/C No ZU-CZU	DOCUMENT NUMBER MET-008-07-13	
		DATE 2013-08-30	ISSUE 2

ITEM: **PROPELLER ASSY., BANTAM LIGHT SPORT AIRCRAFT,
NUMBER ZU-CZU**

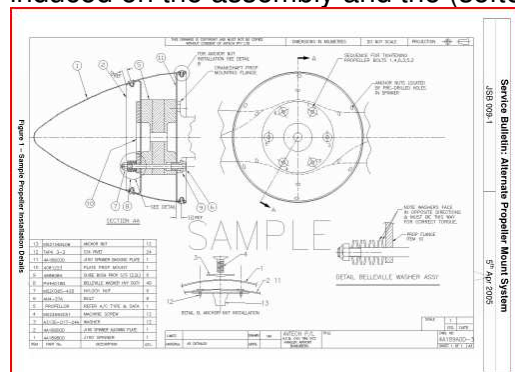
Diagram 3: Propeller Installation (courtesy Jabiru JSB 009-1)

8.1.1. Incorrect Fitment. The photographic and on-site evidence clearly shows that the 6x propeller bolts were fitted with the threaded end facing aft. This in contravention to the prescribed methodology as stated in Jabiru Aircraft Service Bulletin No JSB 014-2, page 5, par. 4.2, dated 09/06/2011, where it refers to Jabiru Aircraft Service Bulletin No JSB 009-1, dated 04/04/2005, as the correct assembly method (Diagram 3, Excerpt 2 and 3). Although no clear reason/s for this orientation of the bolts are described in said documents, it can be derived that this method will not only allow for easier fitment of the (prescribed) Belleville washers (Figure 1), but also for better access to the nut end to ease the application of the torque wrench (Photo 22). No Belleville- or flat washers (Photo 21) were fitted to the assembly under investigation as per JSB 009-1.

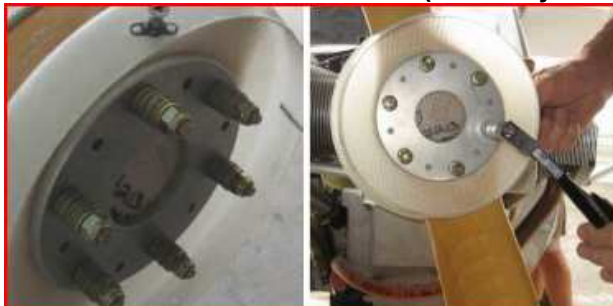
Photo 22: Fitment of Belleville washers and torque wrench application (courtesy Jabiru Constructors Manual)

It is considered good practice for the torque to be applied to the nut end rather than the bolt head end (as per SKF Bolt Tightening Handbook). The damages inflicted to the softer aluminium spinner flange by the bolt heads clearly indicate that the torque wrench was most probably applied to the forward facing bolt heads rather than the aft facing nuts. The final tightening load (torque) are dependent on the corresponding friction coefficients related to the bolt and nut threads as well as the contact surfaces between the nut/bolt head and the flange. In this case the 'binding' effect between the harder steel bolt head and the much softer aluminium based flange surface will render a torque wrench reading that may correspond with the prescribed value whilst a lower than desired axial tension stress on the bolt are in fact present, leaving it under-torque and subsequently prone to loosening, and failure, within the 10.6 operational hours.
