AIRCRAFT ACCIDENT REPORT AND EXECUTIVE SUMMARY

Reference:	CA18/2/3/9211	
Aircraft Registration	ZU-CVH	Date of Accident	19 August 2013		Time of Accident	12:15Z
Type of Aircraft	Magni M16 Gyro		Type of Operation		Hire & Fly (Private)	
Pilot-in-command Licence Type		Recreational Pilots Licence	Age	45	Licence Valid	Yes
Pilot-in-command Flying Experience		Total Flying Hours	70.5		Hours on Type	70.5
Last point of departure		Fisantekraal Airfield (FAFK, Western Cape Province)				
Next point of intended landing		Fisantekraal Airfield (FAFK, Western Cape Province)				
Location of the accident site with reference to easily defined geographical points (GPS readings if possible)						
At the intersection of runway 05 and 32 at GPS coordinates S33°46'299 E018°44'408" at an elevation of 410 ft.						
Meteorological Information		Temperature: 19 °C, Visibility: CAVOK, Wind direction: 230°, Wind speed: ± 5 kts				
Number of people on board	1 + 1	No. of people injured	1	No. of people killed	0

Name of Owner : L van Wyk
Name of Operator : Aerosport
Manufacturer : Magni Gyro
Model : Magni M16 Gyro
Nationality : South African
Registration Marks : ZU-CVH
Place : Fisantekraal Airfield
Date : 19 August 2

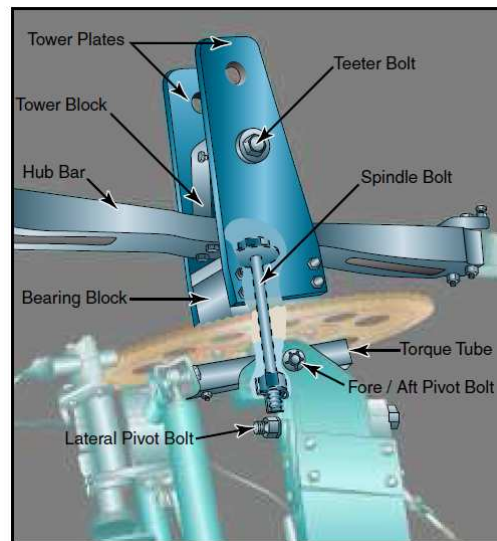
Figure 7: The semi-rigid, teeter-head system is found on most amateur-built gyroplanes. The rotor hub bar and blades are permitted to tilt by the teeter bolt.

1.16.4 Blade Flap – On a gyroplane with a semi-rigid, teeter-head rotor system, blade flap may develop if too much airflow passes through the rotor system while it is operating at low r.p.m. This is most often the result of taxiing too fast for a given rotor speed. Unequal lift acting on the advancing and retreating blades can cause the blades to teeter to the maximum allowed by the rotor head design. The blades then hit the teeter stops, creating a vibration that may be felt in the cyclic control. The frequency of the vibration corresponds to the speed of the rotor, with the blades hitting the stops twice during each revolution. If the flapping is not controlled, the situation can grow worse as the blades begin to flex and bend. Because the system is operating at low r.p.m., there is not enough centrifugal force acting on the blades to keep them rigid. The chock of hitting the teeter stops combined with uneven lift along the length of the blade causes an undulation to begin, which can increase in severity if allowed to progress. In extreme cases, a rotor blade may strike the ground or propeller. Refer to figure 7.
