**AIRCRAFT ACCIDENT REPORT AND EXECUTIVE SUMMARY**

| | | | | Reference: | CA18/2/3/9234 | |
| <b>Aircraft registration</b> | ZU-EUI | <b>Date of accident</b> | 17 October 2013 | | <b>Time of accident</b> | 1030Z |
| <b>Type of aircraft</b> | Sycamore MK1 (Gyrocopter) | | <b>Type of operation</b> | Private | | |

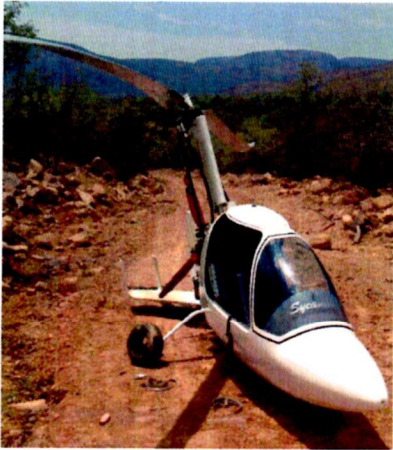
| | | | | | | | | | | | | | | | | | | | | |
| <b>Photo 1: ZU-EUI crash site (courtesy SACAA)</b> | | | | | | | | | | | | | | | | | | | | | |
| 1.2. This report is divided into the following sections: | | | | | | | | | | | | | | | | | | | | | |
|
