## AIRCRAFT ACCIDENT REPORT AND EXECUTIVE SUMMARY

Reference: CA18/2/3/9352	
<b>Aircraft Registration</b>	<b>ZU-FVW</b>	<b>Date of Accident</b>	12 August 2014		<b>Time of Accident</b> 0955Z
<b>Type of Aircraft</b>	Sling 2 (Aeroplane)		<b>Type of Operation</b>	Private	
<b>Pilot-in-command Licence Type</b>	Private pilot licence		<b>Age</b>	28	<b>Licence Valid</b> Yes
<b>Pilot-in-command Flying Experience</b>	Total Flying Hours		168.3		<b>Hours on Type</b> 124.3
<b>Last point of departure</b>		Port Elizabeth (FAPE) international aerodrome: Eastern Cape.			
<b>Next point of intended landing</b>		Tedderfield private aerodrome (FATA): Gauteng.			
<b>Location of the accident site with reference to easily defined geographical points (GPS readings if possible)</b>					
On a privately owned farm at GPS coordinates determined to be (S 32° 50.45.0' E 025° 48 .25.0') at an elevation of approximately 1 782 feet above mean sea level (AMSL).					
<b>Meteorological Information</b>		CAVOK weather conditions were reported.

**Name of Owner/Operator** : Madiba Bay School of Flight.  
**Manufacturer** : The Airplane Factory  
**Model** : Sling 2  
**Nationality** : South African  
**Registration Marks*

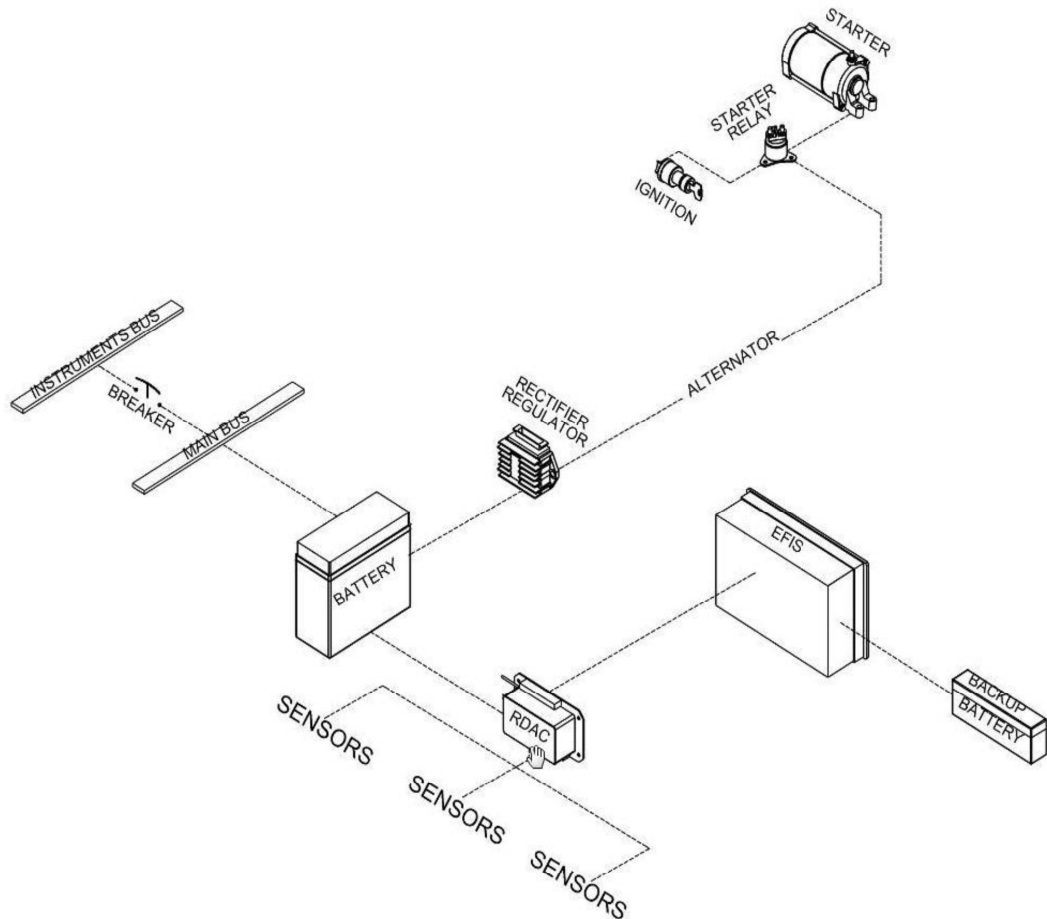
- 5.1 Sling 2 aircraft electrical description and warnings:  
This aircraft's electrical system consists of a 12 Volt DC circuit. An 18 Ah lead acid battery provides the energy necessary to start the engine and acts as an emergency standby supply of electrical power for electrical components in case of generator malfunction. The MGL Voyager has a 3 Ah back-up battery which charges from the Voyager backup battery connection terminals.

A single-phase generator connected to a regulator/rectifier supplies DC power to the bus bar and recharges the battery. The positive end of the rectifier is connected to the primary bus through a 50 Amp circuit fuse mounted on the firewall. A red warning light on the instrument panel will turn on indicating to the pilot that the generator is not operating. Circuit protection is through resettable breakers or fuses located on the lower right side of the instrument panel. Below is a Sling 2 aircraft electrical system.
