AIRCRAFT ACCIDENT REPORT AND EXECUTIVE SUMMARY

Reference:	CA18/2/3/9533	
Aircraft Registration	ZS-DOM	Date of Accident	26 March 2016		Time of Accident	1400Z
Type of Aircraft	Cessna T206H		Type of Operation		Private Part 91	
Pilot-in-command Licence Type	Private Pilot	Age	57	Licence Valid	Yes	
Pilot-in-command Flying Experience	Total Flying Hours	2780.9		Hours on Type	679.2	
Last point of departure	Aviators Paradise Field Airport (FAAP) Gauteng					
Next point of intended landing	Borneo Farm (Timbavati private nature reserve) Mpumalanga					
Location of the accident site with reference to easily defined geographical points (GPS readings if possible)						
On a private farm at end of the runway						
Meteorological Information	Wind direction:190°; Wind speed:5kt; Wind temperature:30°C: Visibility: Good					
Number of people on board	1+3	No. of people injured	4	No. of people killed	0	
Synopsis	<p>The pilot, accompanied by three passengers, was performing a go-around when the accident occurred. A farm worker, who resides on the farm where the accident happened, saw the aircraft on its arrival approach. He stated that he heard the aeroplane approaching and went outside as he was expect

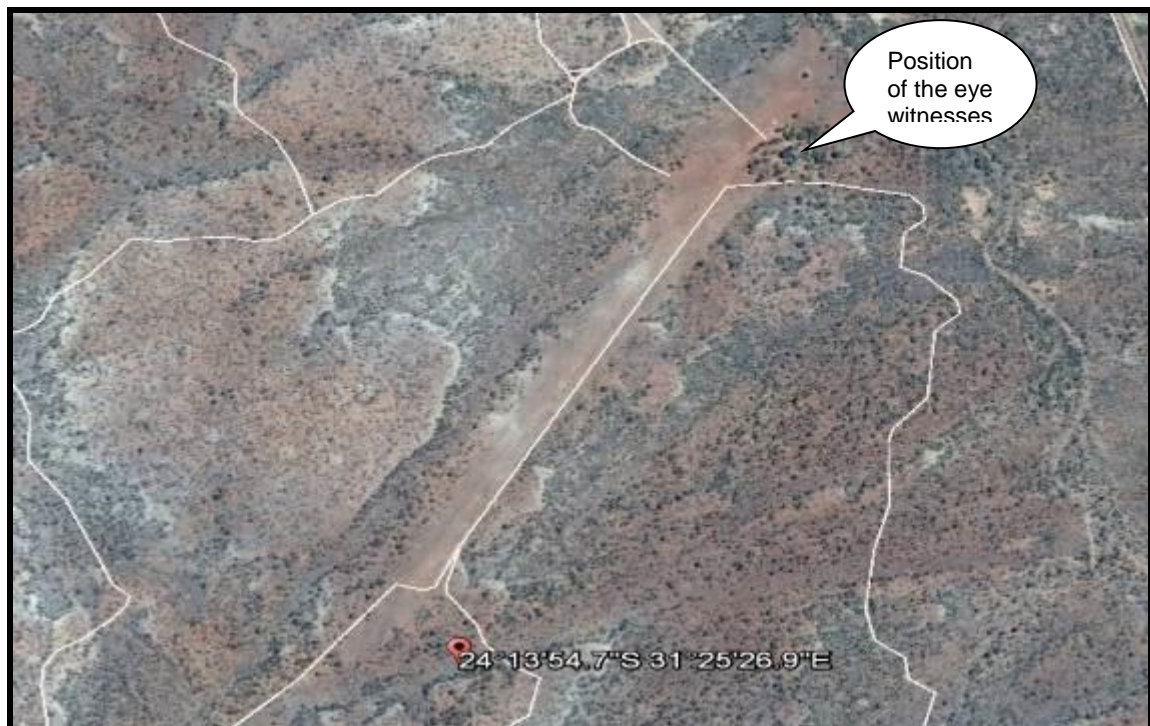
- 1.1.2 Moments afterwards, his wife told him that she heard a noise that sounded like a plane crash. The farm worker went outside and looked towards the top of the runway and then listened and checked to see if the aeroplane was approaching. As he could not see the aeroplane, he decided to drive towards the end of the runway to investigate. Upon approaching the end of the runway, the farm worker noticed that the aeroplane had crashed on the left side of the runway. All four occupants were injured inside the aeroplane.

Figure 1: Google view of the accident site

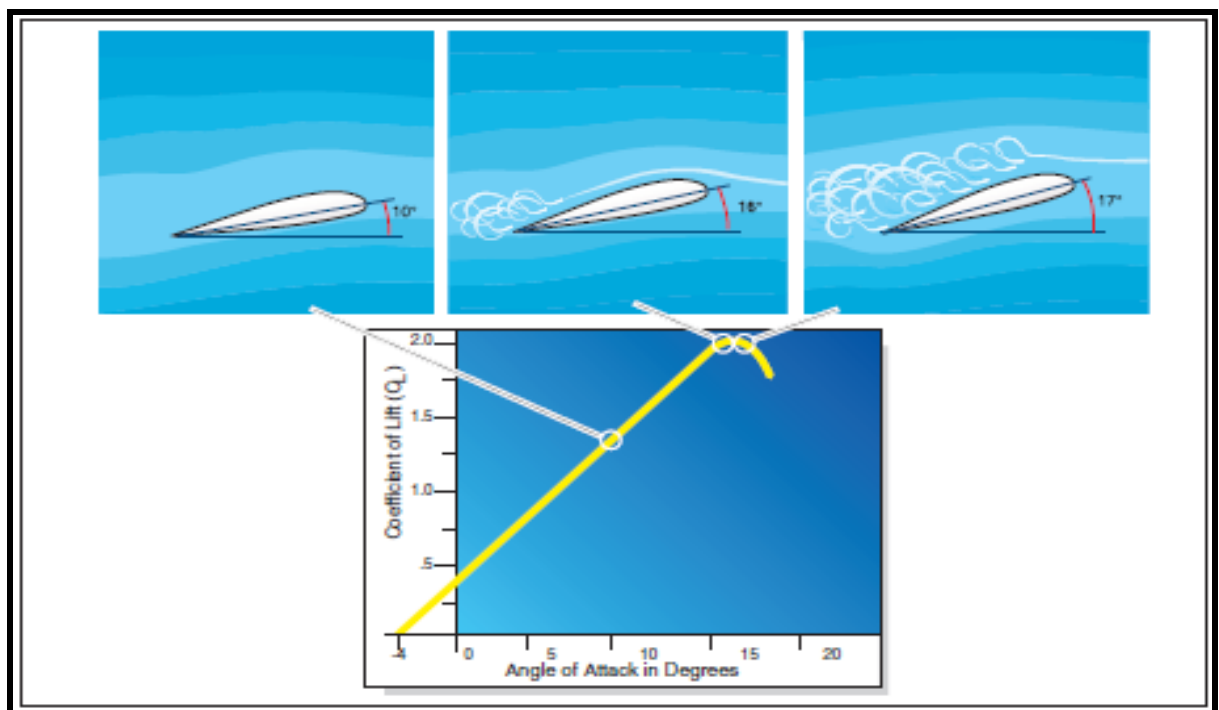
Figure 8: Critical angle of attack and stall

A stall occurs when the smooth airflow over the airplane's wing is disrupted, and the lift degenerates rapidly. This is caused when the wing exceeds its critical angle of attack. This can occur at any airspeed, in any attitude, with any power setting. The practice of stall recovery and the development of awareness of stalls are of primary
