AIRCRAFT ACCIDENT REPORT AND EXECUTIVE SUMMARY

Reference:	CA18/2/3/9585	
Aircraft Registration	ZU-JVR	Date of Accident	7 December 2016		Time of Accident	0900Z
Type of Aircraft	Van's RV 10		Type of Operation		Private (Part 91)	
Pilot-in-command Licence Type		Private Pilot License	Age	48	Licence Valid	Yes
Pilot-in-command Flying Experience		Total Flying Hours	1690.3		Hours on Type	Unknown
Last point of departure		Zebula Lodge Airstrip, Limpopo Province				
Next point of intended landing		Vaalwater private airstrip, Limpopo Province				
Location of the accident site with reference to easily defined geographical points (GPS readings if possible)						
Limpopo Province on the mountainous terrain 6nm north east of Zebula airfield on a place with GPS: S 24°38'36.25", E 027°58'54.47" and a field elevation of 4583ft.						
Meteorological Information		Wind direction: 220; wind speed: 04kt; Air temperature: 32; Visibility: CAVOK				
Number of people on board	1+0	No. of people injured	1	No. of people killed	1

AIRCRAFT ACCIDENT REPORT

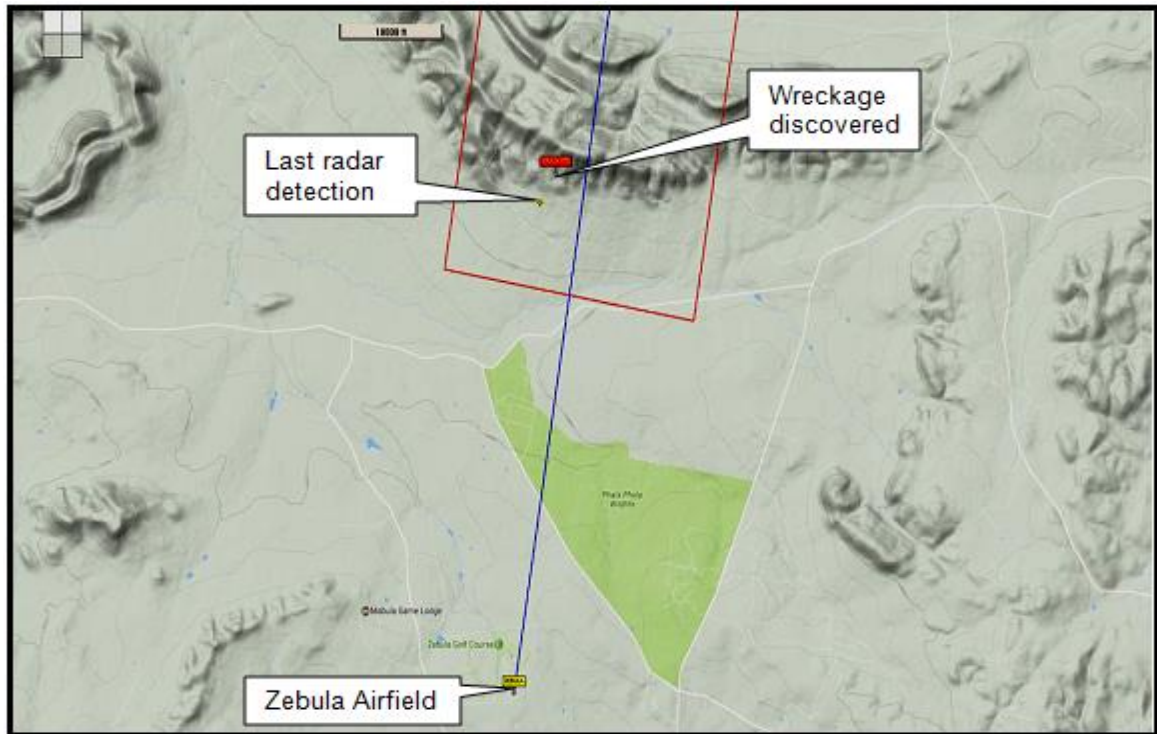
Figure1: Satellite view of where the aircraft wreckage was found

- 1.1.3 The aircraft wreckage was discovered the morning of the next day at approximately 7nm north, north east of Zebula airstrip on the mountains. The aircraft was found destroyed at a place with GPS S 24°38'36.25", E 027°58'54.47" with a field elevation of 4583ft.

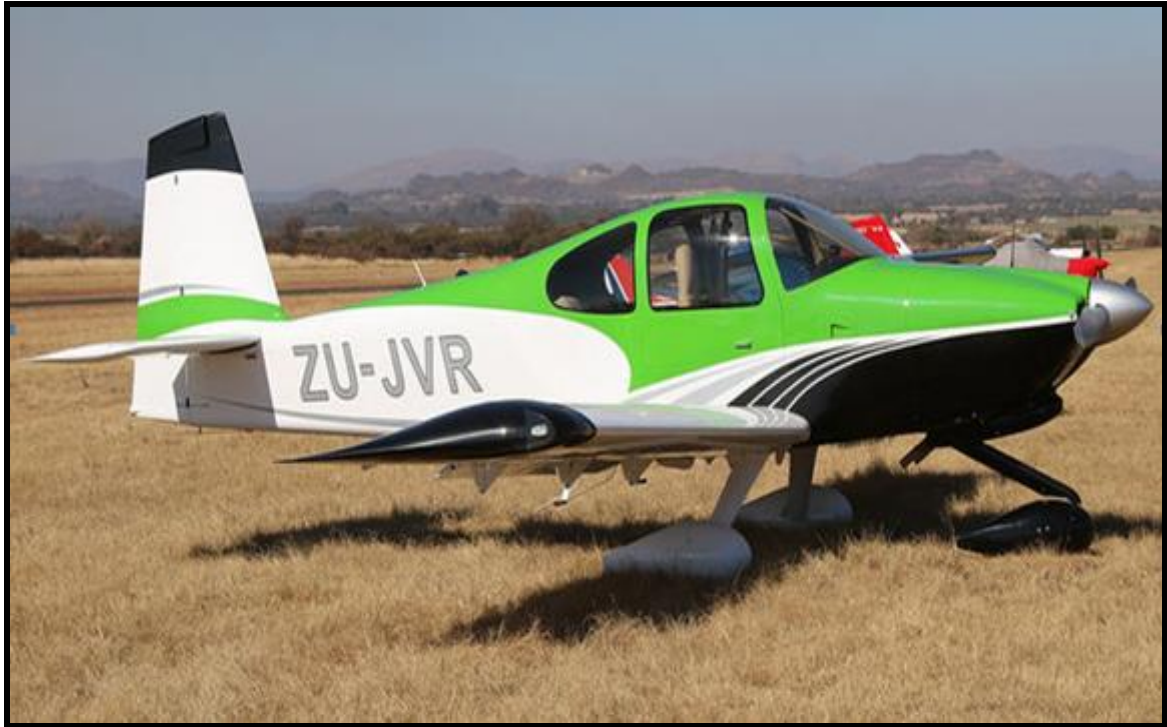
Figure 3: Shows the aircraft type
