**AIRCRAFT ACCIDENT REPORT**

**REPORT ON THE ACCIDENT TO A EUROCOPTER AS 350 B3  
REGISTRATION ZS-HDI WHICH OCCURRED AT FRANCISTOWN AIRPORT  
ON 31<sup>ST</sup> OCTOBER 2012**

**REF: MTC AIG 06/12**

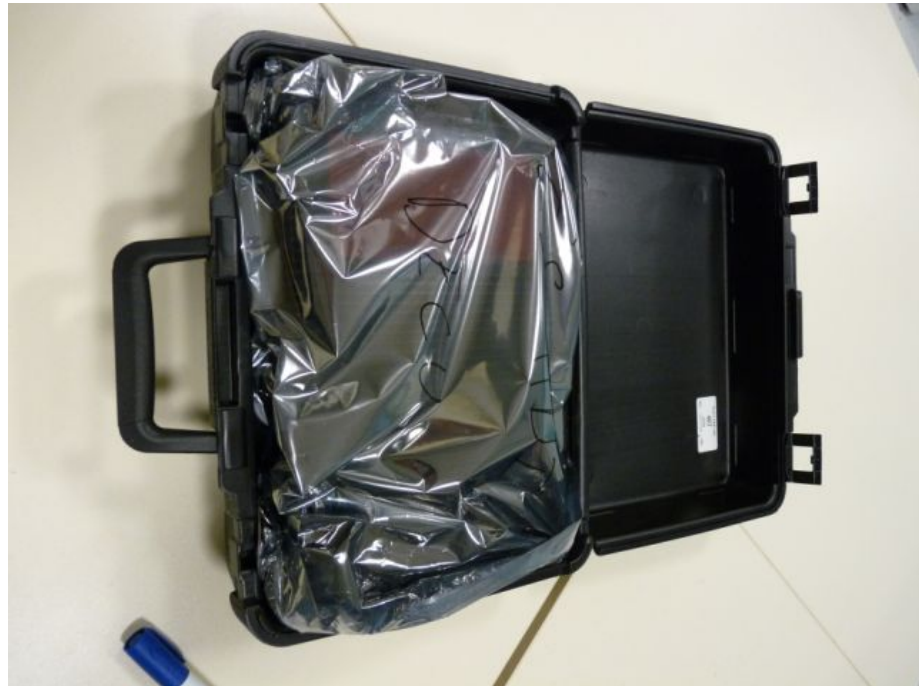
DECU in its box

The DECU was brought by a BEA representative in a box without any caps on the connectors.  
BEA representative informed us that they had performed visual inspection of the boards: no discrepancy was detected.

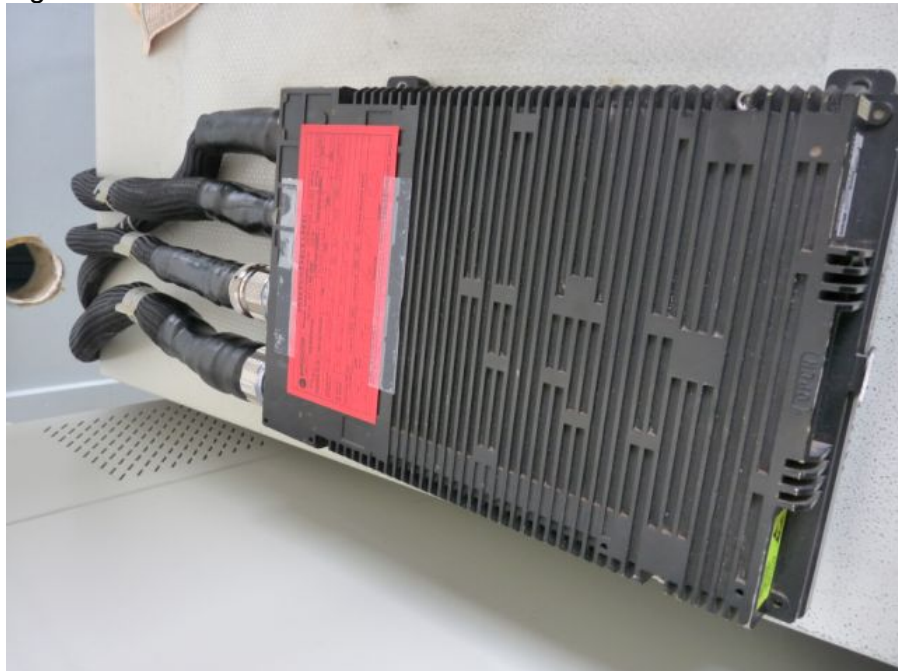
DECU connected to the dump tool

DECU S/N 657 was connected to tool Ref TL0248G017 and its dump performed; 32 “failure” message blocks were recorded.

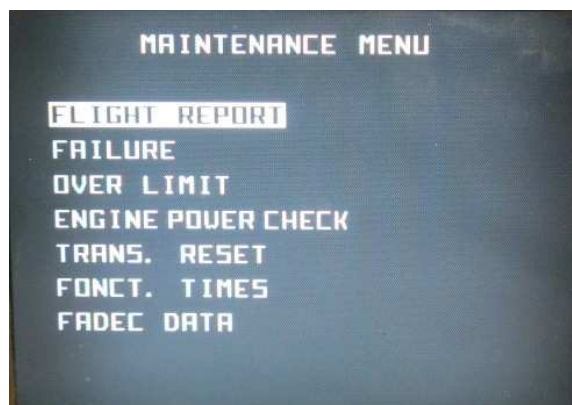
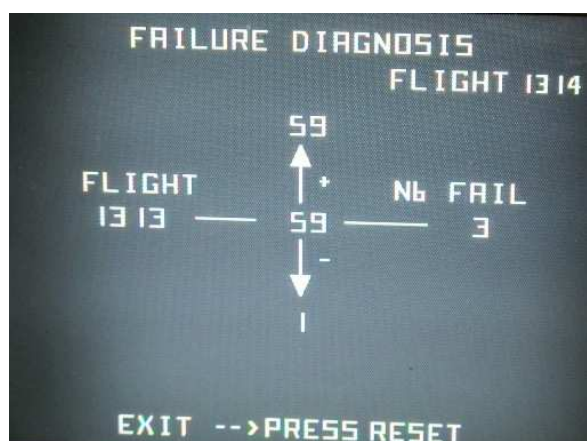
The VEMD was opened in "Maintenance mode". The last flight with failure (#1313) was not the same than the opened session (#1314). That's means that the event flight was already closed. The EC closure process was not necessary in this case and the flight report was available.

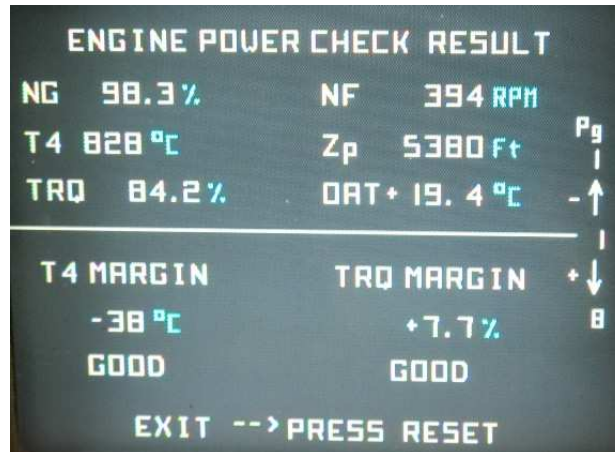
The first Engine Power Check performed by the crew has also a good result... No degradation of the engine between the first and the last EPC.

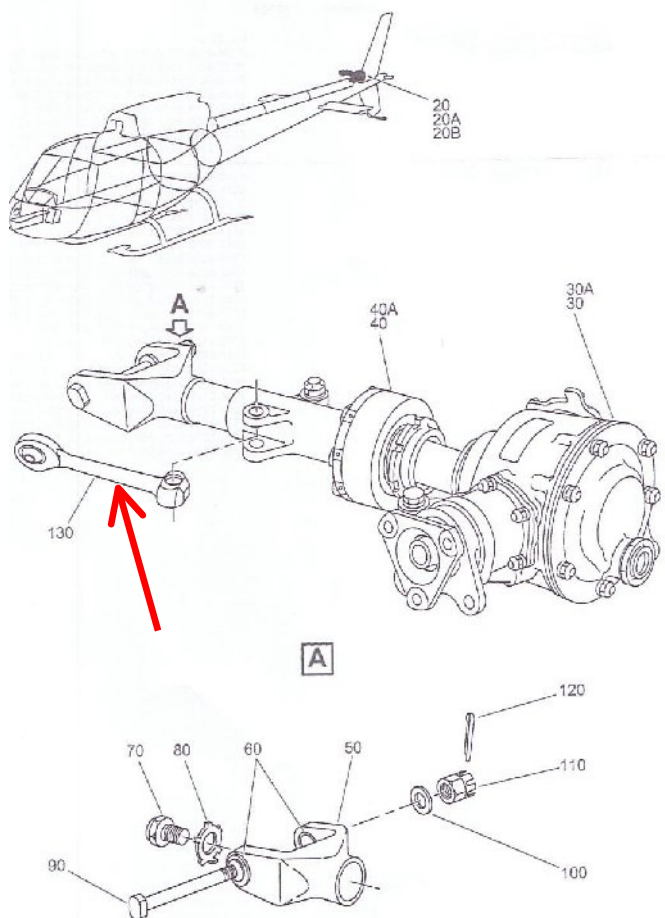
**Diagram 1: Tail Rotor Transmission Assembly (Eurocopter IPC AS350B3)**

8.1. The direction of failure of the yellow blade pitch control rod as well as other damages inflicted proved to be consistent with the tail rotor impacting with a hard object (Photo 3) while under engine power (Consider the rotating direction of the tail rotor, Diagram 1 and Reference Photo 1, yellow arrow). No indications were present suggesting a failure mode originating due to non-compliance of Eurocopter Alert Service Bulletin No 05.00.60. The red blade pitch control rod revealed similar damages but without failure at the big-end bearing side.

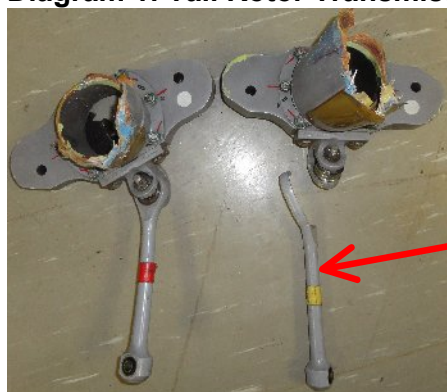
**Photo 4: Supplied parts (digital)**

The visual examination revealed the assembly indicating multiple fractures (Photo 4) and impact marks.
