AIRCRAFT ACCIDENT REPORT AND EXECUTIVE SUMMARY

Reference:		CA18/2/3/10033	
Aircraft Registration	ZS-KFG	Date of Accident	26 August 2021		Time of Accident	0900Z	
Type of Aircraft	Piper Seneca II (PA-34-200T)		Type of Operation		Training (Part 141)		
Pilot-in-command Licence Type	Commercial Pilot Licence (CPL)		Age	26	Licence Valid	Yes	
Pilot-in-command Flying Experience	Total Flying Hours		1 255.4		Hours on Type	78.8	
Last Point of Departure	Springs Aerodrome (FASI), Gauteng Province						
Next Point of Intended Landing	Springs Aerodrome (FASI), Gauteng Province						
Damage to Aircraft	Substantial						
Location of the accident site with reference to easily defined geographical points (GPS readings if possible)							
Runway (RWY) 21 at FASI at Global Position System (GPS) co-ordinates determined to be 26°14'51.86" South 028°23'51.57" East, at elevation 5 340 feet (ft)							
Meteorological Information	Wind 320° at 11kt, Temperature 19°C, Dew point 06°, Visibility 9999m

Probable Cause							
The aircraft landed whilst the main landing gears were not in the down and locked position, which resulted in the failure of the nose gear down lock link assembly. This led to the nose gear c

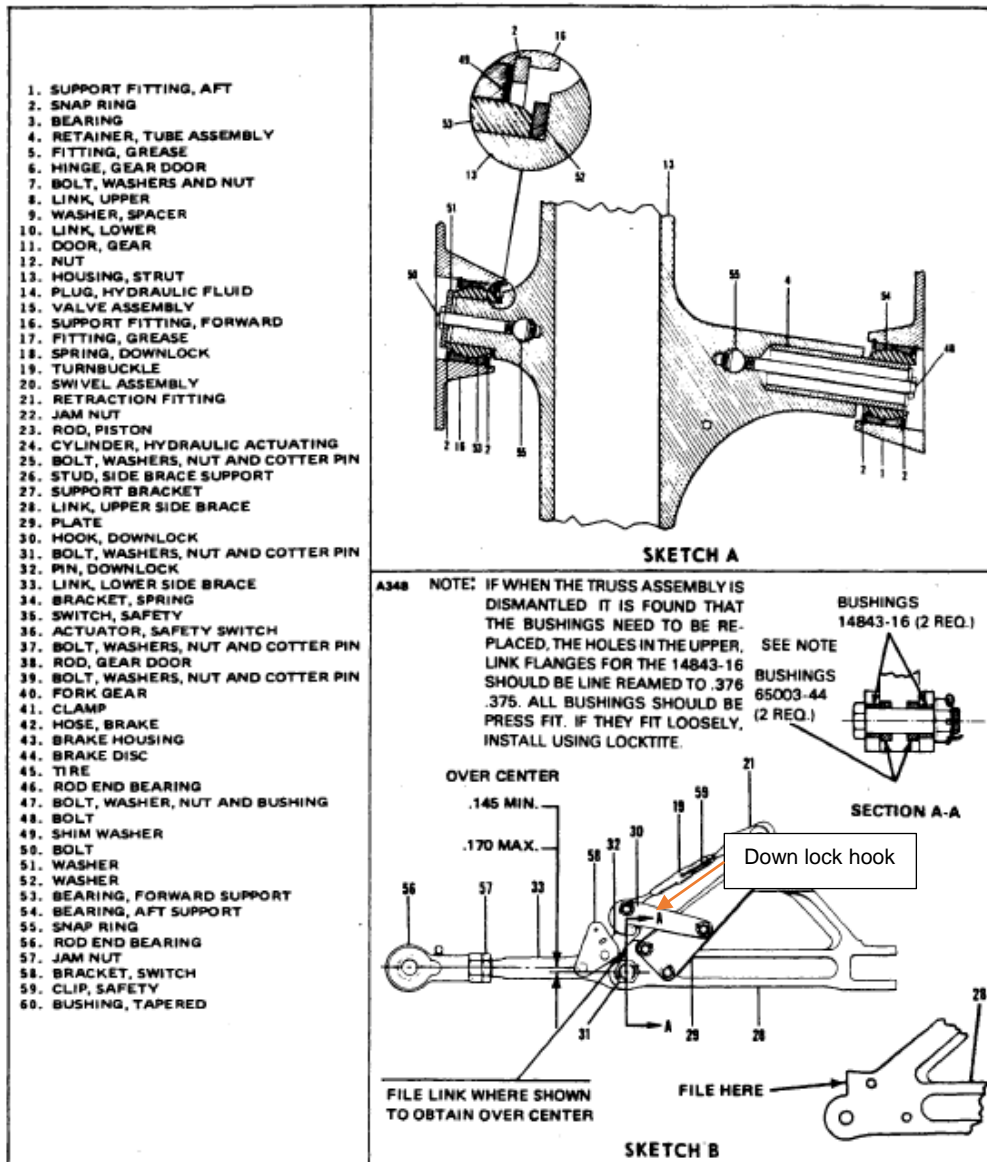
Diagram 2: Main gear installation.

The PA34-200T airplane is equipped with a retractable tricycle air-oil strut type landing gear, hydraulically powered reversible pump. A selector switch in the instrument panel to the left of the control quadrant is used to select UP or Down position. Gear positions are indicated by green lights directly above the selector switch when the gear is down and locked, and a red light at the top of the instrument panel when the gear is unsafe. Activation of all three down lock switches shut the hydraulic pump off. As the instrument lights are turned on the green lights will dim. As manifold pressure drops below 14 inches of mercury, and if the landing gear has not been extended, a throttle switch located in the quadrant will actuate a warning horn indicating to the pilot the landing gear is still up. The warning horn will continue to operate until the landing gear is down and locked, at which time three green lights on the instrument panel will energize. The nose and main gear require no assist springs. Once the gears are down and down lock hooks engage, a spring maintains pressure on each hook in the locked position until released by hydraulic pressure.
