<b>AIRCRAFT ACCIDENT REPORT AND EXECUTIVE SUMMARY</b>
---

<b>Reference:</b>		CA18/2/3/10051		
<b>Helicopter Registration</b>		ZU-RDX	<b>Date of Accident</b>		9 October 2021	<b>Time of Accident</b>		1150Z
<b>Type of Helicopter</b>		RotorWay Executive 162F		<b>Type of Operation</b>		Private (Part 94)		
<b>Pilot-in-command Licence Type</b>		Private Pilot Licence (H)		<b>Age</b>	65	<b>Licence Valid</b>		Yes
<b>Pilot-in-command Flying Experience</b>		<b>Total Flying Hours</b>		2 359		<b>Hours on Type</b>		158
<b>Last Point of Departure</b>		Morning Star Aerodrome, Western Cape Province						
<b>Next Point of Intended Landing</b>		Morning Star Aerodrome, Western Cape Province						
<b>Damage to Helicopter</b>		Substantial						
<b>Location of the accident site with reference to easily defined geographical points (GPS readings if possible)</b>								
Morning Star Aerodrome at GPS co-ordinates determined to be 33°45'44.37" South 018°32'54.69" East, at an elevation of 200 feet (ft)

<b>Probable Cause</b>								
It is probable that the V-belt was severed during transitioning phase which caused failure of the tail rotor, rendering the helicopter uncontrollable. Subsequently, the pilot lost

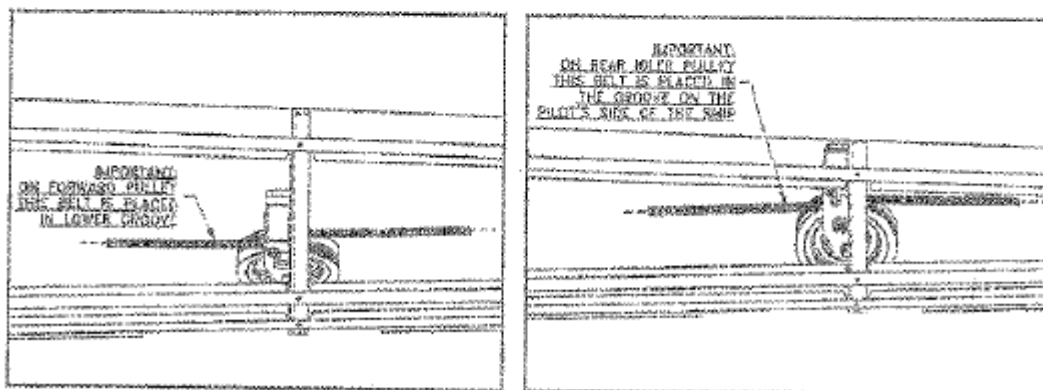
If belts are routed properly there is no further action required.

**ANY BELT NOT PROPERLY ROUTED INTO CORRECT IDLER PULLEY GROOVE SHOULD BE REPLACED IMMEDIATELY.**
