AIRCRAFT ACCIDENT REPORT AND EXECUTIVE SUMMARY

Reference:		CA18/2/3/10062	
Aircraft Registration	ZS-PMT	Date of Accident	30 October 2021		Time of Accident	0800Z	
Type of Aircraft	Cessna 182P			Type of Operation	Private (Part 91)		
Pilot-in-command Licence Type	Private Pilot Licence (PPL)		Age	32	Licence Valid	Yes	
Pilot-in-command Flying Experience	Total Flying Hours		125.6	Hours on Type	52.8		
Last Point of Departure	Lanseria International Airport (FALA), Gauteng Province						
Next Point of Intended Landing	Rand Airport (FAGM), Gauteng Province						
Damage to Aircraft	Destroyed						
Location of the accident site with reference to easily defined geographical points (GPS readings if possible)							
Approximately 1.2 nautical miles (nm) west of FAGM at the following GPS co-ordinates: S 26° 14' 44.8" E 28° 07' 04.7", at an elevation of 5 139ft							
Meteorological Information	Surface wind 260°, 11 knots; Temperature: 20°C; Dew point: 09°C; CAVOK; QNH: 1021hPa

Probable Cause

The throttle cable separated from the throttle lever control in-flight because of the missing cotter pin on the castellated nut, which caused the engine to run at idle. The pilot was unable to maintain the

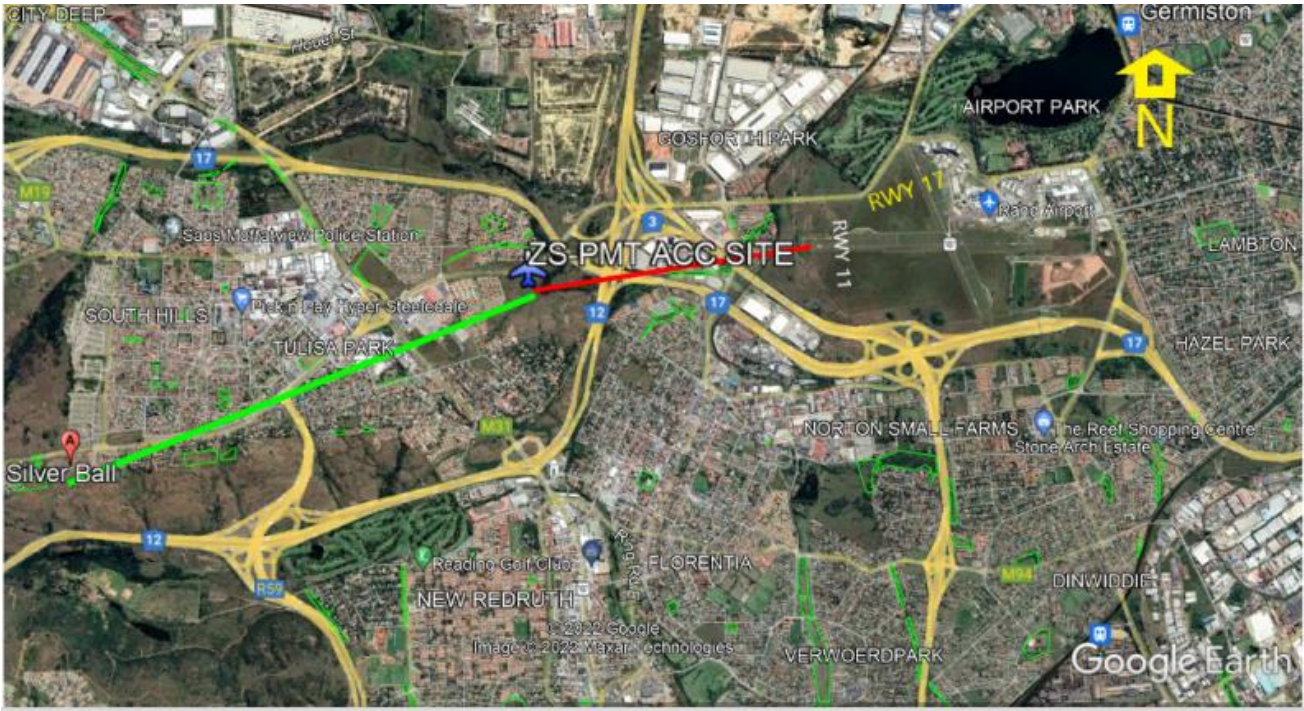
Figure 1: The green line is the aircraft's flight path from Silver Ball to the accident site. The red line, which is 1.2nm, is the distance from the threshold of Runway 11 at FGM.

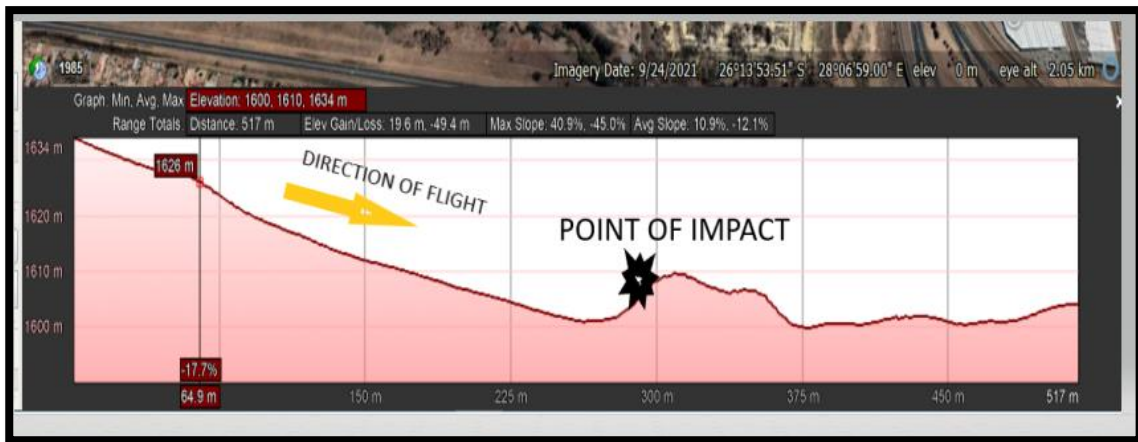
1.12.1 The aircraft was on long final approach for RWY 11 as advised by the FAGM ATC. Post-accident, the pilot stated that he had made certain preparations to slow down the aircraft to reduce the extent of damage. The area chosen by the pilot was sloping downwards and was not suitable for a forced landing (Figure 4 shows the elevation profile). Moreover, the area had large rocks. The first point of contact was the left-side tyre on the rock surface, followed

by broken tree branches on the right-hand side of the pilot. The right-side wing further impacted a tree stump and the aircraft swung 90° to the left and came to a halt facing the river edge.

Figure 4: Profile elevation of the forced landing area. (Source: Google Earth)

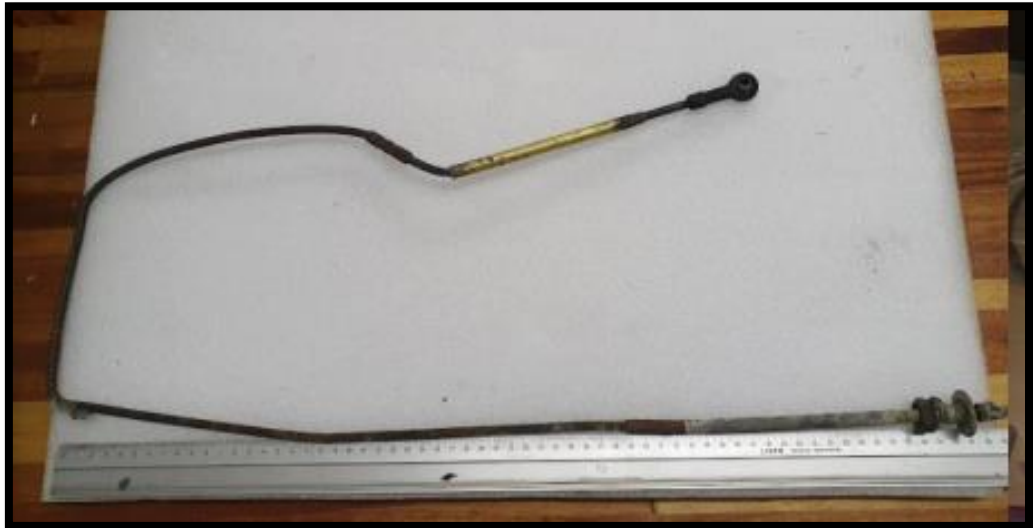
Figure 9: A complete throttle cable. (Source: University of Pretoria)

1.16.3. *The bending damage corresponded with the support bracket- and fire-wall positions when fitted. The inner area of the throttle cable ball-eye end revealed extensive build-up of foreign material.*
