**AIRCRAFT ACCIDENT REPORT AND EXECUTIVE SUMMARY**

<b>Reference:</b>		CA18/2/3/10064	
<b>Helicopter Registration</b>		ZS-HDX	<b>Date of Accident</b>		2 November 2021	<b>Time of Accident</b>	1012Z
<b>Type of Helicopter</b>		Bell 206L Jet ranger		<b>Type of Operation</b>		Commercial Helicopter Operations (Part 127)	
<b>Pilot-in-command Licence Type</b>		Airline Transport Pilot Licence (H)		<b>Age</b>	44	<b>Licence Valid</b>	Yes
<b>Pilot-in-command Flying Experience</b>		<b>Total Flying Hours</b>		4423.3		<b>Hours on Type</b>	164
<b>Last Point of Departure</b>		Rand Airport (FAGM), Gauteng Province					
<b>Next Point of Intended Landing</b>		Buffels Mine, North West Province					
<b>Damage to Helicopter</b>		Substantial					
<b>Location of the accident site with reference to easily defined geographical points (GPS readings if possible)</b>							
On a private farm, 16nm south-west of Fochville at Global Positioning System (GPS) determined to be 26°40'10.6680"S 027°16'14.6640"E, at an elevation of 4602 feet (ft)

**Synopsis**

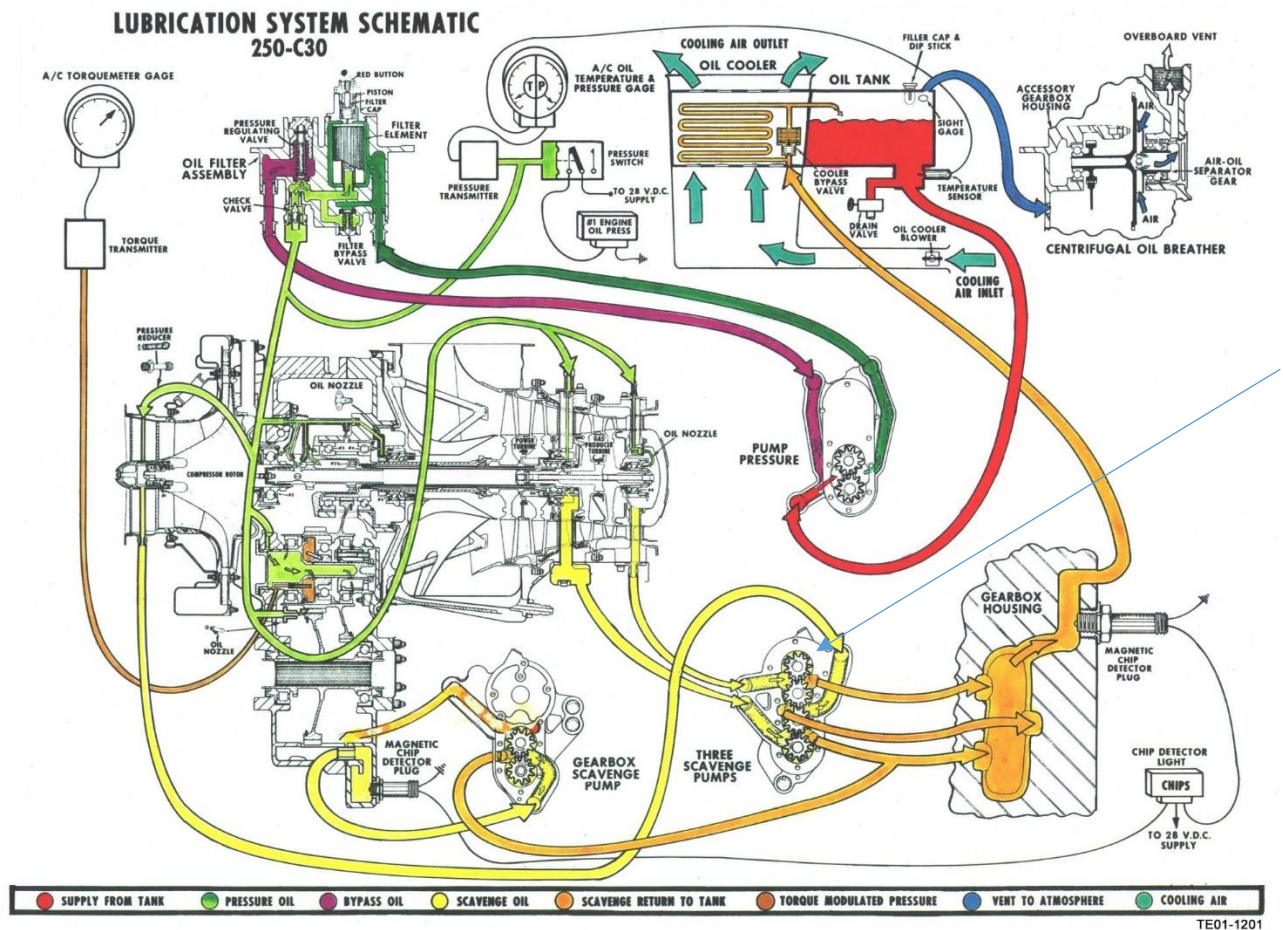
**Diagram 1:** Schematic of Lubrication System with blue arrow on oil pump. (Source: Rolls Royce)

- 1.16.6. *The analysis revealed that the engine failure was due to the gas producer bearing thrust plate anti-rotation tab that separated and travelled through the oil system and finally lodged between an oil pump scavenge gear and wall, causing the oil pump to provide inadequate lubrication to the number 6 and 7 bearings. This led to the number 6 and 7 bearings failure due to thermal damage (Figure 5-10) and the subsequent damage to other turbine parts (see Appendix 1).*

1.16.7 The lubricating system furnishes lubrication, scavenging and cooling as needed for bearings, splines, and gears in all conditions of flight. The system is a circulating, dry sump type, with an external reservoir and oil cooler mounted and furnished by the helicopter manufacturer. The torquemeter in the engine gearbox is hydraulic and uses the engine lubrication system as its oil (hydraulic) pressure source. In order to minimize friction effects and provide accurate measurement of torque, the axial gear thrust on the helical torquemeter gearshaft is high. System pressure must always be greater than the torquemeter oil pressure. Therefore, it is necessary to regulate the system oil pressure to the relatively high value of 115-130 psi. Oil pressure is a function of (1) volume flow, (2) restriction to flow, and (3) viscosity. Volume flow from the pressure element is determined by N1 RPM...volume flow increases as N1 RPM increases. Restriction to flow is determined by the size of the passages, lines, and nozzles. Viscosity or fluid friction is a function of oil temperature. Thus, if the oil temperature and restriction to flow remain constant, oil pressure will increase with increases in N1 RPM until the regulated oil pressure of 115-130 psi is reached. Further increases in N1 RPM do not result in further increases in pressure because the pressure regulating valve bypasses the excess oil to the inlet of the pump.
