AIRCRAFT ACCIDENT REPORT AND EXECUTIVE SUMMARY

Reference:	CA18/2/3/10070		
Aircraft Registration	ZU-EIJ	Date of Accident	7 December 2021		Time of Accident	1520Z	
Type of Aircraft	Evektor SportStar		Type of Operation	Private NTCA (Part 94)			
Pilot-in-command Licence Type	National Pilot Licence		Age	49	Licence Valid	Yes	
Pilot-in-command Flying Experience	Total Flying Hours		333.8	Hours on Type	48.1		
Last Point of Departure	Springs Aerodrome (FASI), Gauteng Province						
Next Point of Intended Landing	Springs Aerodrome (FASI), Gauteng Province						
Damage to Aircraft	Destroyed						
Location of the accident site with reference to easily defined geographical points (GPS readings if possible)							
Bajadam Resort (GPS position: 25°53'52.44" South, 028°42'38.00" East), at an elevation of 4 740 feet (ft)							
Meteorological Information	Strong winds were encountered while flying over the Bronkhorstspruit Dam						
Number of People On-board	1 + 0	Number of People Injured	0	Number of People Killed	1	Other (On Ground)	0

The pilot lost control of the aircraft following the structural failure of the outer left-wing main spar, located 125 centimetres (cm) from the wing tip. The failure

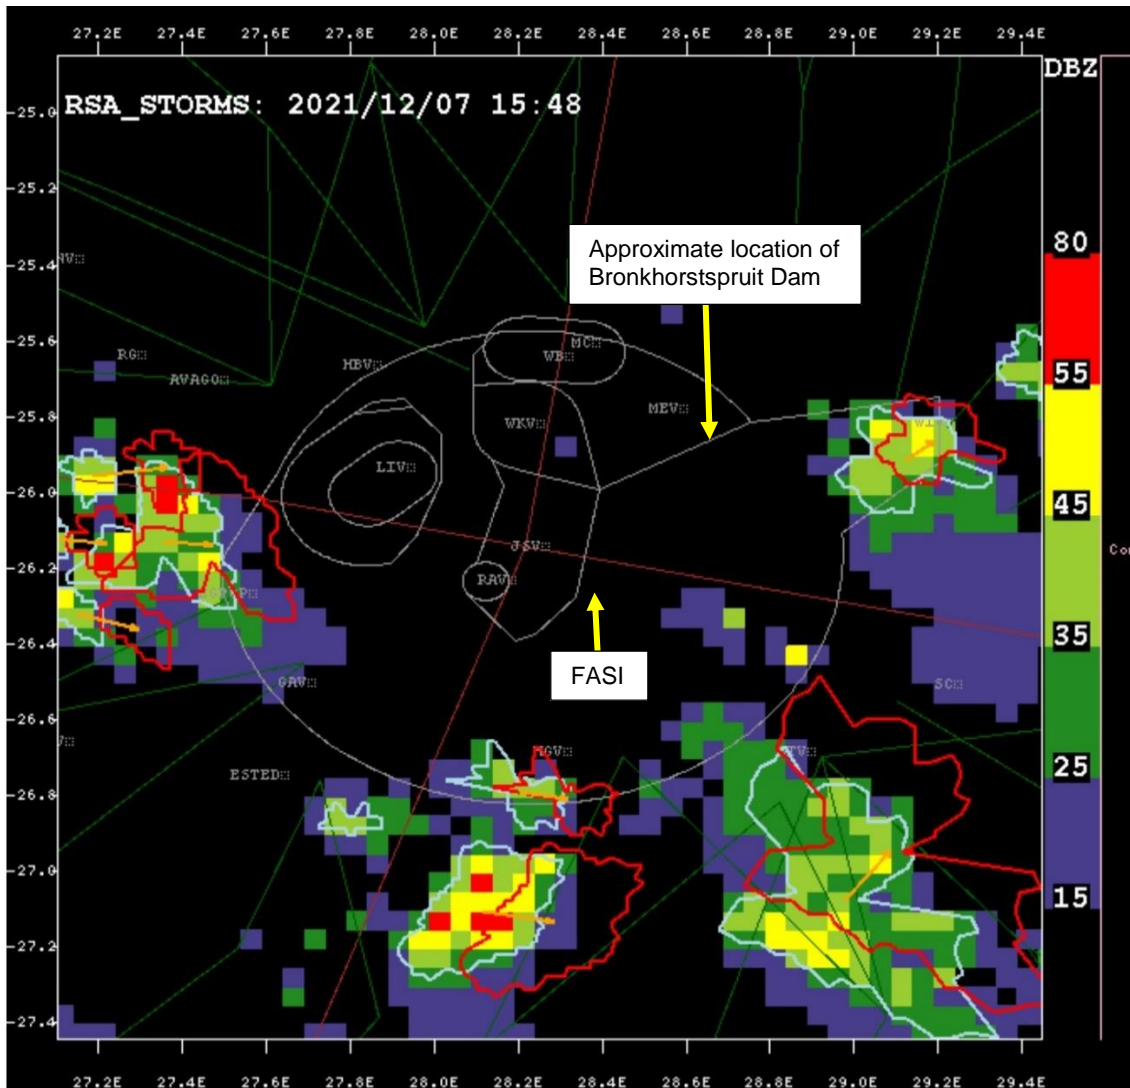
Figure 1: Weather radar information for 7 December 2021 at 1348Z. (Source: ZU-AZY pilot)

The weather data in Figure 1 was taken an hour and thirty-two minutes prior to the accident flight and more than one hour prior to take-off from FASI. During a period of 1.5 hours, the weather conditions (thunderstorm activity) could change radically in Gauteng area. According to the data obtained from the satellite image that was taken at 1500Z on the day, a thunderstorm was present towards the east of the accident area. This was associated with relatively strong winds as well as turbulence.

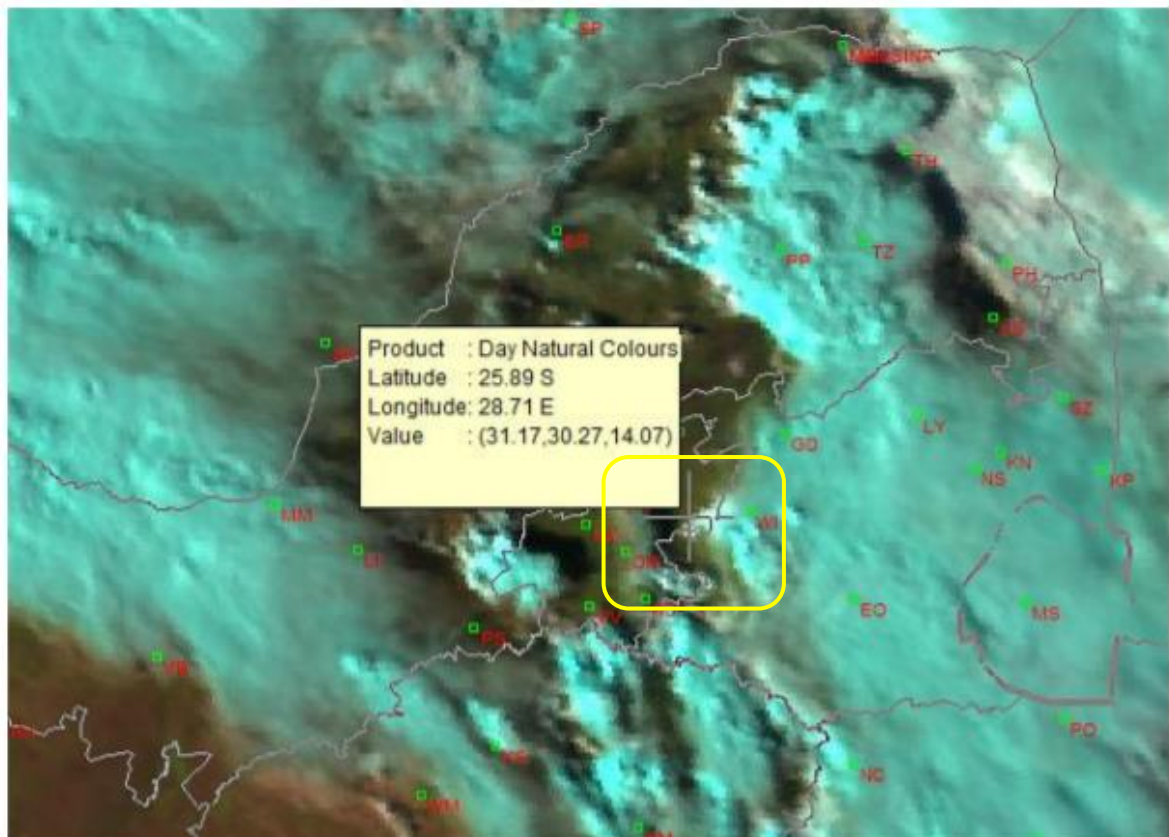
Figure 5: Satellite image of the accident site, marked with a cross in the yellow frame.

The accident site (depicted by a cross) in the satellite image is situated to the west of the thunderstorms, which are visible in the Witbank (FAWI) area (overshooting tops). In the image, it seems possible that cumulus/towering cumulus clouds were present. The eyewitnesses' report did not mention any significant clouds, so it is possible that this development might have been to the immediate east of the dam. It should be noted that turbulence can be expected in any area where cumulus clouds are present.

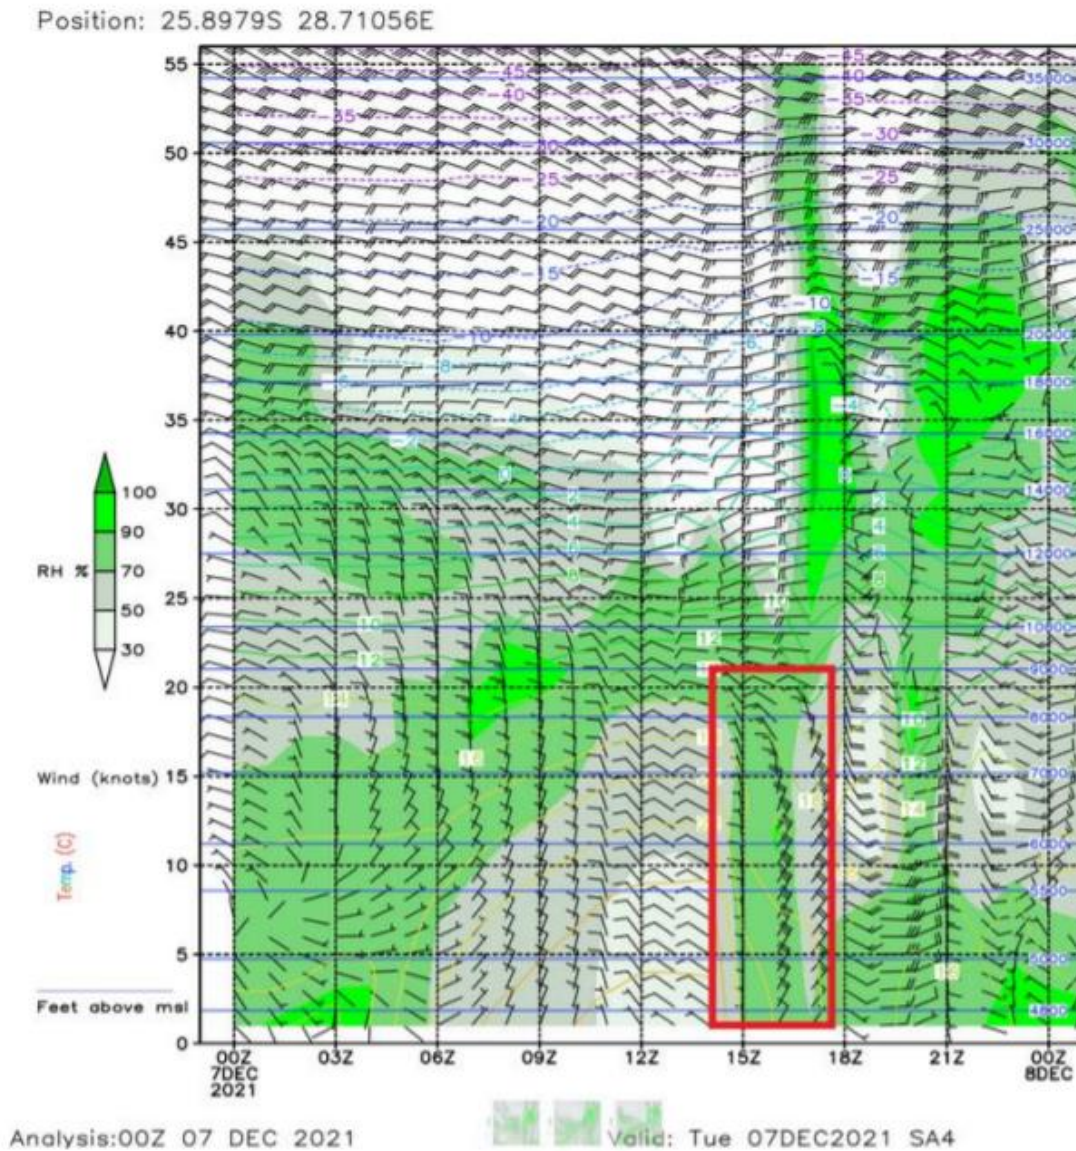
Chart 1: Wind chart

Chart 1 (above) is the Unified Model data for 7 December 2021. The accident occurred at about 1520Z (contained inside the red rectangle). The winds above the surface were expected to pick up to around 25 knots after 1500Z.

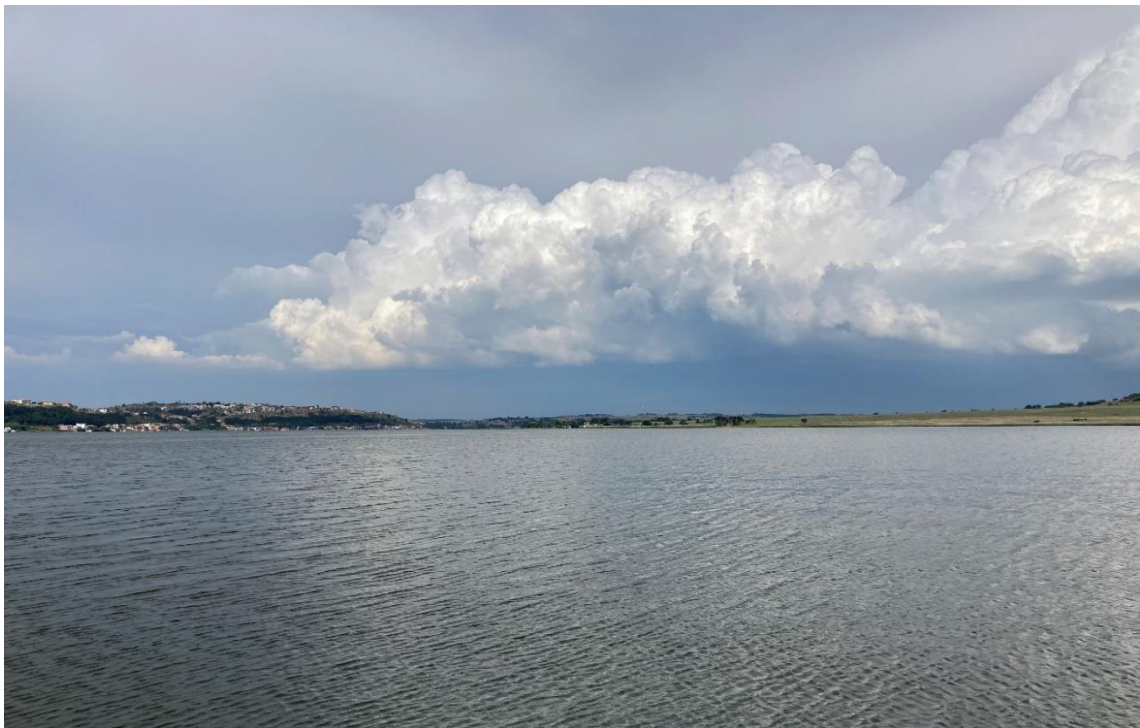
Figure 7: This photograph was taken at 1447Z in an easterly direction. (Source: Eyewitness)

According to the AFM Section 2, Limitations, *manoeuvring load factors the maximum positive load factor for the aircraft at +4.0g and the maximum negative load factor at -2.0g*. It was possible that the maximum positive load factor was exceeded when the pilot experienced severe turbulence associated with the outflow front of a thunderstorm that was moving through the east of his location at the time. Figure 7 of the report was taken at 1447Z with the photographer facing an easterly direction; the picture shows a thunderstorm towards the east of the dam at the time.

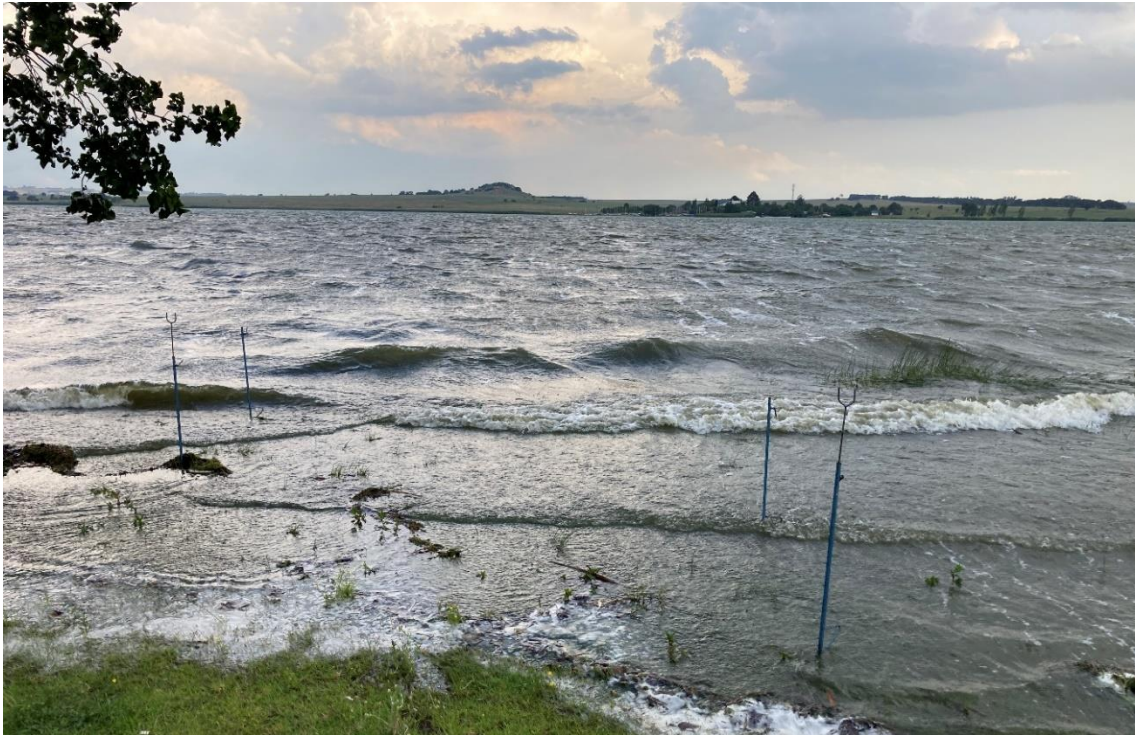
At 1538Z, he again took several photographs of the prevailing weather conditions. He stated that this was after a gale force wind had passed over the area. He further stated that the conditions went from basically no wind to gale force in about 5 minutes. He reported that the

wind was so strong that he could not take any photographs during that period.

Figure 8: This photograph was taken at 1538Z in an easterly direction. (Source: Eyewitness)

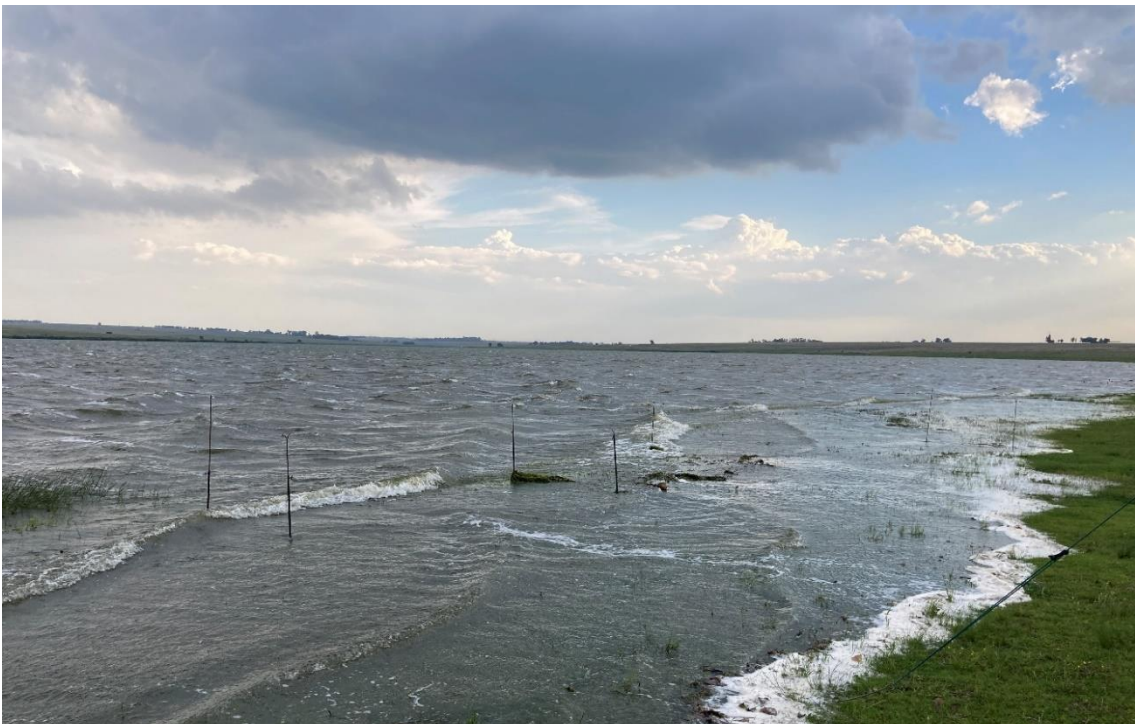
Figure 9: This photograph was taken at 1538Z in a southerly direction. (Source: Eyewitness)

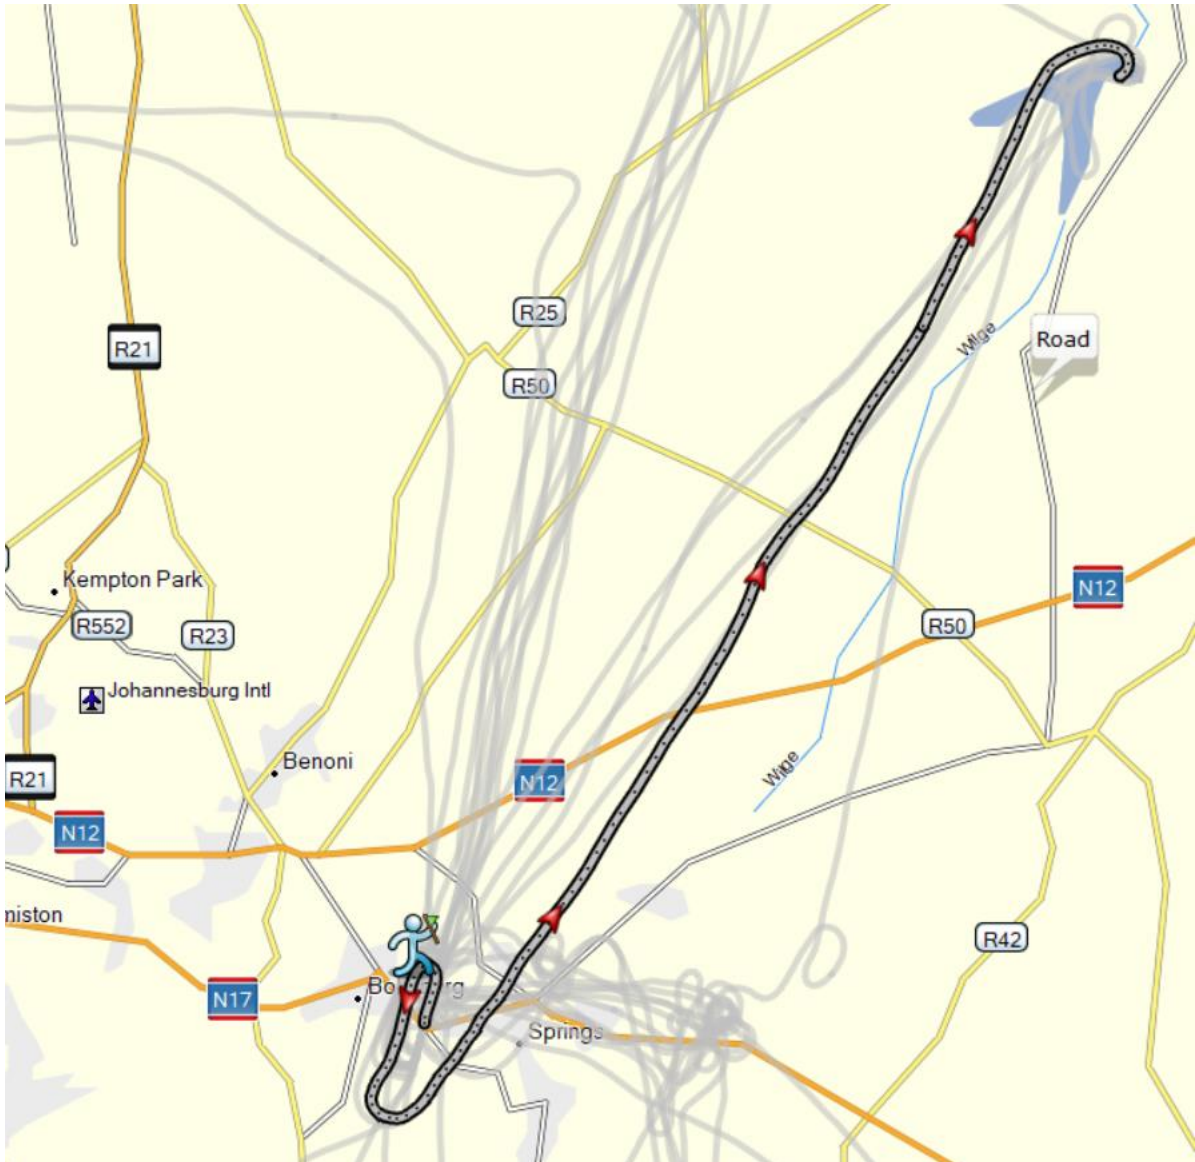
1.11.2 A portable Garmin GPS Map 296 with Serial No. 10701101 was on-board the aircraft. The unit was recovered from the accident site. The accident flight data was downloaded, as well as several previous flights (45 active track logs on the unit). The GPS tracking device recorded that the aircraft was on a north-easterly heading at an average ground speed of 91 knots (kt) (168 km/h) and a height of 6 500ft (GPS height). The highest speed that was captured was 114 kt (211 km/h). The average speed in the right turn prior to the failure of the wing was 93 kt (173 km/h), which was measured from the time the aircraft heading changed (commencing with the turn) until the GPS unit stopped recording. The outer section of the left wing failed while the aircraft was still turning.

Figure 10: The track that was flown by the pilot. (Source: Data downloaded from the GPS)

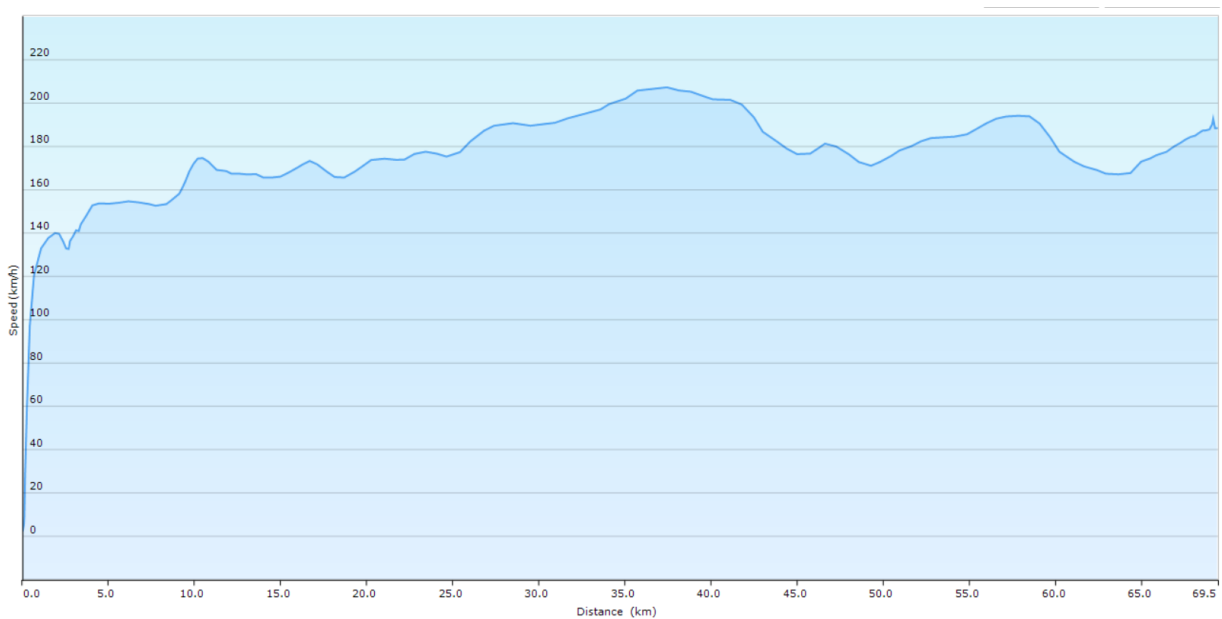
Figure 11: A graph of the flight profile from take-off until the GPS stopped recording. (Source: Data downloaded from the GPS)

It was noted that the maximum speed (GPS speed, which is ground speed) recorded during the inbound flight was captured at 114 kt (211 km/h). The average speed for the duration of the flight was 91 kt (168 km/h) and the average speed during the right turn was 93 kt (173 km/h). This speed was from the time the pilot commenced with the right turn (change of heading was observed) until the GPS recording stopped, which was while the aircraft was still in the right turn.

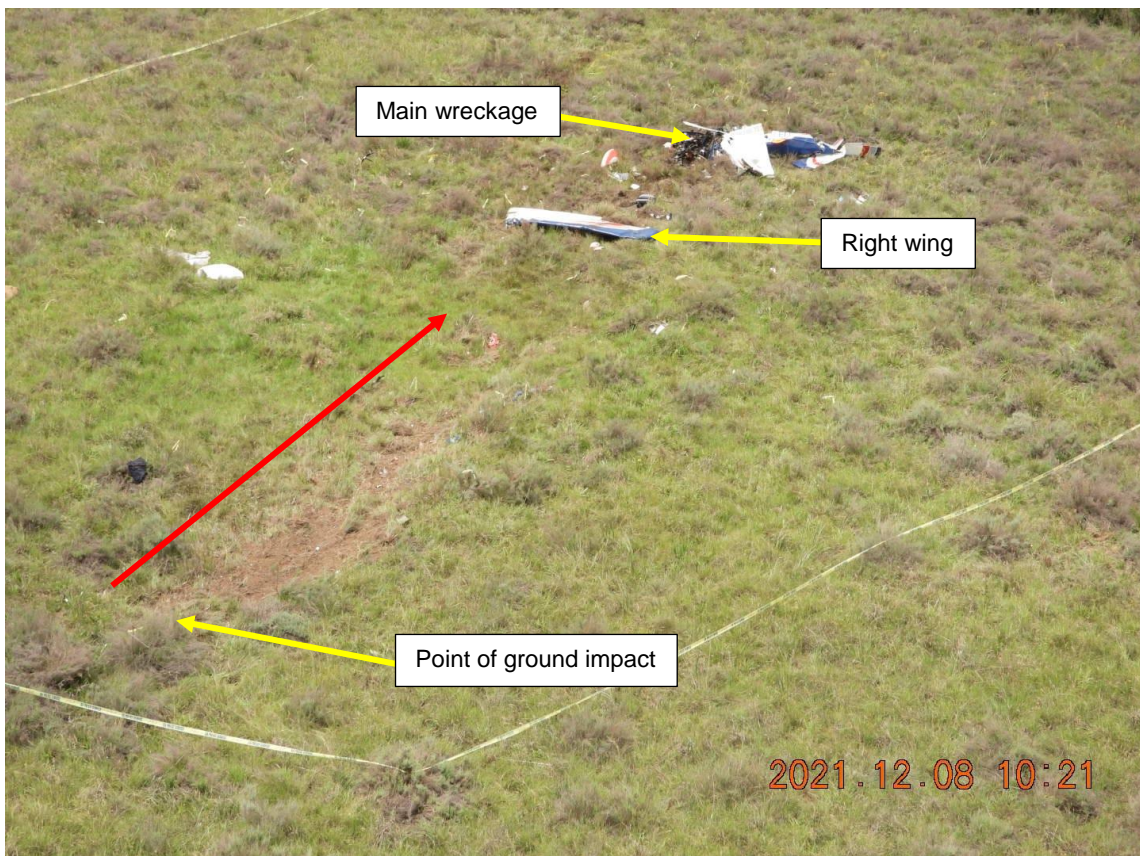
1.12.1 The aircraft impacted the ground on an open field in a westerly direction (255° Magnetic). The aircraft was in a nose-down attitude during ground impact and was described by one of the eyewitnesses as twirling in the air once the outer section of the left wing failed. It was evident from the first ground impact marking and the destruction of the wreckage that the aircraft was out of control during impact. The right-wing assembly was found fractured and was one of the first major components found along the impact line. The inner section of the left-wing remained attached to the fuselage, but was destroyed. The entire propeller hub assembly, including the propeller gearbox, had sheared from the engine. The three wooden propeller blades were severed at the hub assembly, which is an indication that the engine was delivering power to the engine on impact with the terrain. The cockpit area was mangled, and all the flight instruments were ripped out of the instrument panel. The fuel tank selector indicated that the left tank was selected at the time of the accident.

Figure 12: Aerial view of the accident site. The red arrow indicates the direction of impact.

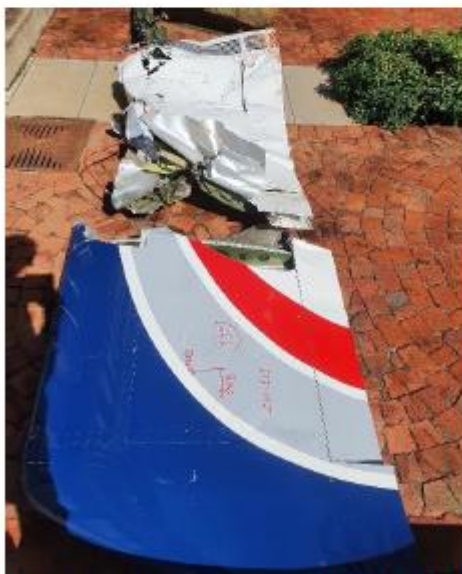
ITEM: LEFT-HAND WING ASSEMBLY, EVEKTOR SPORT STAR, AIRCRAFT ZU-EIJ			
<ol style="list-style-type: none"> 1. BACKGROUND INFORMATION <ol style="list-style-type: none"> 1.1. Selected components from the failed left-hand wing assembly (Photo 2) originating from an Evektor Sport Star Light Sport Aircraft (LSA), registration ZU-EIJ (Photo 1), serial no 2006-0714, were submitted to determine the most probable contributory factor/s towards failure in flight. 1.2. The relevant aircraft was involved in an accident resulting in one fatality (Photo 3).

Photo 2: Supplied components, as found (digital)			
¹ Courtesy www.JetPhotos.com

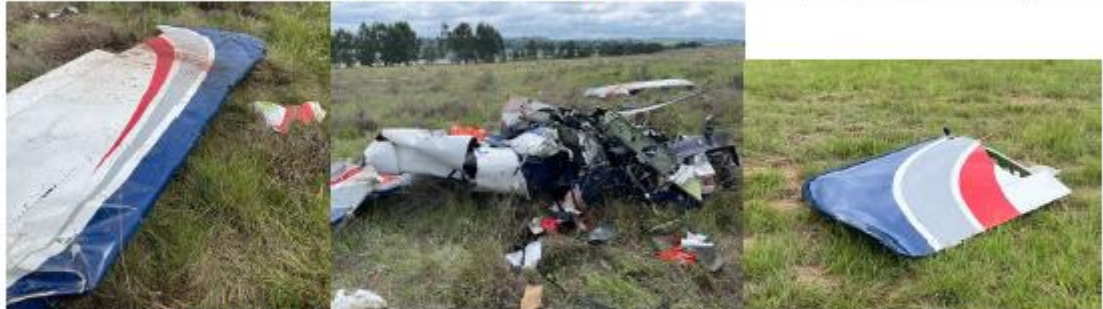
Photo 3: Accident site, ZU-EIJ ²																								
1.3. This report is divided into the following sections:

The damages to the LH main wing inboard section are consistent with an impact force imposed in the direction as indicated (Diagram 1; Photo 3, yellow dashed arrows).

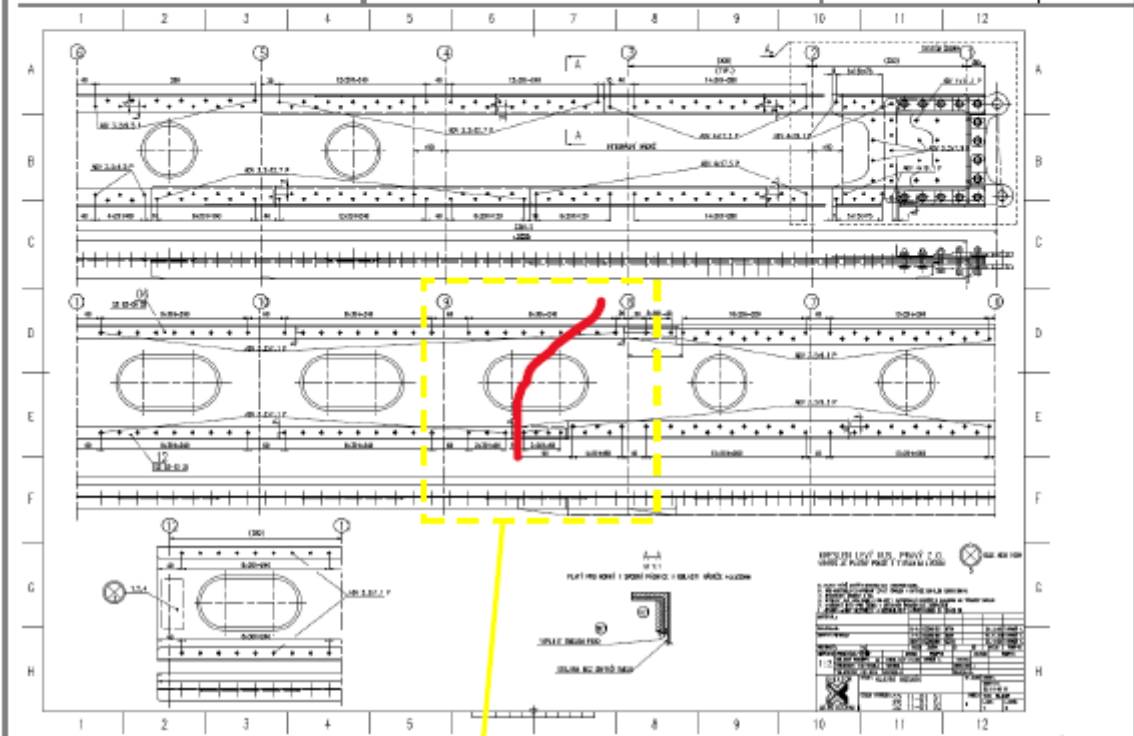
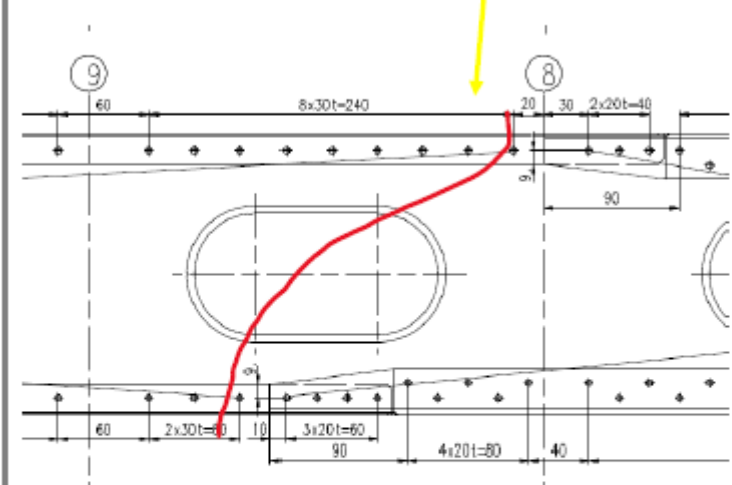
The LH main wing inner spar assembly fractured at positions A and B (Photo 5) between stations 8 and 9 (Diagram 3, red lines). The primary fracture initiated outboard from both the lower and upper spar cap stiffener right-angle bars (Diagram 3, red line; Photo 7, red arrow) while proceeding through the oval shaped hole within the spar web (Photo 5, red dashed circle).

Diagram 3: Main Wing Section/Spar assembly⁵

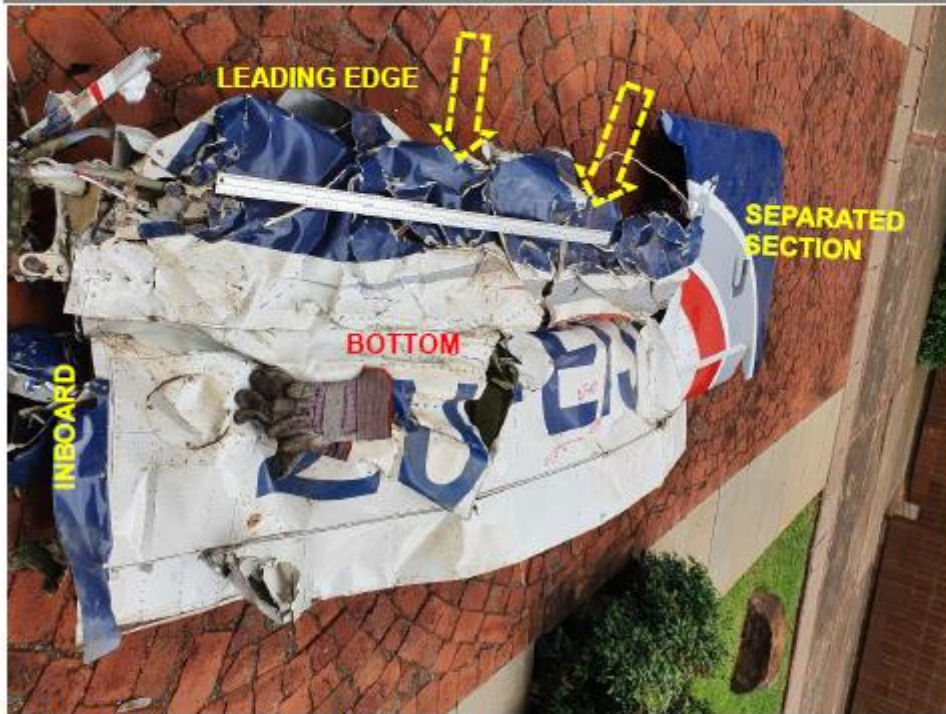
Photo 3: LH wing assembly, as supplied (digital)

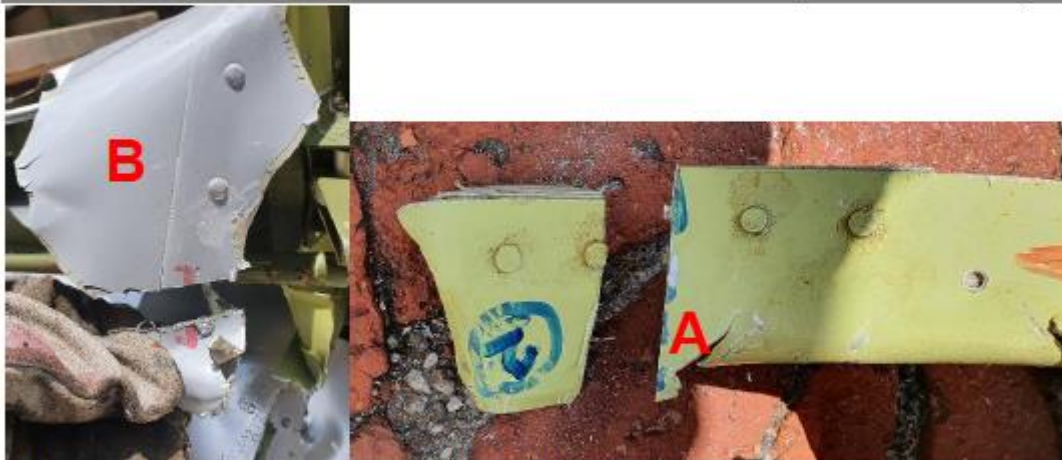
Photo 6: Sectioned fracture locations, outboard section (Stereo)

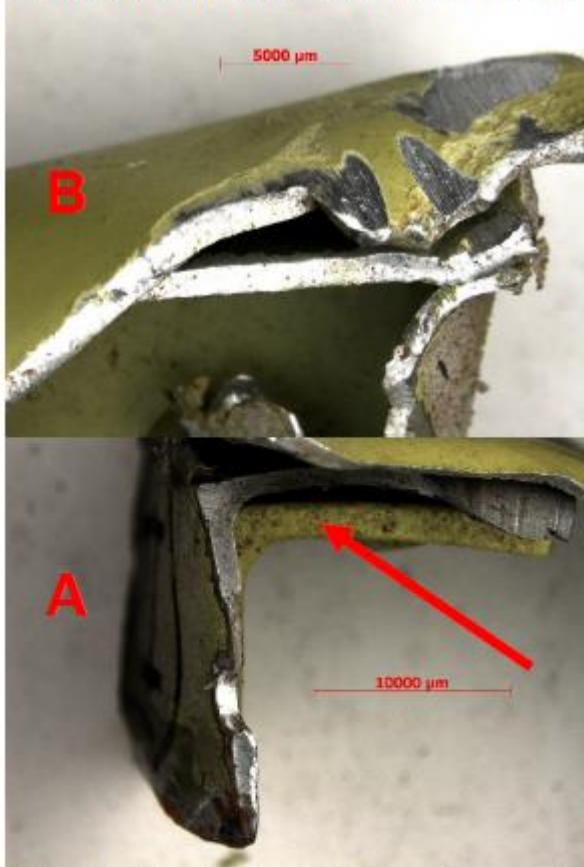
Photo 7: Sectioned fracture locations, outboard section (Stereo)

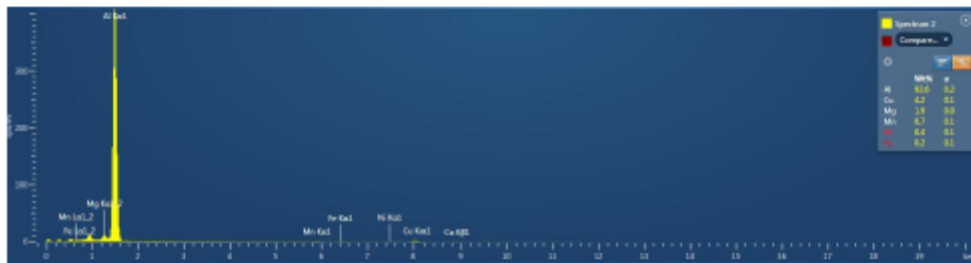
The main spar cap base material conforms to a 2000 series Aluminium alloy (EDS Result 1).

EDS Result 1: Main wing spar cap base material (Oxford Aztec, 20kV, WD 6.5mm, SE detector)
