AIRCRAFT ACCIDENT REPORT AND EXECUTIVE SUMMARY

Reference:		CA18/2/3/10087	
Aircraft Registration	ZS-EZM	Date of Accident	7 December 2021		Time of Accident	0635Z	
Type of Aircraft	Cessna 177 Cardinal		Type of Operation		Private (Part 91)		
Pilot-in-command Licence Type	CPL (A)		Age	23	Licence Valid	Yes	
Pilot-in-command Flying Experience	Total Flying Hours		724.1		Hours on Type	36.4	
Last Point of Departure	Grand Central Airport (FAGC), Gauteng Province						
Next Point of Intended Landing	Grand Central Airport (FAGC), Gauteng Province						
Damage to Aircraft	Substantial						
Location of the accident site with reference to easily defined geographical points (GPS readings if possible)							
Approximately 300 metres from the threshold of RWY 31 at Baragwanath Aerodrome (FASY), at GPS co-ordinates determined to be 26°21'05.2" South 027°47'10.8" East at 5439 ft AMSL							
Meteorological Information	Surface wind: 360°/10kt; temperature: 21°C; dew Point: 15°C; CAVOK; visibility: 9999m; QNH: 1025hPA

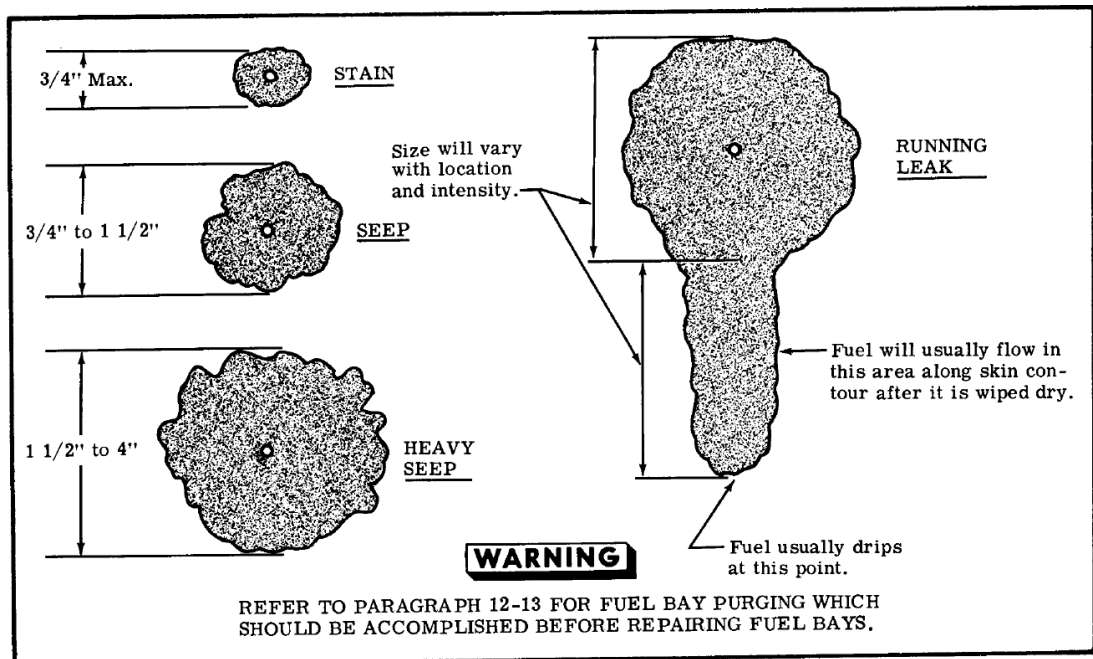
Figure 9: Classification of Fuel Leaks. (Source: Cessna 177 1968-1975, Service Manual)

1.16.2.2. According to the service manual, there was no evidence of a heavy seep or running leak at the time of the fuel leak test after the aircraft's wings were detached, which would have prohibited further flights.

1.16.2.3. According to the AMO, following the initial fuel leak test, the left fuel tank was repaired and reinstalled on the fuselage, and all fuel lines reconnected. Upon refuelling, a system leak test was conducted, and a minor fuel drip was observed on the forward (FWD) inboard and outboard end ribs of the left fuel tank. The leak was still not of a measurable quantity and was classified as a heavy seepage.

The fuel was drained, and the fuel tank cleaned and resealed. Pressure tests were performed with no further leaks observed.
