**AIRCRAFT ACCIDENT REPORT AND EXECUTIVE SUMMARY**

<b>Reference:</b>		CA18/2/3/10091		
<b>Aircraft Registration</b>	ZU-MDA	<b>Date of Accident</b>	11 December 2021		<b>Time of Accident</b>	0930Z	
<b>Type of Aircraft</b>	Slick-360		<b>Type of Operation</b>		Private (Part 94)		
<b>Pilot-in-command Licence Type</b>		ATPL (Aeroplane)	<b>Age</b>	66	<b>Licence Valid</b>	Yes	
<b>Pilot-in-command Flying Experience</b>		<b>Total Flying Hours</b>	± 16 300		<b>Hours on Type</b>	± 170	
<b>Last Point of Departure</b>		Baragwanath Aerodrome (FASY), Johannesburg, Gauteng Province					
<b>Next Point of Intended Landing</b>		Baragwanath Aerodrome (FASY), Johannesburg, Gauteng Province					
<b>Damage to Aircraft</b>		Destroyed					
<b>Location of the accident site with reference to easily defined geographical points (GPS readings if possible)</b>							
Open area adjacent the taxiway at FASY at GPS co-ordinates: 26°20'56.1" South 027°46'37.7" East, at an elevation of 5 426 feet (ft)

<b>Reference Number</b>	: CA18/2/3/10091
<b>Occurrence Category</b>	: Accident (Category 2)
<b>Type of Operation</b>	: Private (Part 94)
<b>Operator Type</b>	: Private
<b>Aircraft Registration</b>	: ZU-MDA
<b>Aircraft

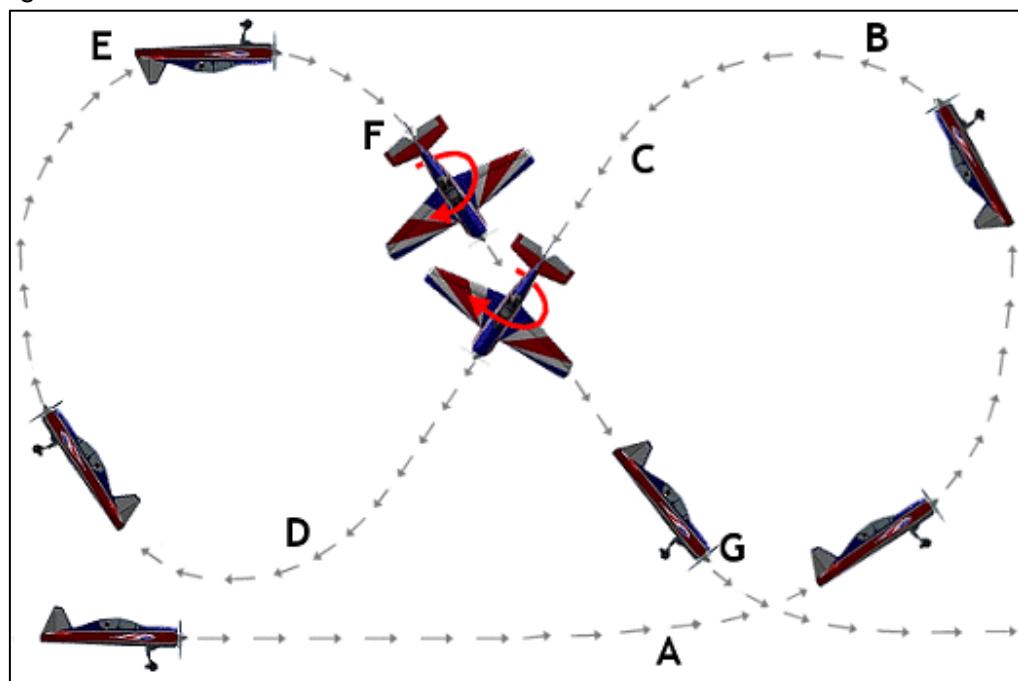
- 1.1.3. According to the eyewitness (a judge), during the pilot's last aerobatic display sequence, which was the half Cuban-8 manoeuvre (Illustration 1) and includes a one-and-a-half snap roll (Illustration 2), the aircraft's left wing stalled. The pilot recovered from the stall and shortly afterwards, the aircraft stalled again but this time the aircraft continued to descend towards the ground.

**Illustration 1:** The Cuban-8 manoeuvre.

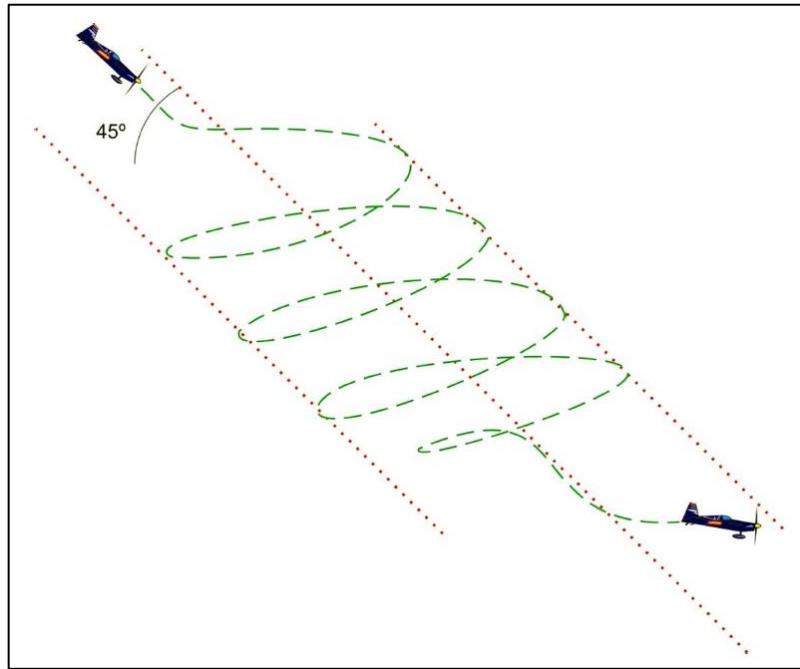
**Illustration 2:** Snap roll manoeuvre with four consecutive turns at 45° descending and positive. (Source: ZIVKO EDGE 540 aircraft accident report, 2010)

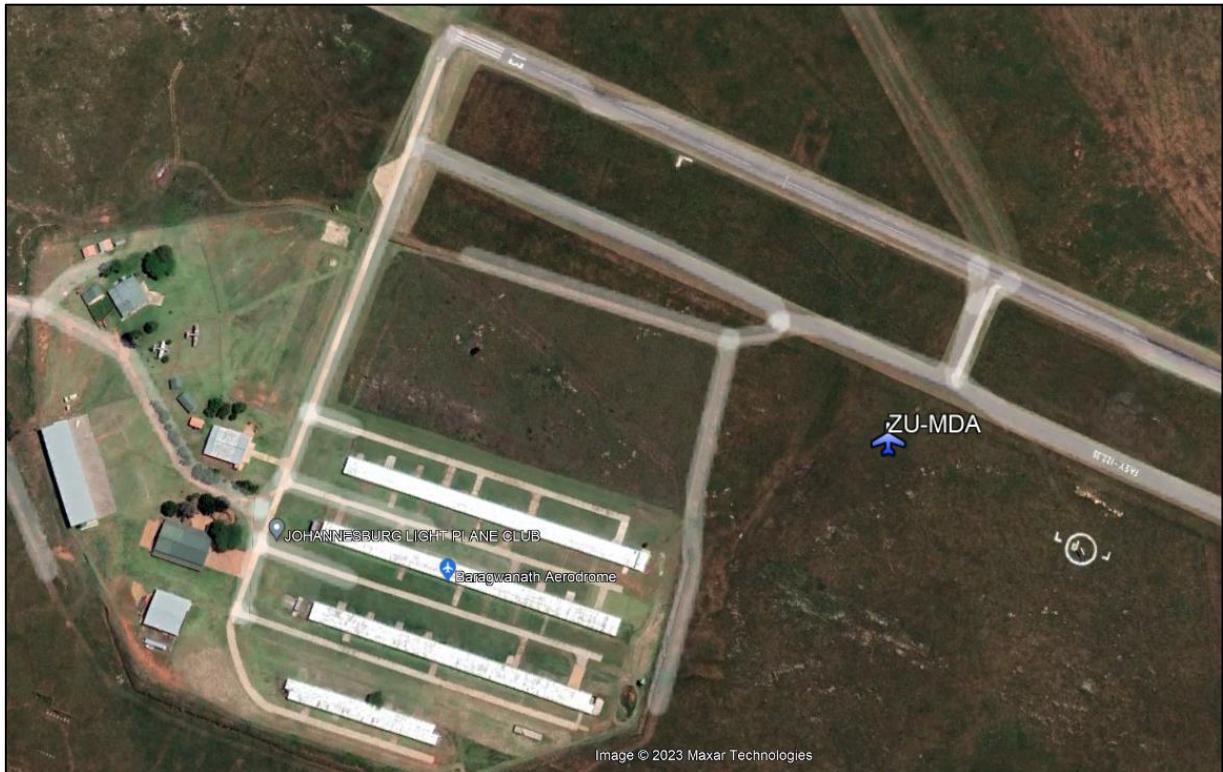
- 1.1.8. The aircraft crashed on an open field in the vicinity of FASY at Global Positioning System (GPS) co-ordinates determined to be 26°20'56.1" South 027°46'37.7" East, at 5 426 ft above mean sea level (AMSL).

**Figure 1:** Aerial view of the accident site. (Source: Google Earth Pro)

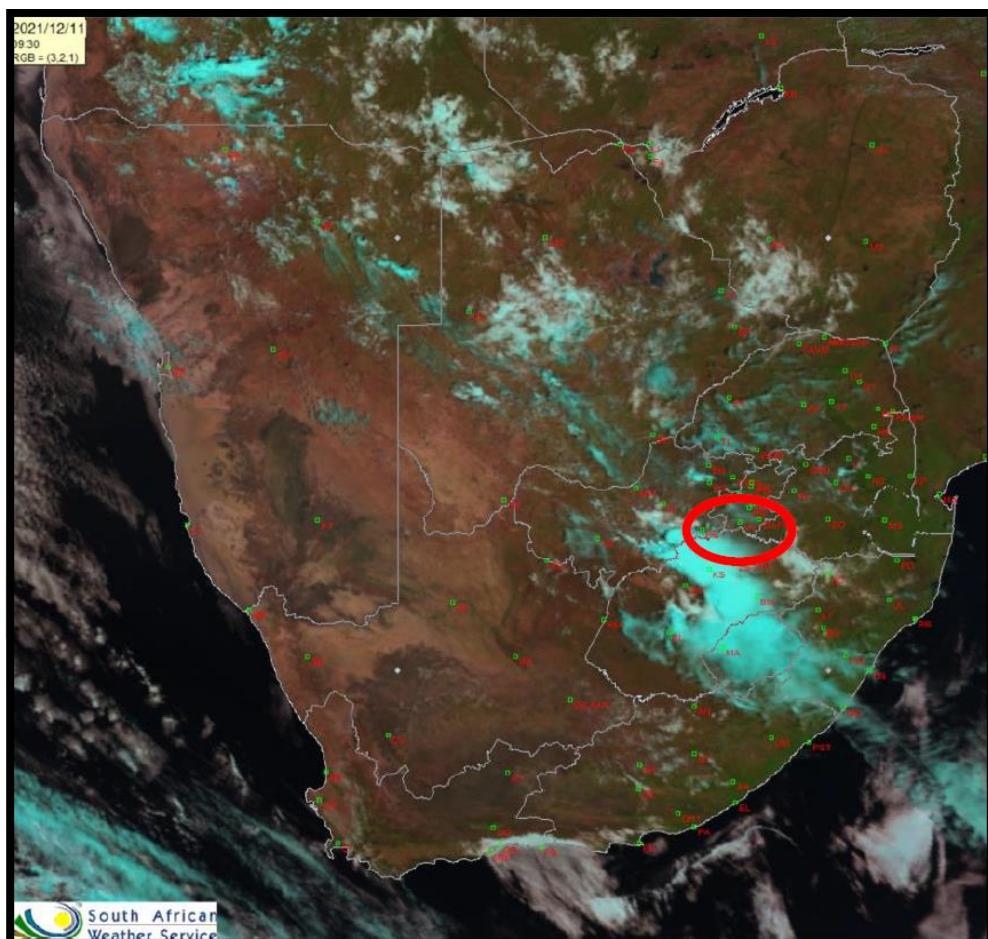
The SAWS satellite image (below) was taken at 0930Z on the day of the accident; it shows *south Gauteng region with a few broken and scattered clouds and with no turbulence; and visible high-level cloud and thunderstorms in the Free-State*, which had no effect on Gauteng region.

**Figure 4:** Satellite image at 0930Z on 11 December 2021. (Source: SAWS report)

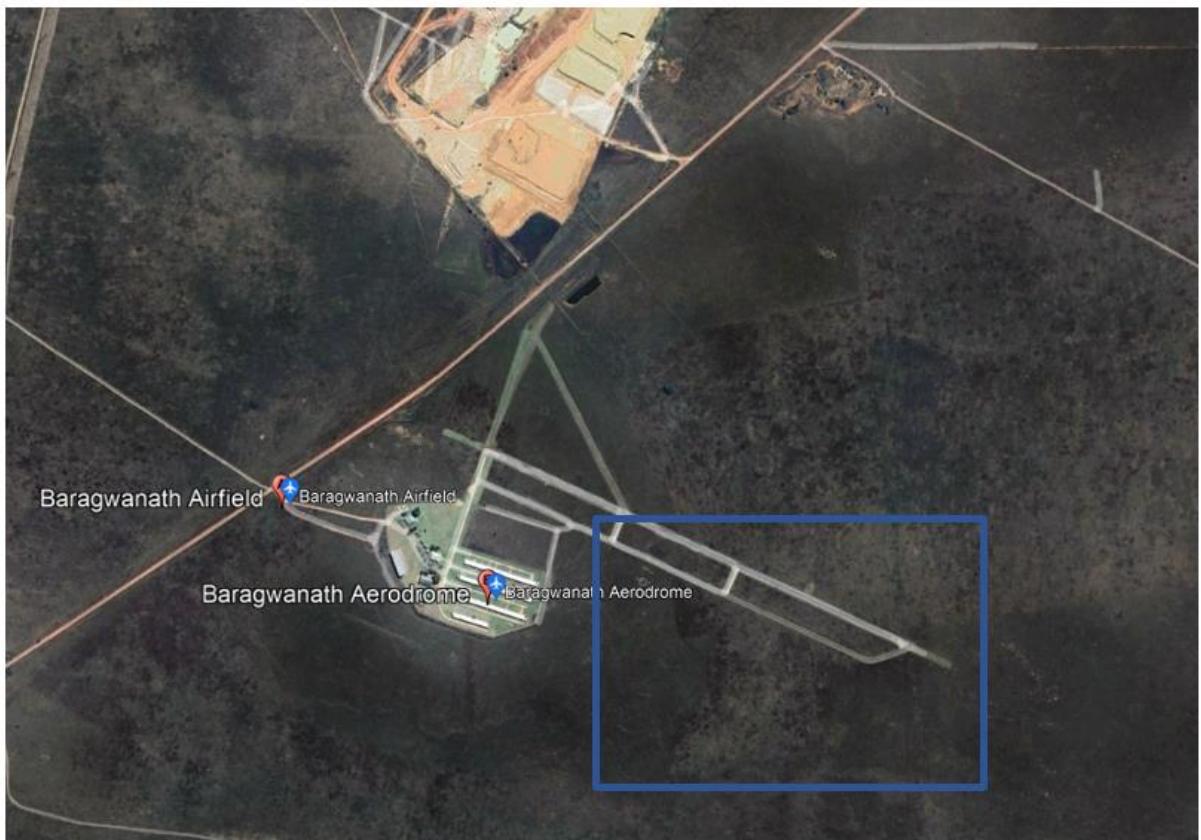
1.10.1. Within the aerodrome's airspace is a designated aerobatic box consisting of an imaginary cube of 1 kilometre (km) by 1 km (1 km x 1km) diameter in which aerobatic manoeuvres are performed. The aerobatic box is used as a reference by judges during the aerobatic competition. The box is intended to ensure the safety of the spectators, the aircraft performing aerobatic manoeuvres and other traffic using the aerodrome (Figure 5). Aerodrome procedures define the method to be used by traffic at the aerodrome to make approaches, take-offs and landings when there are activities in the aerobatic box (blue square).

**Figure 5:** Aerial view of the Baragwanath Aerodrome with the imaginary aerobatic box in blue.  
(Source: Google Earth Pro)

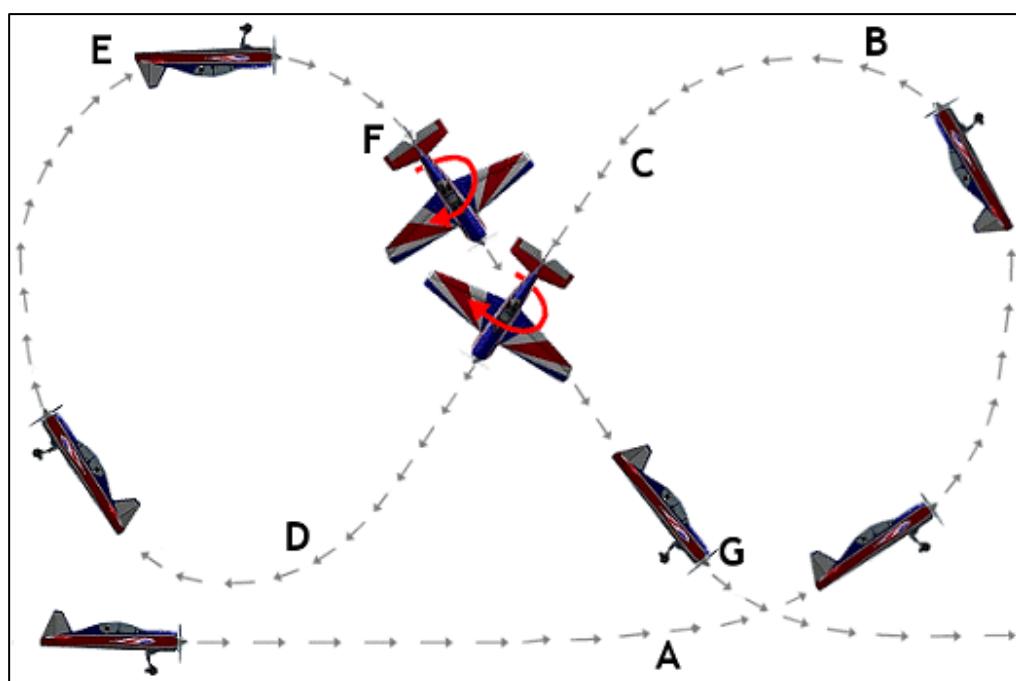
Illustration 3: The Cuban-8 manoeuvre.

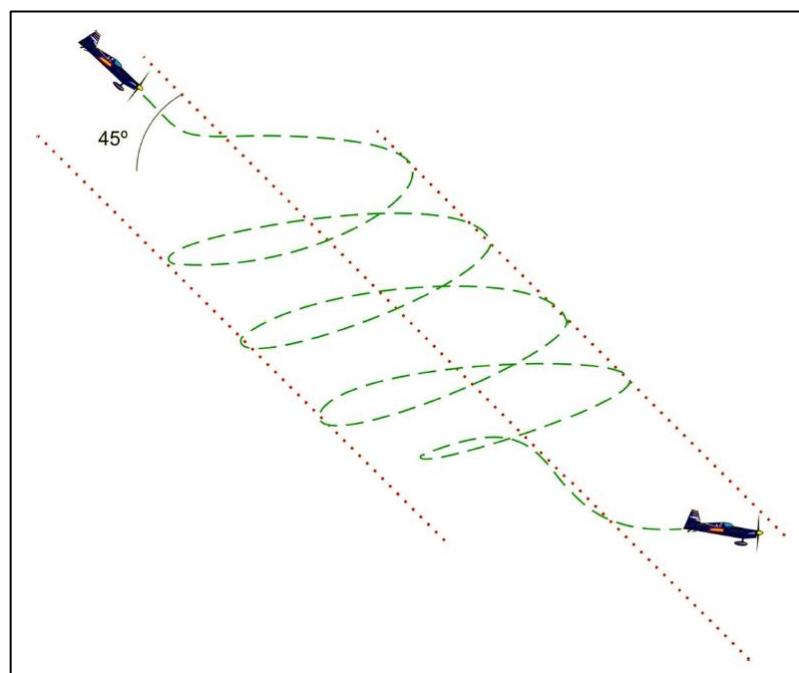
*This is performed as follows: the stick is pulled back to cause a stall and the aircraft is placed at 45° up angle. This is normally initiated at 3000ft and ends at 1000ft, depending on the number of turns to be made, with approximately 150ft being lost per roll. This manoeuvre involves mainly the use of the rudder, with the pedal on the side to which the turn is to be executed being fully depressed.*

*To recover from the manoeuvre, the opposite pedal is applied, with the angle of attack being maintained with the stick. If the smoke system is used, the manoeuvre looks like a coiled telephone cord (see Illustration 3). The aircraft nose comes out on the same trajectory. This manoeuvre is performed very fast, and the amount of inertia accumulated by the aircraft because of the turns can result in the aircraft rotating an additional ¼ roll approximately.*

**Illustration 4:** Snap roll manoeuvre with four consecutive turns at 45° descending and positive. (Source: ZIVKO EDGE 540 aircraft accident report, 2010)
