AIRCRAFT ACCIDENT REPORT AND EXECUTIVE SUMMARY

Reference:		CA18/2/3/10116	
Aircraft Registration	ZU-IKI	Date of Accident	10 February 2022		Time of Accident	1110Z	
Type of Aircraft	Jabiru 430		Type of Operation		Private (Part 94)		
Pilot-in-command Licence Type	Private Pilot Licence (Aeroplane)		Age	64	Licence Valid	Yes	
Pilot-in-command Flying Experience	Total Flying Hours		647.5	Hours on Type	59		
Last Point of Departure	Robertson Aerodrome (FARS), Western Cape Province						
Next Point of Intended Landing	Morning Star Aerodrome, Western Cape Province						
Damage to Aircraft	Substantial						
Location of the accident site with reference to easily defined geographical points (GPS readings if possible)							
Cape Point Nature Reserve Road, at Global Positioning System (GPS) co-ordinates determined to be 34°21'02.72"S 018°29'06.23"E at an elevation of 416 feet							
Meteorological Information	Wind velocity: 290° at 9kt; Temperature: 25°C; Dew Point: 16°C; Visibility: ≥10000m; Cloud: SCT 3500 ft; QNH: 1014 hPa

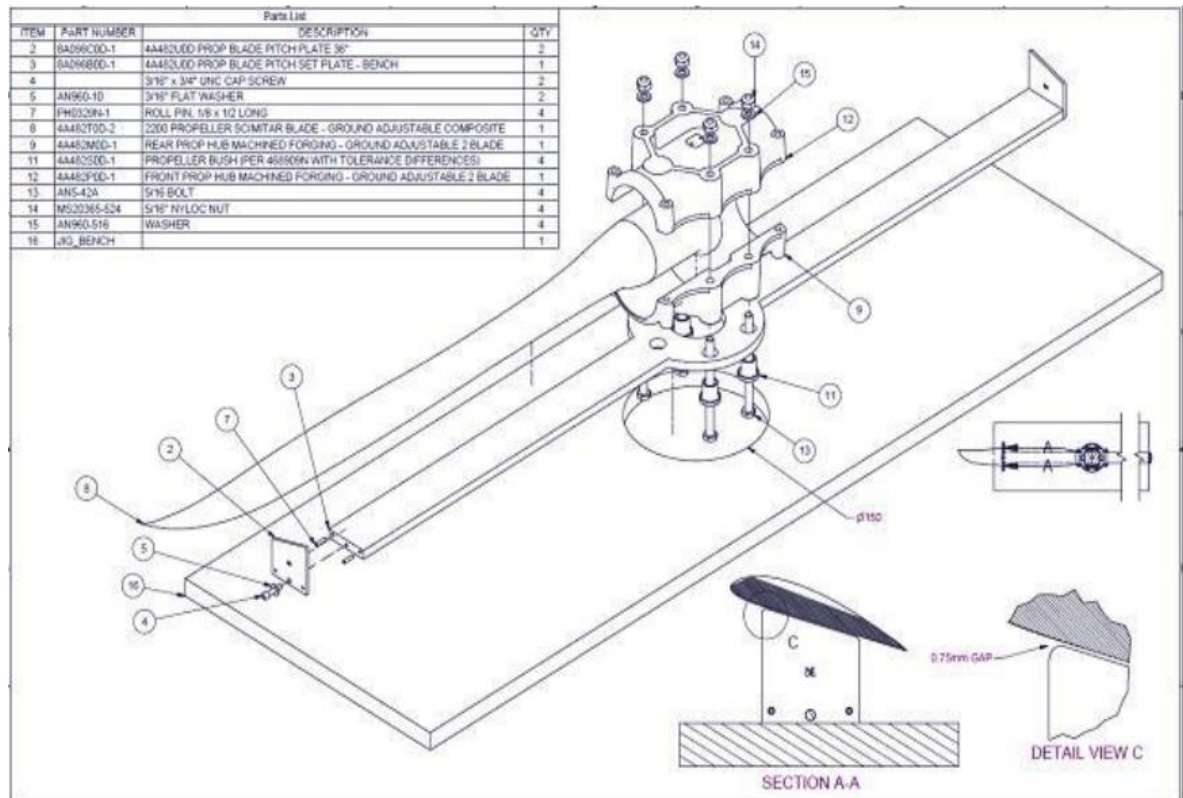
Diagram 1: The schematics of the propeller.

- 1.6.8 The propeller detached in-flight. A flight inspection post-accident was carried out by the manufacturer in the absence of the investigator. The flight inspection could not determine the cause of the propeller detaching in-flight.
- 1.6.9 According to the JPM0001-6 Jabiru Propeller Technical Manual :*Propeller Bolt Tension:*
If the propeller bolts loose tension the propeller may move and fret on the mounting flange of the engine. This will lead to damage to both the propeller and the engine.
