AIRCRAFT ACCIDENT REPORT AND EXECUTIVE SUMMARY

Reference:		CA18/2/3/10130		
Helicopter Registration		ZS-RVP	Date of Accident		2 March 2022	Time of Accident		0740Z
Type of Helicopter		Agusta-Bell 206A			Type of Operation		Private (Part 91)	
Pilot-in-command Licence Type		Private Pilot Licence (PPL)		Age	54	Licence Valid	Yes	
Pilot-in-command Flying Experience		Total Flying Hours		475.9		Hours on Type	0	
Last Point of Departure		Virginia Aerodrome (FAVG), Kwazulu-Natal Province						
Next Point of Intended Landing		Virginia Aerodrome (FAVG), Kwazulu-Natal Province						
Damage to Helicopter		Substantial						
Location of the accident site with reference to easily defined geographical points (GPS readings if possible)								
On the grass, 3 metres (m) west of Runway 05 at FAVG at Global Positioning System (GPS) co-ordinates determined to be 29° 46' 14" South 031°03'30" East, at an elevation of 20 feet								
Meteorological Information		Wind: 060°at 14kt, temperature: 30°C, Dew point: 21°C, Visibility: 9999m, QNH: 1011hPa

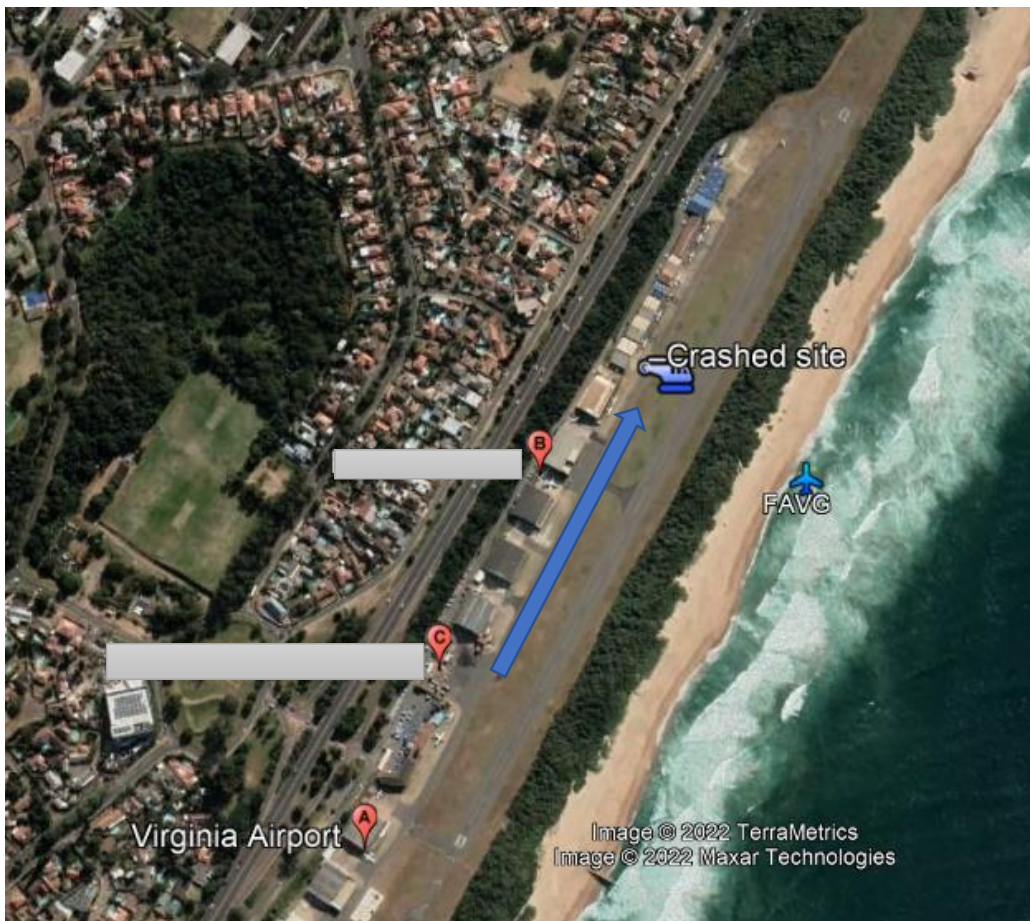
1.1.11 The accident occurred on the grass, 3 metres (m) west of Runway 05 at FAVG in Durban, KwaZulu-Natal province at Global Positioning System (GPS) co-ordinates determined to be 29° 46'14" South 031°03'30" East at elevation of 20 feet (ft).

Figure 4: Overlay of the accident site and the direction of the helicopter. (Source: Google Earth)
