AIRCRAFT ACCIDENT REPORT AND EXECUTIVE SUMMARY

Reference:		CA18/2/3/10160	
Aircraft Registration	ZS-BTL	Date of Accident	18 May 2022		Time of Accident	0805Z	
Type of Aircraft	Piper PA-25-235D Pawnee		Type of Operation		Private (Part 91)		
Pilot-in-command Licence Type	PPL (A)	Age	52		Licence Valid	Yes	
Pilot-in-command Flying Experience	Total Flying Hours	1060.1	Total Hours on Type		17.6		
Last Point of Departure	Potchefstroom Aerodrome (FAPS), North West Province						
Next Point of Intended Landing	Bospan Airstrip, North West Province						
Damage to Aircraft	Substantial						
Location of the accident site with reference to easily defined geographical points (GPS readings if possible)							
± 910 metres from the threshold of Runway 21 at FAPS (GPS co-ordinates: 26°39'45.65" South 027°05'01.94" East) at an elevation of 4 459 feet (ft)							
Meteorological Information	Surface wind: 340°/06-10kt; temperature: 19.7°C; dew Point: 7°C; visibility: 9999m

Reference Number : CA18/2/3/10160
Occurrence Category : Accident (Category 2)
Type of Operation : Private (Part 91)
Operator Type : Private
Aircraft Registration : ZS-BTL
Aircraft Make and Model : Piper Aircraft Corporation, PA-25-2

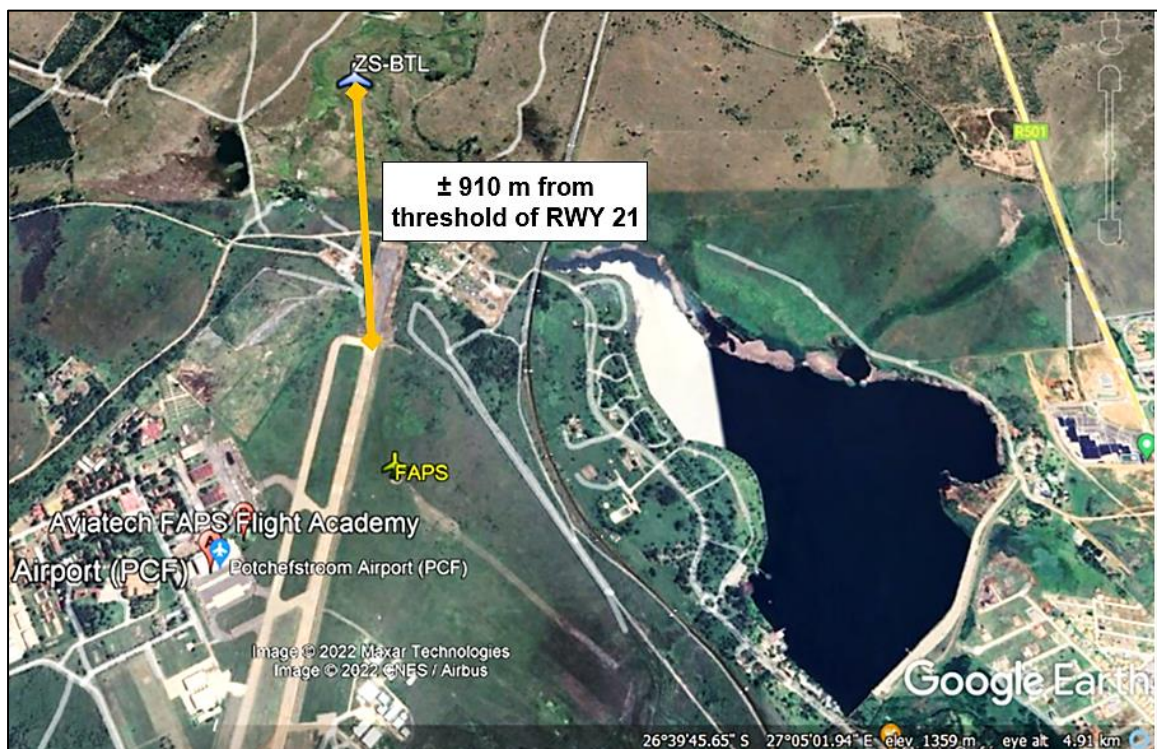
- 1.1.4. According to the pilot, the engine power loss occurred towards the end of the runway with the aircraft at a low altitude, thus cancelling out the option for the pilot to attempt a turn back to the aerodrome. The pilot continued with the flight and carried out the aircraft's emergency procedure for engine power loss during take-off; however, the engine power could not be regained. The pilot then sought out and identified an open field of grass, about 30 degrees (°) left of the aircraft's flight path, on which to conduct an emergency landing.

Figure 1: Aerial view of the accident site in proximity to FAPS. (Source: Google Earth)

- 1.1.5. After touchdown on a waterbed area, the aircraft ran over a body of water which caused the main gears to sink into the mud, abruptly decelerating the aircraft. As a result, the tail lifted forward which caused the aircraft to nose over before it came to rest in an inverted position.
- 1.1.6. The aircraft sustained substantial damage during the accident sequence; however, the pilot was not injured and disembarked from the aircraft without assistance.
- 1.1.7. The accident occurred during daylight at Global Positioning System (GPS) co-ordinates determined to be 26°39'45.65" South 027°05'01.94" East, at an elevation of 4 459 ft above mean sea level (AMSL).
