AIRCRAFT ACCIDENT REPORT AND EXECUTIVE SUMMARY

Reference:		CA18/2/3/10167	
Aircraft Registration	ZS-WAP	Date of Accident	1 June 2022		Time of Accident	0935Z	
Type of Aircraft	Piper PA-28R-200 Cherokee Arrow II		Type of Operation		Training (Part 141)		
Pilot-in-command Licence Type	Commercial Pilot Licence (CPL)		Age	25	Licence Valid	Yes	
Pilot-in-command Flying Experience	Total Flying Hours		1486.3		Hours on Type	494	
Last Point of Departure	Cape Town International Airport (FACT), Western Cape Province						
Next Point of Intended Landing	Stellenbosch Airport (FASH), Western Cape Province						
Damage to Aircraft	Destroyed						
Location of the accident site with reference to easily defined geographical points (GPS readings if possible)							
R44 road in Firgrove, Stellenbosch, at Global Positioning System (GPS) co-ordinates determined to be 34°01'29.23" South 18°49'12.39" East at an elevation of 95 feet (ft)							
Meteorological Information	Wind: 040° at 05kts, Temperature: 17°C, Clouds cover: Nil, Dew Point: 10°C, Cloud Base 3200ft, Visibility: 10km and QNH: 1030hPa

Probable Cause							
The flight instructor executed a forced landing on the R44 road following an engine failu

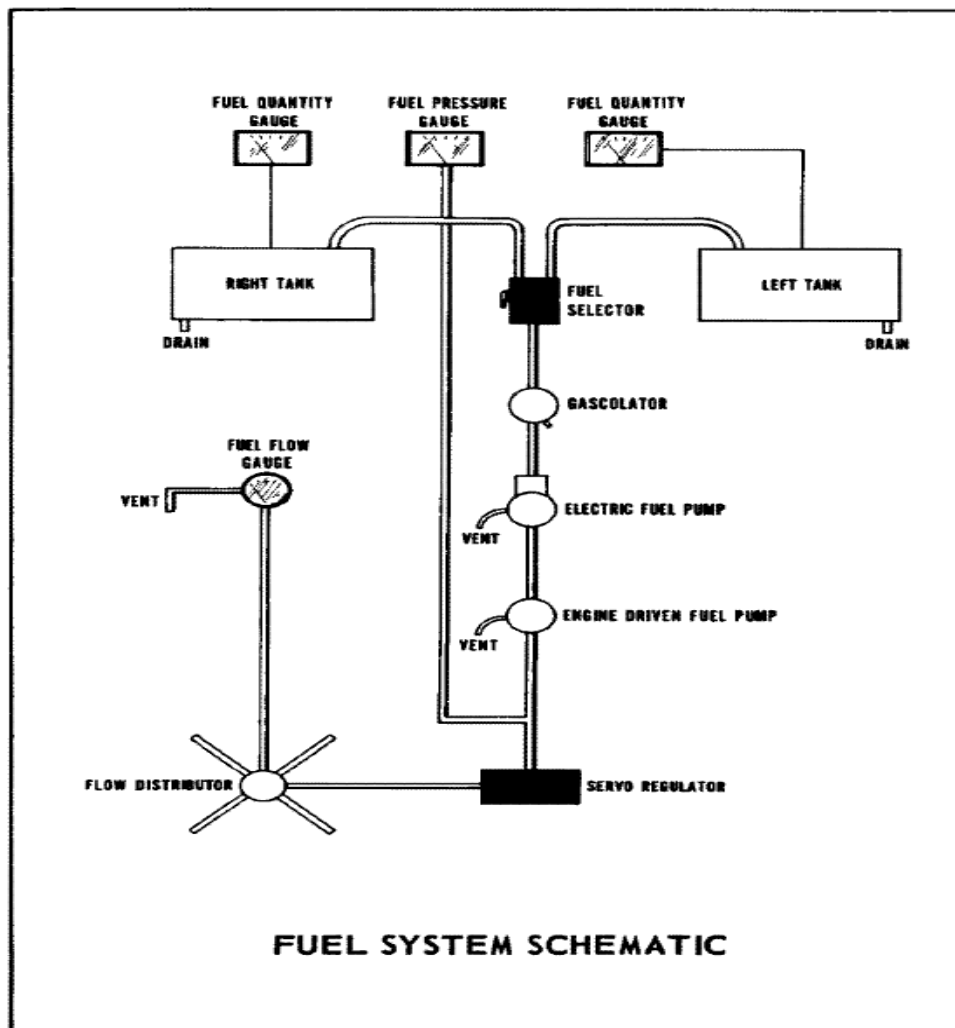
Diagram 1: Schematics of the fuel system. (Source: POH)

The fuel system is stored in two twenty-five-gallon tanks which are secured to the leading-edge structure of each wing by screws and nut plates. This allows easy removal for service or inspection. An auxiliary electric fuel pump is provided in case of failure of driven pump. The electric pump must be switched on for all take-offs and landings, and when switching tanks. The pump switch is in the switch panel above the throttle quadrant. Each tank has an individual quick drain located at the bottom, and inboard, rear corner, and should be drained to check for water before each flight. (A special bottle is furnished for this project.) The fuel strainer, which is also equipped with a quick drain is located on the front lower left firewall. This strainer should be drained regularly to check for water or sediment accumulation.
