LIMITED OCCURENCE INVESTIGATION REPORT – FINAL

Reference Number	CA18/2/3/10172						
Classification	Accident	Date	12 June 2022	Time	0900Z		
Type of Operation	Private (Part 94)						
Location							
Place of Departure	Worcester Aerodrome (FAWC), Western Cape Province		Place of Intended Landing	Worcester Aerodrome, Western Cape province			
Place of Occurrence	Worcester Aerodrome (FAWC)						
GPS Co-ordinates	Latitude	33°39'55.80" S	Longitude	019°25'04.04" E	Elevation	663ft	
Aircraft Information							
Registration	ZS-GUJ						
Make; Model; S/N	Glaser-Dirks; DG-500M (Serial Number: 5E114M51)						
Damage to Aircraft	Substantial			Total Aircraft Hours	2 207.7		
Pilot-in-command							
Licence Type	Glider Pilot Licence		Gender	Male		Age	47
Licence Valid	Yes	Total Hours	1 782.1		Total Hours on Type	46.7	
Total Hours 30 Days	10.9		Total Hours on Type Past 90 Days	10.9			
People On-board	1 + 1	Injuries	0	Fatalities	0	Other (on ground)	0
What Happened							
<p>On Sunday morning, 12 June 2022, a pilot and a passenger on-board a Glaser-Dirks DG-500M self-launch power glider with registration ZS-GUJ intended to engage in a private flight with the take-off from Runway 33 at Worcester Aerodrom

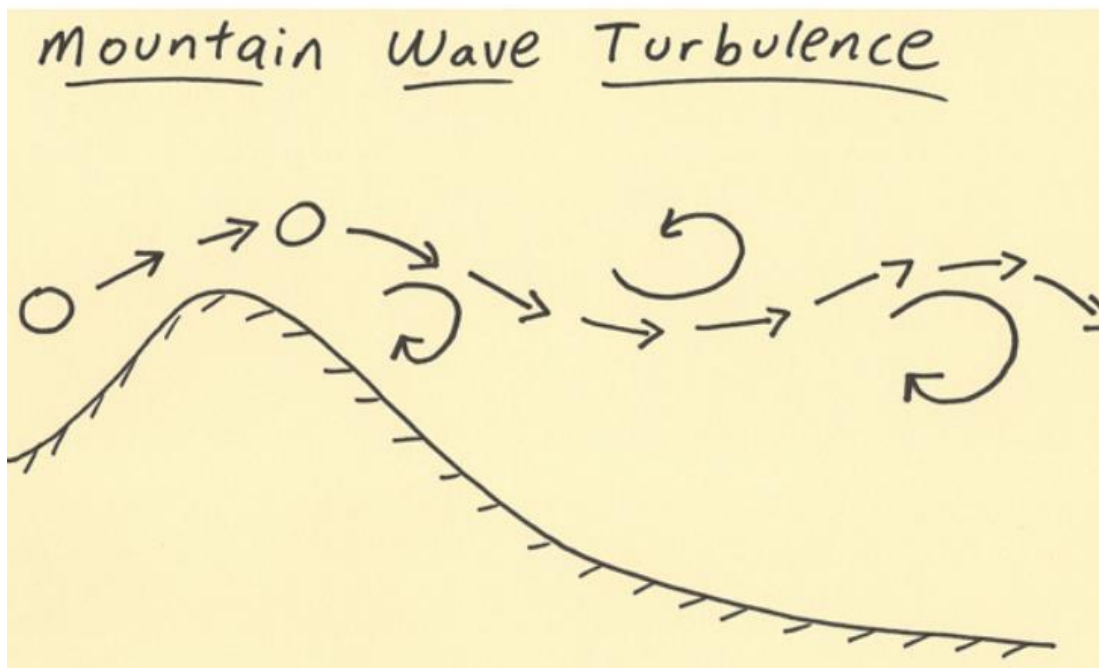
Illustration 1: Mountain wave turbulence. (Source: Google)

The flow over elevated terrain can set up turbulence that produces unique cloud formations and airflow patterns that can be dangerous to aircraft. As air flows over the mountain or mountain range it is forced upwards. If the air is unstable, the air will continue to rise and can produce rain or storms in the vicinity of the mountain. Mountain wave turbulence is typically set off when the air is stable. This is because as the air is forced lifted, after it goes over the mountain it will want to return to its original elevation. As the air moves downstream it will overshoot and undershoot this equilibrium point as it continues to move downstream. This produces a wave pattern to the airflow. What is dangerous to aircraft is the turbulent eddies that can be set off as air moves through a curved pattern at the base and top of each wave. This produces dramatically different wind directions over a short distance. An aircraft trying to adjust to a certain wind speed and direction will suddenly be impacted by a totally different wind speed and direction. This can produce severe turbulence as the aircraft goes across the eddy.

Probable Cause(s)
Incorrect technique during take-off and lack of situational awareness during low-level wind shear and buffeting. The aircraft's speed was too low at lift-off.
Contributing Factor(s)
None.
Safety Action(s)
None.
Safety Message and/or Safety Recommendation/s
None.
About this Report
<i>The decision to conduct a limited investigation is based on factors, including whether the cause is known and the evidence supporting the cause is clear, the level of safety benefit likely to be obtained from an investigation</i>
