LIMITED OCCURRENCE INVESTIGATION REPORT – FINAL

Reference Number	CA18/2/3/10181						
Classification	Accident	Date	29 June 2022	Time	1625Z		
Type of Operation	Training (Part 141)						
Location							
Place of Departure	Grand Central Aerodrome (FAGC), Gauteng Province		Place of Intended Landing	Grand Central Aerodrome (FAGC), Gauteng Province			
Place of Occurrence	Runway 17, Grand Central Aerodrome (FAGC), Gauteng Province						
GPS Co-ordinates	Latitude	25° 98' 94" S	Longitude	28° 13' 96" E	Elevation	5 325 ft	
Aircraft Information							
Registration	ZS-MBY						
Make; Model; S/N	Piper PA-34-220T Seneca III (Serial Number: 34-8133020)						
Damage to Aircraft	Substantial		Total Aircraft Hours	3 403.4			
Pilot-in-command							
Licence Type	Airline Transport Pilot Licence (ATPL) Aeroplane (A)		Gender	Male	Age	30	
Licence Valid	Yes	Total Hours on Type	83	Total Flying Hours	4 405.1		
People On-board	2 + 0	Injuries	0	Fatalities	0	Other (on ground)	0
What Happened

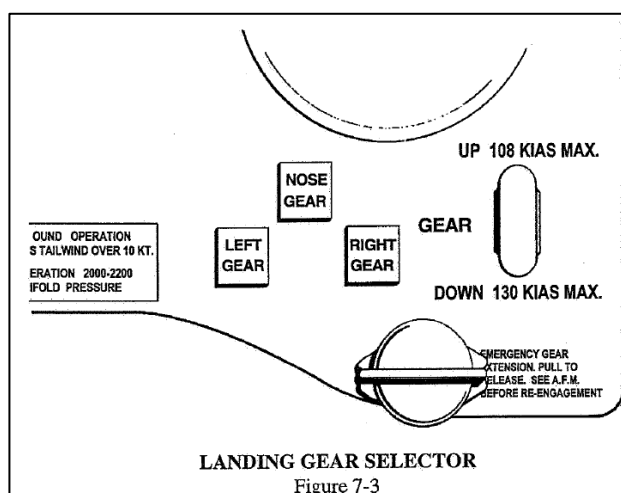
Hydraulic pressure for gear operation is furnished by an electrically powered, reversible hydraulic pump. The pump is activated by a two-position gear selector switch located to the left of the control quadrant on the instrument panel (Figure 7-3). The gear selector switch must be pulled out before it is moved to the “UP” or “DOWN” position. When hydraulic pressure is exerted in one direction, the gear is retracted; when it is exerted in the other direction, the gear is extended. Gear extension or retraction normally takes six to seven seconds.
