**LIMITED OCCURRENCE INVESTIGATION REPORT – FINAL**

<b>Reference Number</b>	CA18/2/3/10186						
<b>Classification</b>	Accident	<b>Date</b>	9 July 2022			<b>Time</b>	0900Z
<b>Type of Operation</b>	Training (Part 141)						
<b>Location</b>							
Place of Departure	Worcester Aerodrome (FAWC), Western Cape Province		Place of Intended Landing	Worcester Aerodrome (FAWC), Western Cape Province			
Place of Occurrence	Extended centreline on Runway 15, Worcester Aerodrome						
GPS Co-ordinates	Latitude	33°40'10.31" S	Longitude	019°25'35.73" E	Elevation	672 feet (ft)	
<b>Aircraft Information</b>							
Registration	ZS-FMO						
Make; Model; S/N	Piper Aircraft Company, Piper PA-28-180 Cherokee (Serial number: 28-4895)						
Damage to Aircraft	Destroyed			Total Aircraft Hours	9 971.0		
<b>Pilot-in-command</b>							
Licence Type	Commercial Pilot Licence		Gender	Male		Age	45
Licence Valid	Yes	Total Hours	352.9		Total Hours on Type	21.6	
Total Hours 90 Days	20.4		Total Flying Hours on Type Past 90 Days	6.7

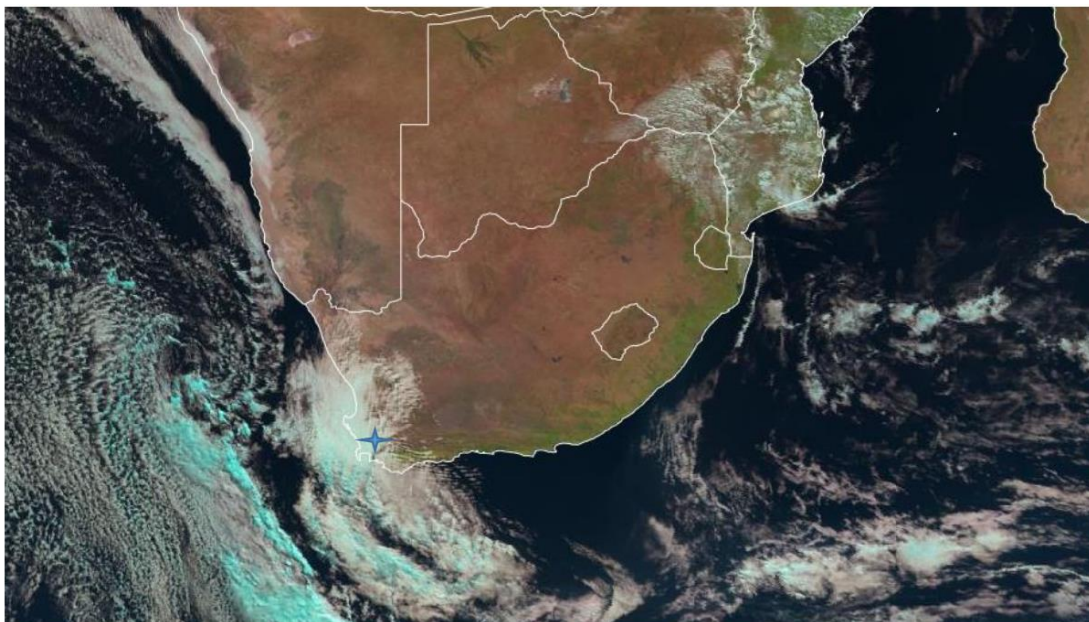
The Day Natural Colour RGB satellite imagery of the Meteosat Second Generation (MSG) was taken at 0915Z, which was approximately the time of the accident. The satellite imagery indicates a cold front just off the West Coast of the country, advected by the moist air ahead (of it) over the western parts of the country which resulted in cloud formation as depicted on the satellite imagery. The satellite imagery also shows the presence of mountain and gravity waves.

**Figure 9:** The Day Natural Light RGB satellite imagery at 0915Z on 9 July 2022. (Source: SAWS)

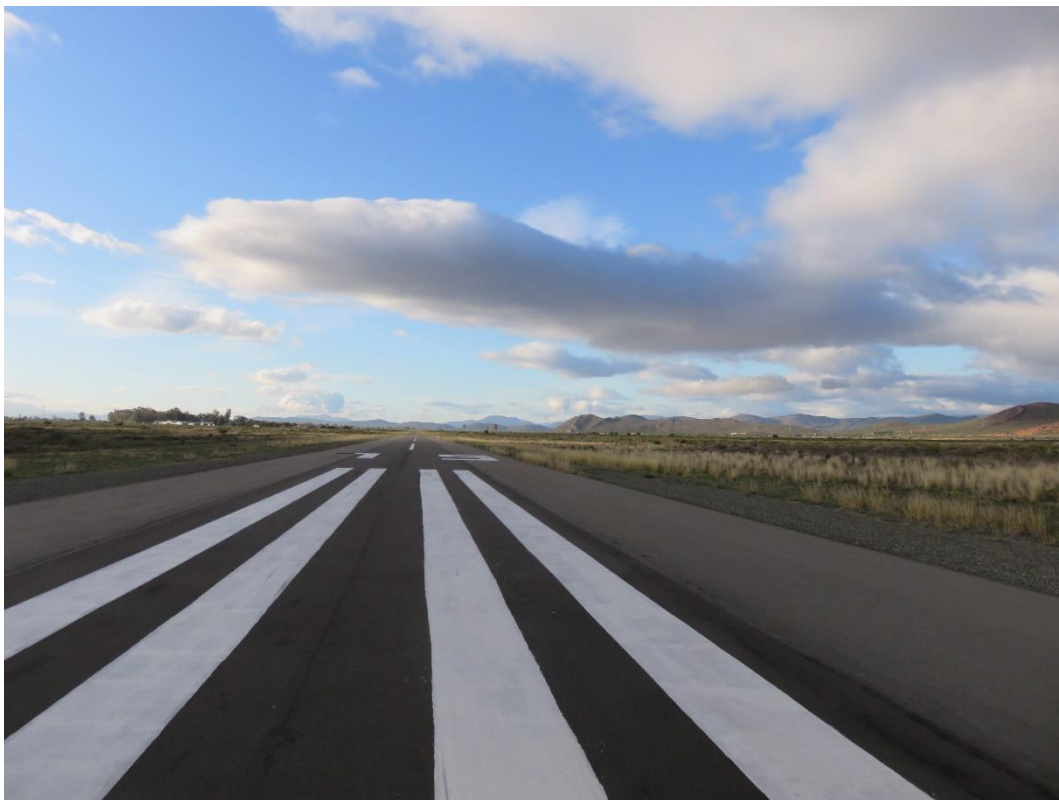
**Figure 13:** Photograph was taken at the threshold of Runway 15

- (ix) The flight was accordingly authorised in the flight authorisation sheet.
- (x) FAWC is a licensed aerodrome. Only the primary windsock was found to be in good condition to provide the prevailing wind conditions at the aerodrome. Parts of the gravel runway surface of Runway 15 were waterlogged, which was regarded as unsafe for aircraft making use of the runway.

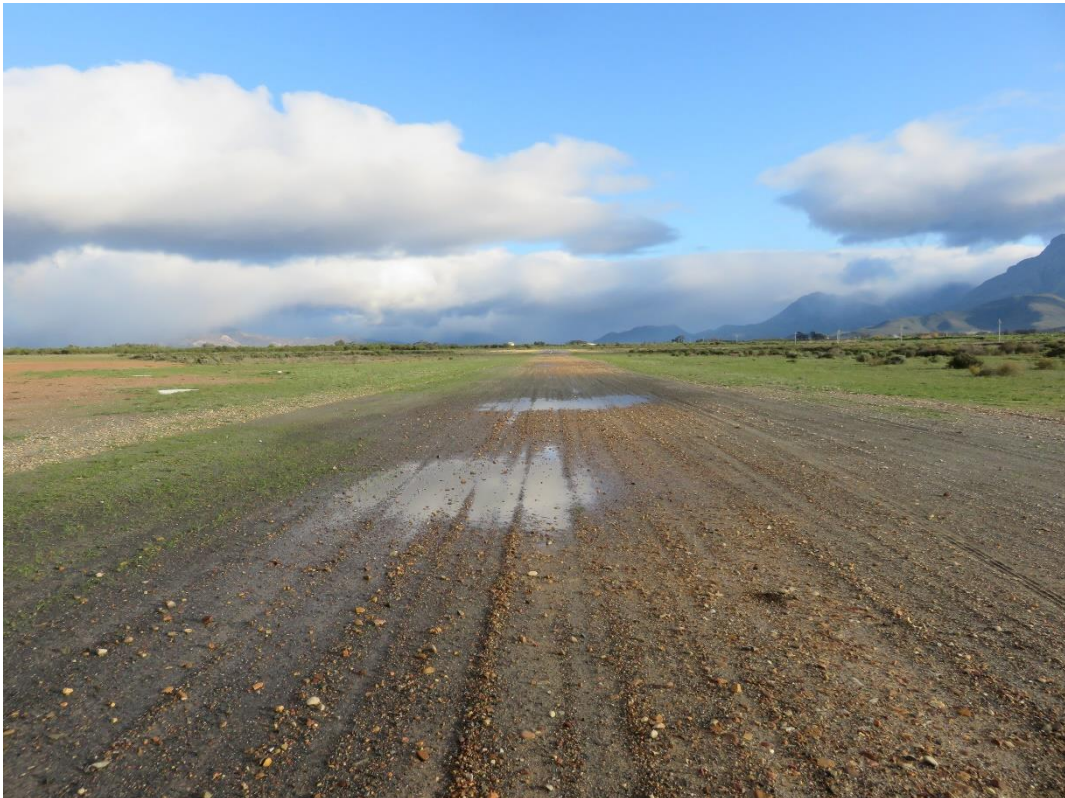
**Figure 15:** View of the runway looking towards the threshold of Runway 15.
