LIMITED OCCURRENCE INVESTIGATION REPORT – FINAL

Reference Number	CA18/2/3/10187						
Classification	Accident	Date	10 July 2022	Time	0910Z		
Type of Operation	Training (Part 141)						
Location							
Place of Departure	Lanseria International Airport (FALA), Gauteng Province		Place of Intended Landing	Lanseria International Airport (FALA), Gauteng Province			
Place of Occurrence	On Runway 07 at Lanseria International Airport (FALA), Gauteng Province						
GPS Co-ordinates	Latitude	25° 55' 44.81" S	Longitude	27°56'17.67" E	Elevation	4 393ft	
Aircraft Information							
Registration	ZS-ZIP						
Make; Model; S/N	Cirrus SR20 (Serial Number: 1496)						
Damage to Aircraft	Substantial			Total Aircraft Hours	7 164.8		
Pilot-in-command							
Licence Type	Student Pilot Licence (SPL)		Gender	Male		Age	44
Licence Valid	Yes	Total Hours	73.2	Total Hours on Type	26.5		
Total Hours 30 Days	6.6		Total Flying on Type Past 90 Days	26.6			
People On-board	1+0	Injuries	0	Fatalities	0	Other (on ground)	0

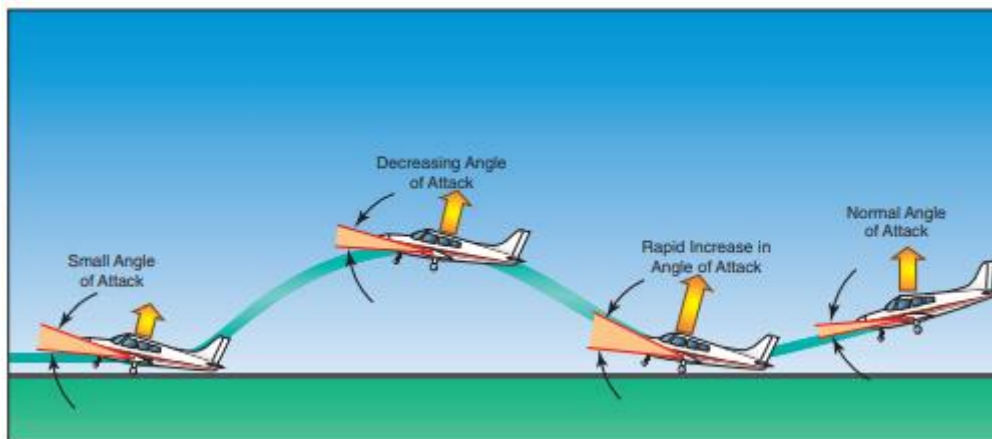
If the airspeed on final approach is excessive, it will usually result in the airplane floating. [Figure 2] Before touchdown can be made, the airplane may be well past the desired landing point and the available runway may be insufficient. When diving an airplane on final approach to land at the proper point, there will be an appreciable increase in airspeed. The proper touchdown attitude cannot be established without producing an excessive angle of attack and lift. This will cause the airplane to gain altitude or balloon. Any time the airplane floats, judgment of speed, height, and rate of sink must be especially acute. The pilot must smoothly and gradually adjust the pitch attitude as the airplane decelerates to touchdown speed and starts to settle, so the proper landing attitude is attained at the moment of touchdown. The slightest error in judgment and timing will result in either ballooning or bouncing. The recovery from floating will depend on the amount of floating and the effect of any crosswind, as well as the amount of runway remaining. Since prolonged floating utilizes considerable runway length, it should be avoided especially on short runways or in strong crosswinds. If a landing cannot be made on the first third of the runway, or the airplane drifts sideways, the pilot should EXECUTE A GO-AROUND.

Illustration 1: Bouncing during touchdown. (Source: Airplane flying handbook FAA-8083-3A)

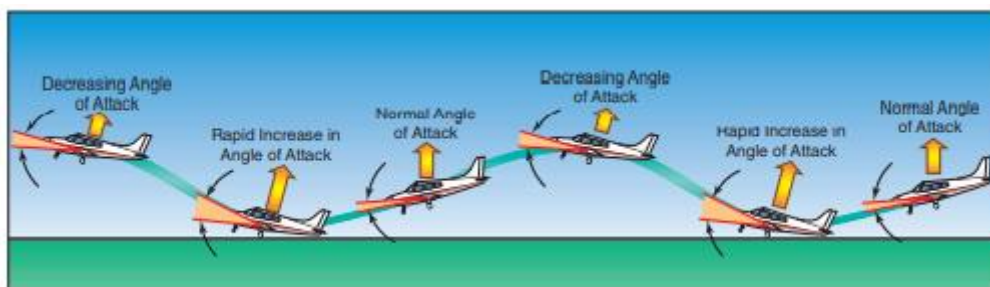
In a bounced landing that is improperly recovered, the airplane comes in nose first setting off a series of motions that imitate the jumps and dives of a porpoise— hence the name. [Figure 3] The problem is improper airplane attitude at touchdown, sometimes caused by inattention, not knowing where the ground is, mis trimming or forcing the airplane onto the runway. Ground effect decreases elevator control effectiveness and increases the effort required to raise the nose. Not enough elevator or stabilator trim can result in a nose low contact with the runway and a porpoise develops. Porpoising can also be caused by improper airspeed control. Usually, if an approach is too fast, the airplane

floats and the pilot try to force it on the runway when the airplane still wants to fly. A gust of wind, a bump in the runway, or even a slight tug on the control wheel will send the airplane aloft again. The corrective action for a porpoise is the same as for a bounce and similarly depends on its severity. When it is very slight and there is no extreme change in the airplane's pitch attitude, a follow-up landing may be executed by applying sufficient power to cushion the subsequent touchdown, and smoothly adjusting the pitch to the proper touchdown attitude. When a porpoise is severe, the safest procedure is to EXECUTE A GO-AROUND IMMEDIATELY. In a severe porpoise, the airplane's pitch oscillations can become progressively worse, until the airplane strikes the runway nose first with sufficient force to collapse the nose gear. Pilot attempts to correct a severe porpoise with flight control and power inputs will most likely be untimely and out of sequence with the oscillations, and only make the situation worse. No attempt to salvage the landing should be made. Full power should be applied while simultaneously maintaining directional control and lowering the nose to a safe climb attitude.

Illustration 2: Porpoising. (Source: Airplane Flying Handbook FAA-8083-3A)
