AIRCRAFT ACCIDENT REPORT AND EXECUTIVE SUMMARY

Reference:		CA18/2/3/10190	
Aircraft Registration	ZU-ECG	Date of Accident	16 July 2022		Time of Accident	1120Z	
Type of Aircraft	Rainbow Cheetah		Type of Operation		Private (Part 94)		
Pilot-in-command Licence Type	NPL Aeroplane	Age	50	Licence Valid	Yes		
Pilot-in-command Flying Experience	Total Flying Hours		434.8	Hours on Type	128.3		
Last Point of Departure	Wings Park Aerodrome, Eastern Cape Province						
Next Point of Intended Landing	Wavecrest Aerodrome, Eastern Cape Province						
Damage to Aircraft	Substantial						
Location of the accident site with reference to easily defined geographical points (GPS readings if possible)							
Wings Park Aerodrome RWY04, Eastern Cape Province, at Global Positioning System (GPS) determined to be 32°49'22.63"S 027°50'05.88"E at an elevation of 675 feet							
Meteorological Information	Wind velocity: 110° at 6kts; Temperature: 22°C; Dew Point: 11°C; Visibility: ≥10000m; Cloud: CAVOK; QNH: 1024 hPa

Reference Number : CA18/2/3/10190
Occurrence Category : Accident
Type of Operation : Private (Part 94)
Name of Operator : J N Moolman
Aircraft Registration : ZU-ECG
Aircraft Make and Model : Rainb

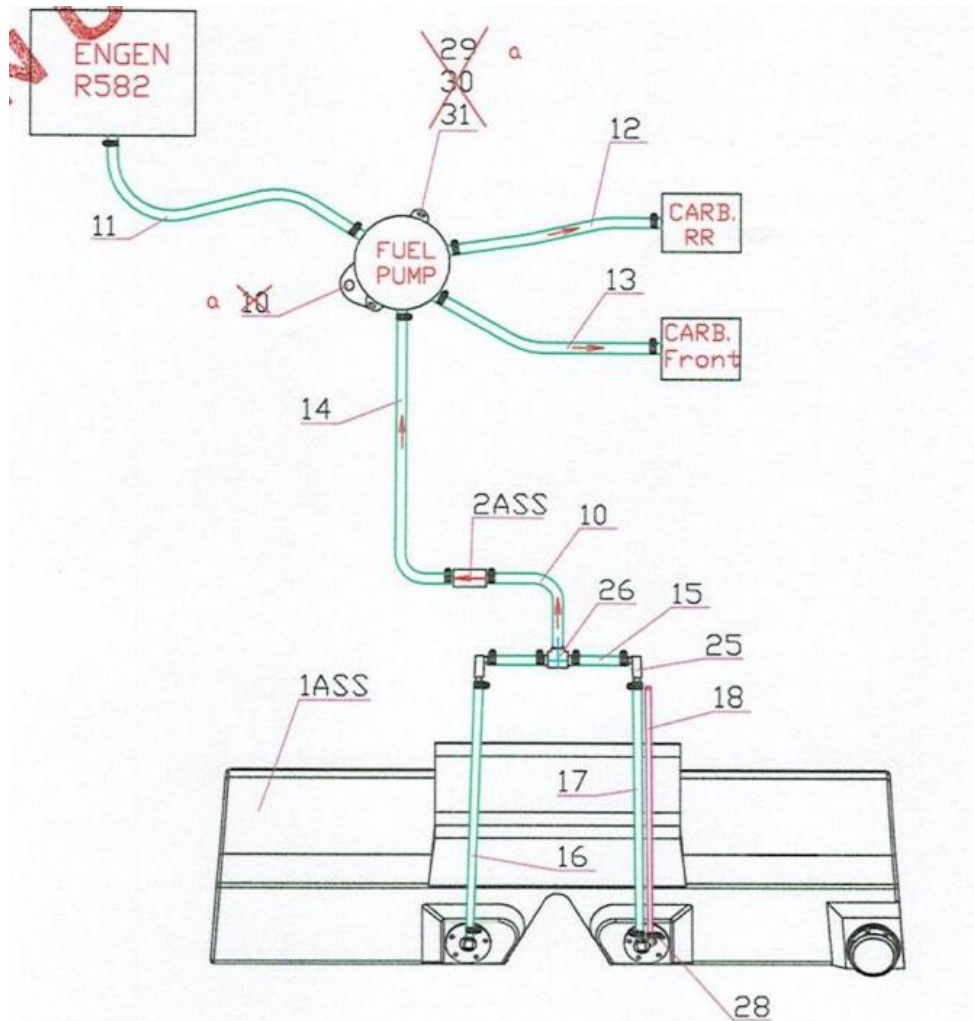
Diagram 4: The fuel system illustration for Cheetah 582R. (Source: Rainbow SkyReach)

- Check carburettors, fuel floats and needles – all were found to be in good condition.
- Check the backup electric fuel pump (Facet: serial number 60245) – the electric battery powered auxiliary fuel pump was not working.
- There were no defects with the wiring and the switches.

1.16.3 According to the maintenance manual, the fuel pump must be inspected every 100 hours or every 12 months, and must be replaced every 5 years (see Appendix 2). The aircraft documents did not show any evidence of the replacement of the auxiliary fuel pump.

- 3.2.6. There was no evidence that the auxiliary fuel pump was replaced in the past five years as prescribed in the flight manual.

1.16.2 The electric auxiliary fuel pump was replaced with a serviceable one. The engine was started and the fuel pressure read good; the engine ran smoothly without further problems.
