**LIMITED OCCURRENCE INVESTIGATION REPORT - FINAL**

<b>Reference Number</b>	CA18/2/3/10193						
<b>Classification</b>	Accident		<b>Date</b>	18 July 2022		<b>Time</b>	1540Z
<b>Type of Operation</b>	Private Non-type Certificated Aircraft (Part 91)						
<b>Location</b>							
Place of Departure	Grand Central Aerodrome (FAGC), Gauteng Province		Place of Intended Landing		Zebula Aerodrome, Limpopo Province		
Place of Occurrence	Left of Runway 26 (RWY26) Zebula Aerodrome						
GPS Co-ordinates	Latitude	25°45'25.01" S	Longitude	027°58'12.99" E	Elevation	4212 ft	
<b>Aircraft Information</b>							
Registration	ZS-PSW						
Make; Model; S/N	Cessna Aircraft Company, C172M (Serial Number: 17261665)						
Damage to Aircraft	Substantial			Total Aircraft Hours	3 234.8		
<b>Pilot-in-command</b>							
Licence Type	Private Pilot Licence (Aeroplane)		Gender	Male		Age	27
Licence Valid	Yes	Total Hours	121.7		Total Hours on Type	109.1	
Total Hours 30 Days	3.3		Total Flying on Type Past 90 Days	11.8

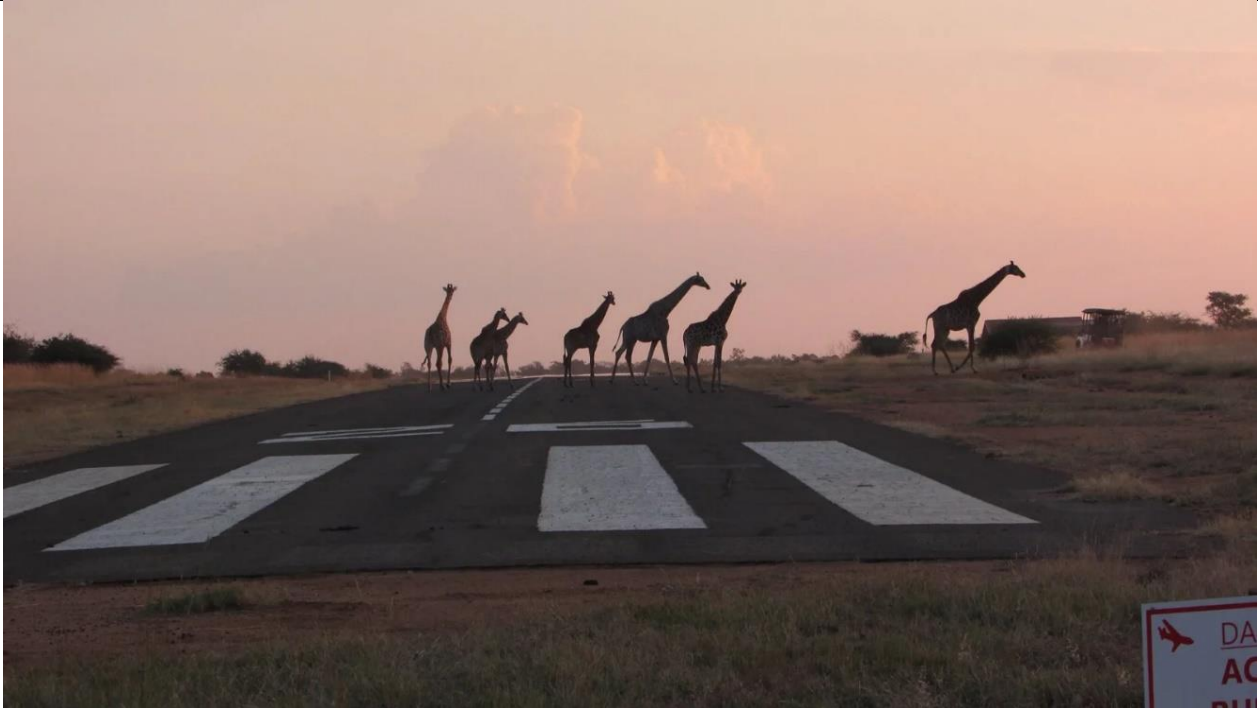
**Figure 4:** A file picture of the view of RWY 26 at Zebula Aerodrome. (Source: [www.zebula.co.za](http://www.zebula.co.za))
