LIMITED OCCURRENCE INVESTIGATION REPORT – FINAL

Reference Number	CA18/2/3/10194						
Classification	Accident	Date	28 October 2022	Time	0655Z		
Type of Operation	Training (Part 141)						
Location							
Place of Departure	Wonderboom Aerodrome (FAWB), Gauteng Province		Place of Intended Landing	Wonderboom Aerodrome (FAWB), Gauteng Province			
Place of Occurrence	Wonderboom Aerodrome (FAWB), Gauteng Province						
GPS Co-ordinates	Latitude	25° 39' 26.93" S	Longitude	028° 12' 53.12" E	Elevation	4110ft	
Aircraft Information							
Registration	ZS-FOR						
Make; Model; S/N	Piper PA-28-140 (SN: 28-24105)						
Damage to Aircraft	Substantial		Total Aircraft Hours	11 548.92			
Pilot-in-command							
Licence Type	Student Pilot Licence (SPL)		Gender	Male		Age	26
Licence Valid	Yes	Total Hours	25.7		Total Hours on Type	25.7	
Total Hours 30 Days	7.7		Total Flying on Type Past 90 Days	12.0			
People On-board	1+0	Injuries	0	Fatalities	0	Other (on ground)	0
What Happened

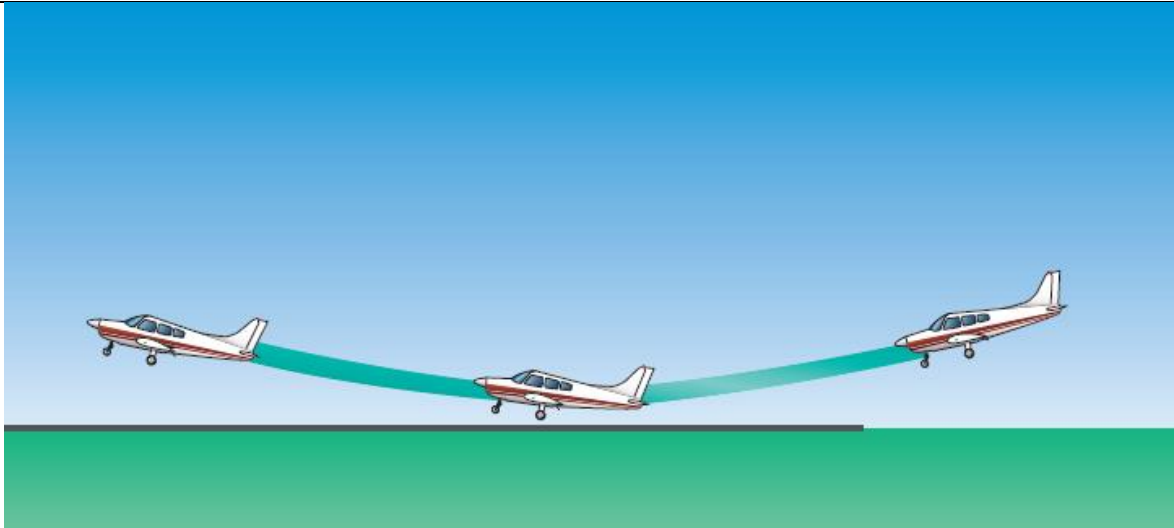
Ballooning During Round-out (Source: Federal Aviation Administration (FAA) Airplane Flying Handbook chapter 8)

If the pilot misjudges the rate of sink during a landing and thinks the airplane is descending faster than it should, there is a tendency to increase the pitch attitude and angle of attack too rapidly. This not only stops the descent, but actually starts the airplane climbing. This climbing during the round out is known as ballooning. [Figure 2] Ballooning can be dangerous because the height above the ground is increasing, and the airplane may be rapidly approaching a stalled condition.

The altitude gained in each instance will depend on the airspeed or the speed with which the pitch attitude is increased. When ballooning is slight, a constant landing attitude should be held, and the airplane allowed to gradually decelerate and settle onto the runway. Depending on the severity of ballooning, the use of throttle may be helpful in cushioning the landing. By adding power, thrust can be increased to keep the airspeed from decelerating too rapidly and the wings from suddenly losing lift, but throttle must be closed immediately after touchdown. Remember that torque will be created as power is applied; therefore, it will be necessary to use rudder pressure to keep the airplane straight as it settles onto the runway.

When ballooning is excessive, it is best to EXECUTE A GO-AROUND IMMEDIATELY; DO NOT ATTEMPT TO SALVAGE THE LANDING. Power must be applied before the airplane enters a stalled condition. The pilot must be extremely cautious of ballooning when there is a crosswind present because the crosswind correction may be inadvertently released, or it may become inadequate. Because of the lower airspeed after ballooning, the crosswind affects the airplane more. Consequently, the wing will have to be lowered even further to compensate for the increased drift. It is imperative that the pilot makes certain that the appropriate wing is down, and that directional control is maintained with opposite rudder. If there is any doubt, or the airplane starts to drift, EXECUTE A GO-AROUND.

Illustration 1: Ballooning during round-out.
