**LIMITED ACCIDENT INVESTIGATION REPORT**

<b>Reference Number</b>	CA18/2/3/10196						
<b>Classification</b>	Accident	<b>Date</b>	22 July 2022	<b>Time</b>	1256Z		
<b>Type of Operation</b>	Private (Part 94)						
<b>Location</b>							
Place of Departure	Brits Aerodrome (FABS), North West Province		Next Point of Intended Landing	Wonderboom Aerodrome (FAWB), Gauteng Province			
Place of Accident	Open field, approximately 8 nautical miles (nm) north of FAWB						
GPS Co-ordinates	Latitude	25° 33'29. 3" S	Longitude	028° 10'.45.5" E	Elevation	4 058ft	
<b>Aircraft Information</b>							
Registration	ZU-FCT						
Make/Model	Sling 2 (Serial Number: 081)						
Damage to Aircraft	Substantial		Total Aircraft Hours	2979.05			
<b>Pilot-in-command</b>							
Licence Type	Private Pilot Licence (PPL)		Gender	Male		Age: 20	
Licence Valid	Yes						
Total Hours on Type	31.12		Total Flying Hours	103.49			
<b>People On-board</b>	1 + 0	Injuries	0	Fatalities	0	Other (On ground)	0

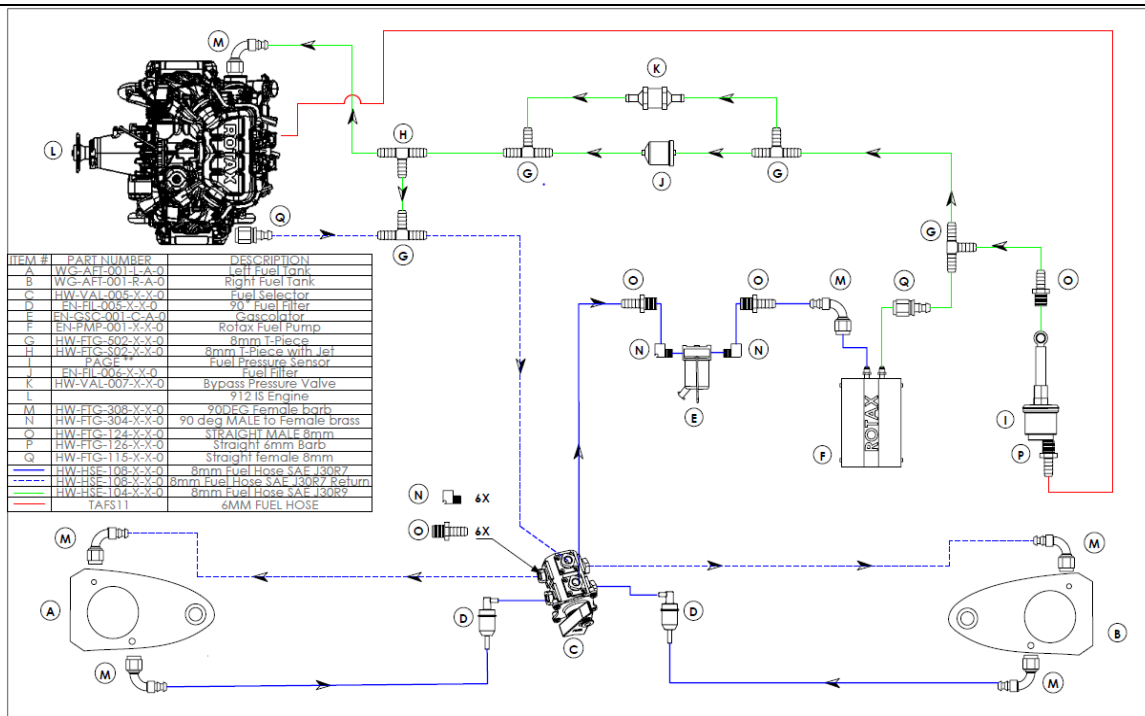
**Diagram 1:** The aircraft's fuel system schematic. (Source: Pilot's Operating Handbook)

*Fuel on the aircraft is contained in two integral fuel tanks located in the leading-edge forward of the main spar. The tank in each wing has a capacity of 98.8 United States (US) gallons (75l) of which 146l of fuel is useable. Fuel burn is approximately 18l per hour (p/h) at 5 000RPM power setting. The fuel flows from the tanks via a water separator filter to the electric fuel pumps from where it is pumped through the fine filter to the fuel pressure reading unit through the fuel rails into the fuel injectors at 3 bars (43 pressure per square inch [psi]). The fuel pump activated directly through the switch OFF/ON. A fuel pressure regulator ensures that the pressure differential between the fuel injectors and the intake manifold remains constant. This enables the fuel injection system to inject the same quantity of fuel at any point given the same injection period. Through the return line surplus fuel flows back to the fuel tank. The engine is equipped with an electronic fuel injection system. The objective of the fuel injection system is to regulate and optimize the fuel/air ratio that enters the engine. This system is controlled by the ECU, sensors and enables highly accurate metering of the fuel according to operating and load conditions, whilst at the same time also taking ambient conditions into account.*
