**LIMITED OCCURRENCE INVESTIGATION REPORT – FINAL**

<b>Reference Number</b>	CA18/2/3/10204						
<b>Classification</b>	Accident	<b>Date</b>	11 August 2022	<b>Time</b>	1710Z		
<b>Type of Operation</b>	Private (Part 91)						
<b>Location</b>							
Place of Departure	Port Elizabeth Airport (FAPE), Eastern Cape Province		Place of Intended Landing	Port Elizabeth Airport (FAPE), Eastern Cape Province			
Place of Occurrence	On Runway 08 at Port Elizabeth Airport (FAPE), Eastern Cape Province						
GPS Co-ordinates	Latitude	33° 59'26.76"S	Longitude	025° 36'21.32"E	Elevation	229 ft	
<b>Aircraft Information</b>							
Registration	ZS-TLS						
Make; Model; S/N	Mooney M-20M; (Serial Number: 27-0217)						
Damage to Aircraft	Substantial		Total Aircraft Hours	856			
<b>Pilot-in-command</b>							
Licence Type	Commercial Pilot Licence (CPL)		Gender	Male		Age	19
Licence Valid	Yes	Total Hours	255		Total Hours on Type	30.1	
Total Hours 30 Days	5.2		Total Flying on Type Past 90 Days	10.3

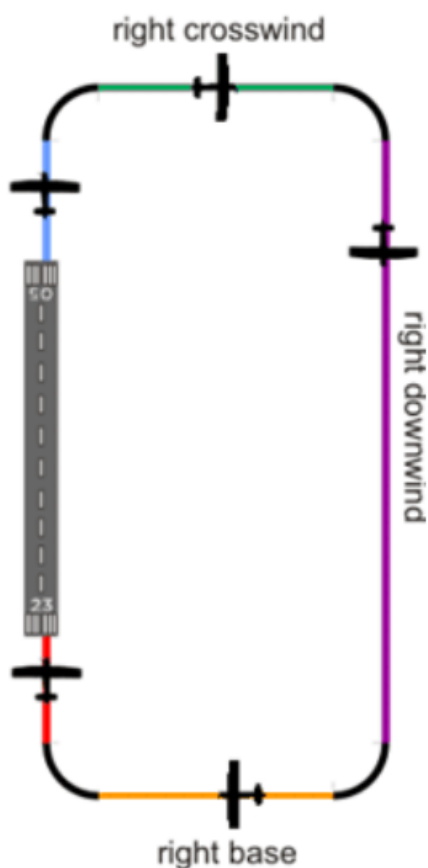
Retarding the throttle below 12 inches of manifold pressure causes the gear warning horn to emit a regular, intermittent tone, unless the gear is down and locked.

In the circuit, there are certain checks that are mandatory as well as advisable. One is expected to memorise, unlike the ground checks for which one is expected to use the checklist.
