**LIMITED OCCURRENCE INVESTIGATION REPORT – FINAL**

<b>Reference Number</b>	CA18/2/3/10210						
<b>Classification</b>	Accident	<b>Date</b>	28 June 2022	<b>Time</b>	0737Z		
<b>Type of Operation</b>	Aerial Survey (Part 101)						
<b>Location</b>							
Place of Departure	Groote Schuur Hospital, Western Cape Province		Place of Intended Landing	Groote Schuur Hospital, Western Cape Province			
Place of Occurrence	Groote Schuur Hospital, Western Cape Province						
GPS Co-ordinates	Latitude	33° 56' 28.47" S	Longitude	18° 27' 41.83" E	Elevation	197 ft	
<b>Aircraft Information</b>							
Registration	ZT-UKZ						
Make; Model; S/N	DJI Phantom 4 PRO; (Serial Number: OAXDECD00S1736)						
Damage to Aircraft	Substantial		Total Aircraft Hours	122.36			
<b>Pilot-in-command</b>							
Licence Type	Remote Pilot Licence (RPL)		Gender	Male	Age	57	
Licence Valid	Yes	Total Hours	254.42	Total Hours on Type	245.30		
Total Hours 90 Days	12.07		Total Flying on Type Past 90 Days	9.08

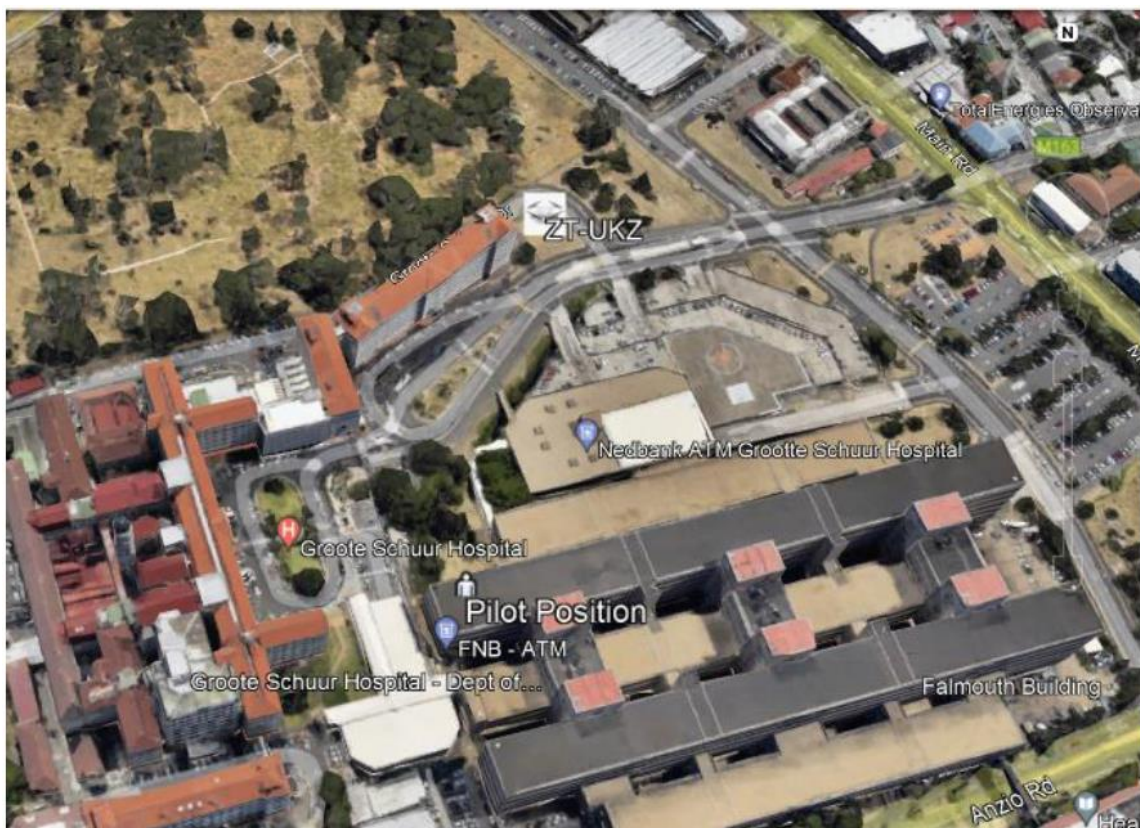
The pilot stated that he lost sight of the RPA even though it was suspected to have been approximately 150 metres (m) to 200m from his position. The pilot attempted to re-establish connection but without success. He deduced that the RPA might have crashed. The RPA was located on one of the roads in the hospital; it had 28% battery power remaining at the time of the accident.

**Figure 1:** An aerial representation of the pilot's position and where the RPA was found.  
(Source: Google Earth)
