LIMITED OCCURRENCE INVESTIGATION REPORT – FINAL

Reference Number	CA18/2/3/10222						
Classification	Accident	Date	03 February 2023		Time	1024Z	
Type of Operation	Training (Part 141)						
Location							
Place of Departure	Beaufort West Aerodrome, (FABW) Western Cape Province		Place of Intended Landing		Beaufort West Aerodrome, (FABW) Western Cape Province		
Place of Occurrence	Runway 08 at Beaufort West Aerodrome (FABW)						
GPS Co-ordinates	Latitude	32°18'00.0"S	Longitude	028°00'00.0"E	Elevation	2929 ft	
Aircraft Information							
Registration	ZS-TBK						
Make; Model; S/N	Cessna, C172S (Serial Number: 172S11301)						
Damage to Aircraft	Substantial			Total Aircraft Hours	5493.2		
Pilot-in-command							
Licence Type	Student Pilot Licence (SPL) Integrated Course (IC)		Gender	Male		Age	22
Licence Valid	Yes	Total Hours	131.0		Total Hours on Type	131.0	
Total Hours 30 Days	78.1		Total Flying on Type Past 90 Days			78.1	
People On-board	1 + 0	Injuries	1	Fatalities	0	Other (on ground)	0

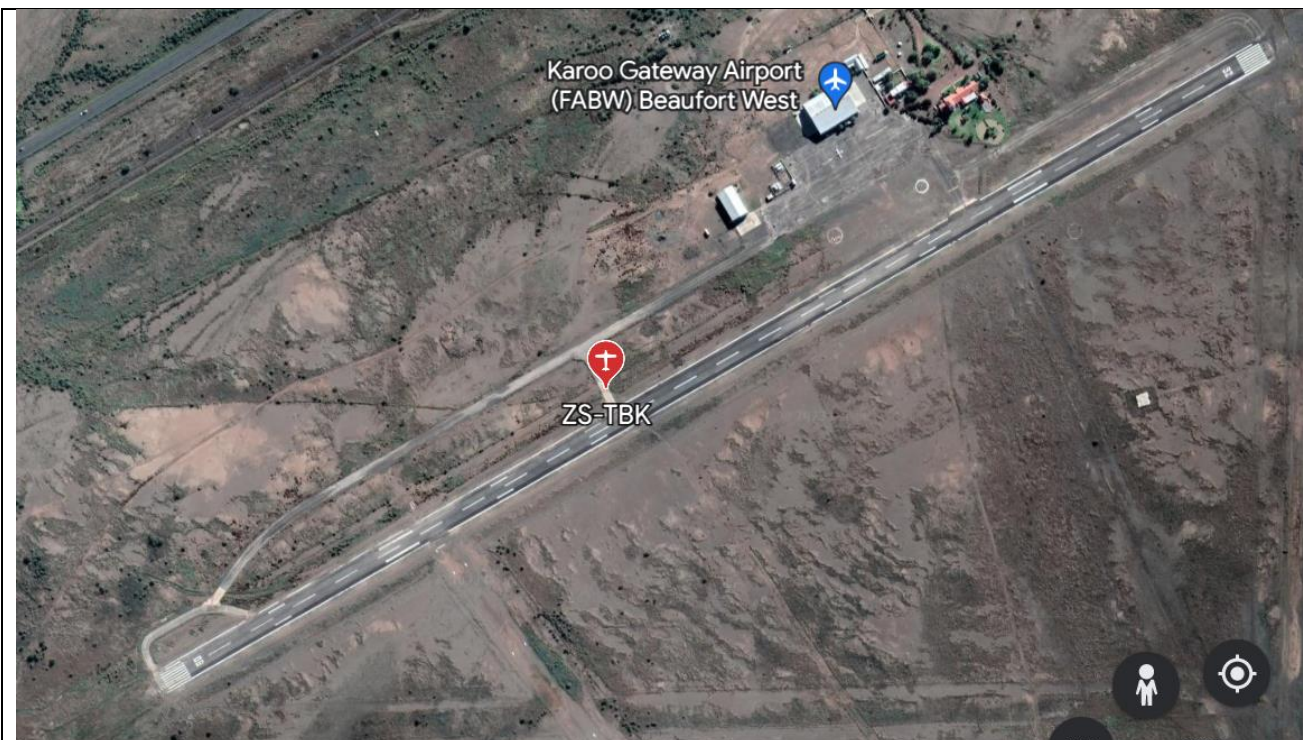
Figure 1: Aerial view of Beaufort West Aerodrome.

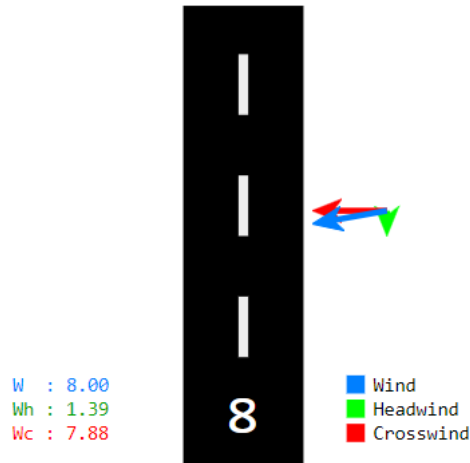
Wind Direction	160°	Wind Speed	08 kt	Visibility	10 km
Temperature	34°C	Cloud Cover	CAVOK	Cloud Base	CAVOK
Dew Point	15°C	QNH	1016 hPa

Figure 3: Weather conditions at time of the accident. (Source: Operator)
