LIMITED OCCURRENCE INVESTIGATION REPORT – FINAL

Reference Number	CA18/2/3/10229						
Classification	Accident	Date	15 October 2022		Time	0854Z	
Type of Operation	Aerial Surveillance (Part 101)						
Location							
Place of Departure	Anglo American Mogalakwena Mine in Limpopo Province		Place of Intended Landing		Anglo American Mogalakwena Mine in Limpopo Province		
Place of Occurrence	Anglo American Mogalakwena Platinum Mine						
GPS Co-ordinates	Latitude	25°58'49.03" S	Longitude	028°54'9.73" E	Elevation	4478 ft	
Aircraft Information							
Registration	ZT-XNE						
Make; Model; S/N	DJI MATRICE, 300 RTK (Serial Number: 1ZNBJ7B00C00GL)						
Damage to Aircraft	Substantial			Total Aircraft Hours	68.58		
Pilot-in-command							
Licence Type	RPL Multirotor		Gender	Male		Age	46
Licence Valid	Yes	Total Hours	20.0		Total Hours on Type	17.09	
Total Hours 30 days	07.39		Total Flying on Type Past 90 days		07.39		
People Controlling	1	Injuries	0	Fatalities	0	Other (on ground)	0

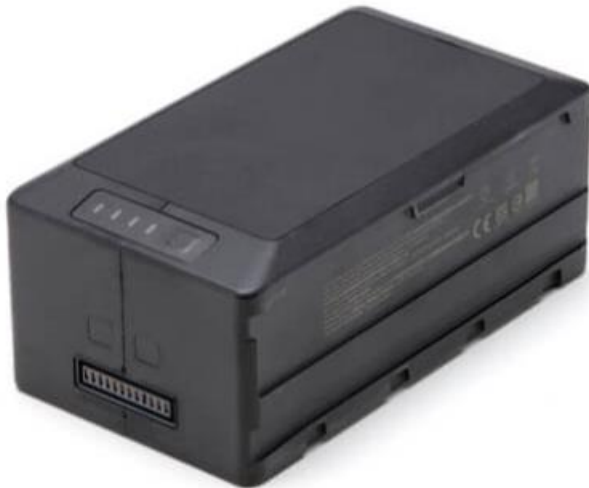
- Matrice 300 Series TB60 Intelligent Flight Battery (Source: DJI M300 Manual)

The TB60 intelligent flight battery has a capacity of 5.935 Milliamp hours (mAh). It supports the hot-swap function allowing to change the battery without powering off the drone, which saves time and ensures smooth flight operation during critical tasks. The battery allows Matrice 300 RTK to fly 55 minutes without load. (Source: <https://www.dji.com/>).

Never use damaged, leaking, or swollen batteries. In any of these cases, contact DJI or designated dealers.
