LIMITED OCCURRENCE INVESTIGATION REPORT – FINAL

Reference Number	CA18/2/3/10231						
Classification	Accident	Date	20 October 2022		Time	1208Z	
Type of Operation	Training (Part 141)						
Location							
Place of Departure	Virginia Aerodrome (FAVG), KwaZulu-Natal Province			Place of Intended Landing	Virginia Aerodrome (FAVG), KwaZulu-Natal Province		
Place of Occurrence	During landing on the left-side of Runway 05 at FAVG						
GPS Co-ordinates	Latitude	29° 46' 20.77" S	Longitude	031° 3' 26.19" E	Elevation	28 ft	
Aircraft Information							
Registration	ZS-IEI						
Make; Model; S/N	Piper Cherokee PA-28 -140; Piper Aircraft Corporation (Serial Number: 28-26628)						
Damage to Aircraft	Substantial			Total Aircraft Hours	11 527.83		
Pilot-in-command							
Licence Type	Student Pilot Licence		Gender	Male		Age	19
Licence Valid	Yes	Total Hours	30.7		Total Hours on Type	30.7	
Total Hours 30 Days	12.8		Total Flying on Type Past 90 Days	12.8			
People On-board	1+0	Injuries	0	Fatalities	0	Other (on ground)	0

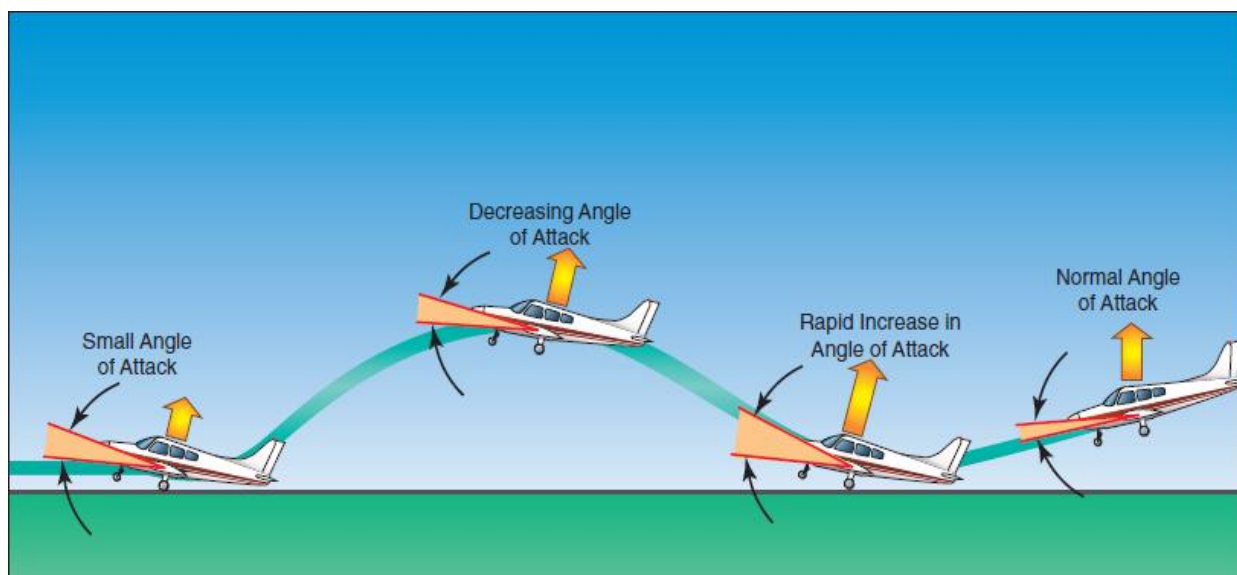
Illustration 1: The aircraft rebounds after touchdown.

The severity of the bounce depends on the airspeed at the moment of contact and the degree to which the angle of attack or pitch attitude was increased. Since a bounce occurs when the airplane makes contact with the ground before the proper touchdown attitude is attained, it is almost invariably accompanied by the application of excessive back-elevator pressure. This is usually the result of the pilot realizing too late that the airplane is not in the proper attitude and attempting to establish it just as the second touchdown occurs. The corrective action for a bounce is the same as for ballooning and similarly depends on its severity. When it is very slight and there is no extreme change in the airplane's pitch attitude, a follow-up landing may be executed by applying sufficient power to cushion the subsequent touchdown and smoothly adjusting the pitch to the proper touchdown attitude.
