LIMITED OCCURRENCE INVESTIGATION REPORT – FINAL
--

Reference Number	CA18/2/3/10239						
Classification	Accident	Date	3 December 2022		Time	0900Z	
Type of Operation	Skydiving (Part 96)						
Location							
Place of Departure	Skydive the Ranch Airfield, Mpumalanga Province		Place of Intended Landing	Wonderboom Aerodrome (FAWB), Gauteng Province			
Place of Occurrence	Skydive the Ranch Airfield, near Delmas Mpumalanga Province						
GPS Co-ordinates	Latitude	26° 02' 44.31" S	Longitude	028° 48' 18.39" E	Elevation	5015ft	
Aircraft Information							
Registration	ZS-WZP						
Make; Model; S/N	Atlas Angel AL-60C4M KUDU (Serial Number: 967)						
Damage to Aircraft	Substantial		Total Aircraft Hours	6443.1			
Pilot-in-command							
Licence Type	Private Pilot Licence (PPL)		Gender	Male		Age	40
Licence Valid	Yes	Total Hours	352		Total Hours on Type	4.8	
Total Hours 30 Days	11.5		Total Flying on Type Past 90 Days	4.8			
People On-board	1+9	Injuries	0	Fatalities	0	Other (on ground)	0

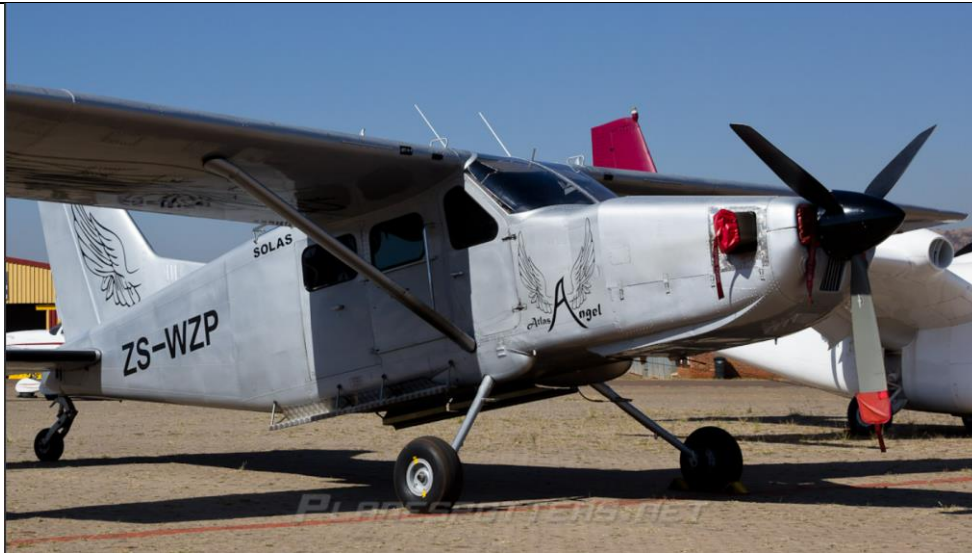
Figure 1: A file picture of the aircraft. (Source: <https://www.planespotters.net/photo/605043/zs-wzp-atlas-angel-lockheed-atlas-al-60c-4m-tp-angel-l-402>)
