AIRCRAFT ACCIDENT REPORT AND EXECUTIVE SUMMARY

Reference:	CA18/2/3/10246		
Aircraft Registration	ZU-PPA	Date of Accident	2 January 2023		Time of Accident	1615Z	
Type of Aircraft	Sling 4 TSi			Type of Operation	Private (Part 94)		
Pilot-in-command Licence Type	Private Pilot Licence		Age	47	Licence Valid	Yes	
Pilot-in-command Flying Experience	Total Flying Hours		6 881.6		Hours on Type	Unknown	
Last Point of Departure	Tedderfield Aerodrome (FATA), Gauteng Province						
Next Point of Intended Landing	Tedderfield Aerodrome (FATA), Gauteng Province						
Damage to Aircraft	Destroyed						
Location of the accident site with reference to easily defined geographical points (GPS readings if possible)							
Bass Lake near Henley on Klip (GPS position: 26°30'33.66" South 028°03'58.27" East, elevation 4 850 feet)							
Meteorological Information	Surface wind, 030°/1kt; temperature, 23°C; dew point, 11°C; CAVOK						
Number of People On-board	1 + 1	Number of People Injured	0	Number of People Killed	2	Other (On Ground)	0

Reference Number : CA18/2/3/10246
Occurrence Category : Accident (Category 1)
Type of Operation : Private (Part 94)
Name of Operator : Private Flight
Aircraft Registration

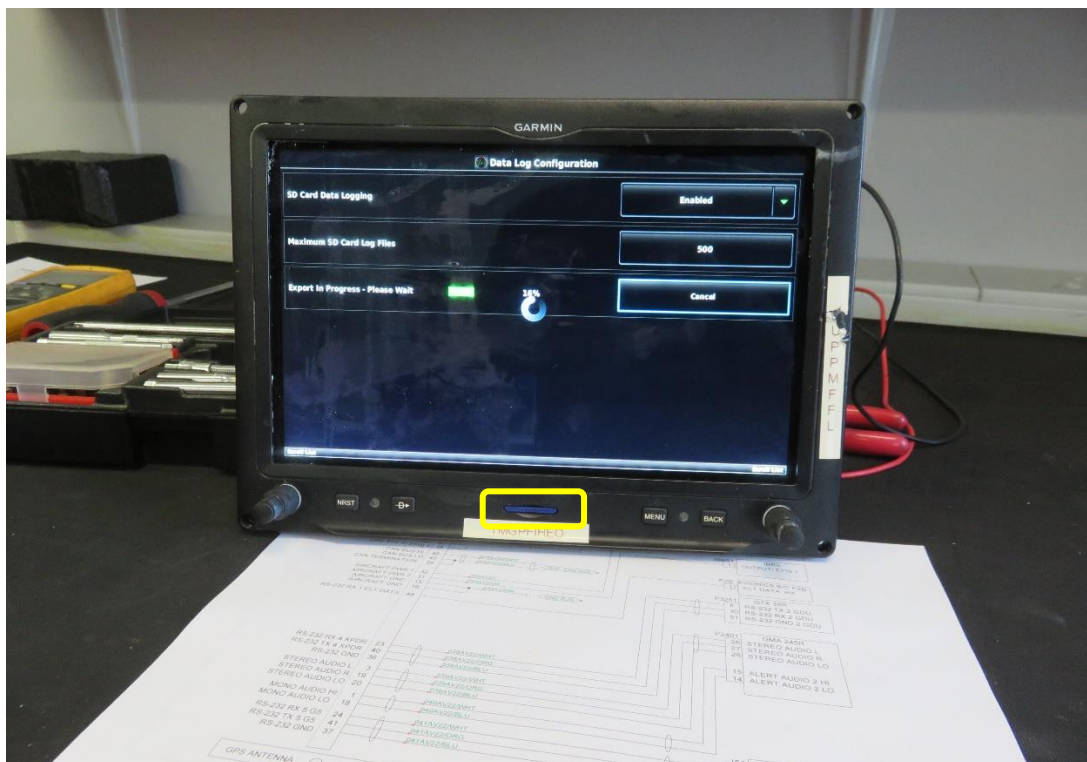
1.11.2 The aircraft was equipped with an on-board Garmin G3X Touch EFIS unit. The unit sustained impact damage; however, the memory device remained intact. The data card that was retrieved from the unit contained no data on the last four flights that were flown on the aircraft. The aircraft was also equipped with a Garmin G5 unit, but the device had no volatile memory that could be downloaded. Both units were taken to an approved Garmin approved avionics facility to assist with possible data retrieval. It was possible to retrieve data of the last four flights from the memory data device of the Garmin G3X unit. The picture below was taken during the process.

Figure 4: The Garmin G3X Touch EFIS unit with the data card installed (yellow window). This is the actual unit that was in the aircraft at the time of the accident flight.

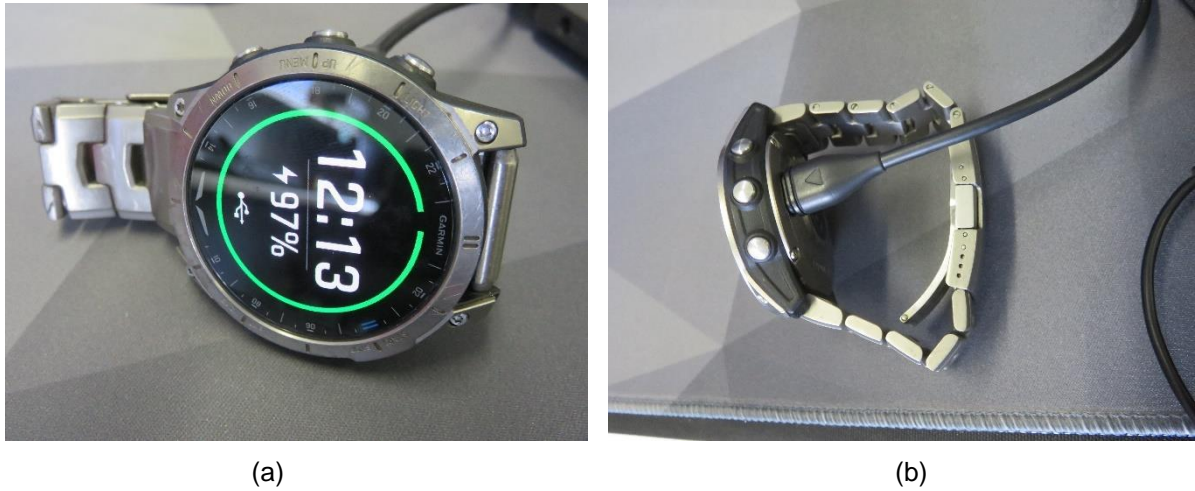
1.11.3 The pilot was wearing a Garmin D2 Mach 1 wristwatch, unit number 3415575589. The watch, which is water-resistant, was recovered and was made available to the investigator. The watch contained 15 Gigabytes (GB) of data, which included multiple flights inclusive of the

Figure 5: The wristwatch (a), and the download cable attached to it (b).

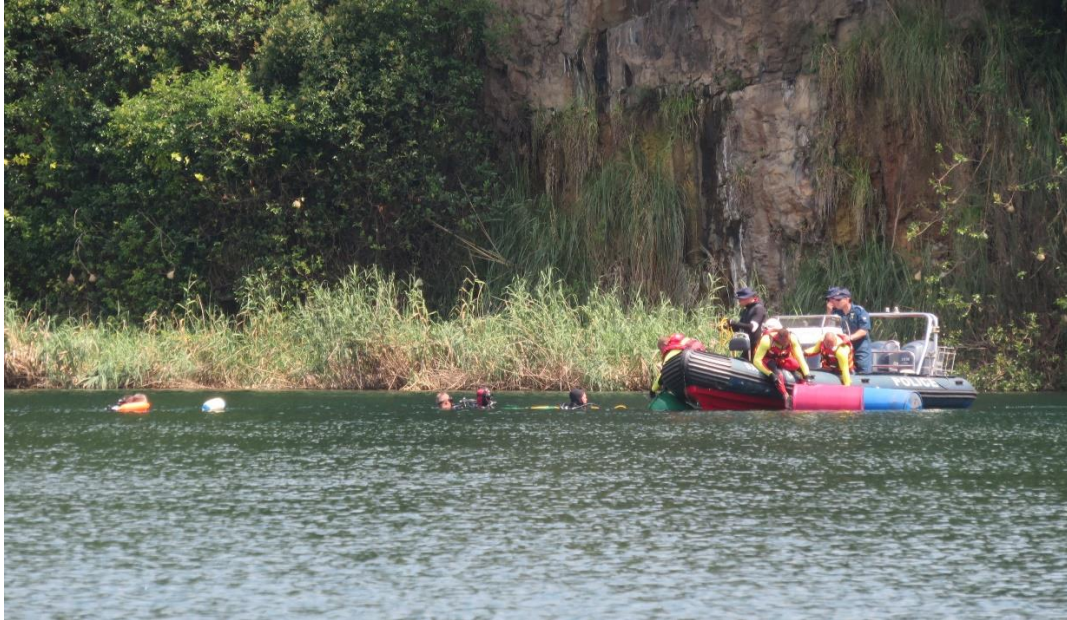
1.12.2 The wreckage was floated with the assistance of several divers and was slowly towed to the shore using a boat after it was lifted out of the lake with a mobile crane. Initial observations of the wreckage indicated severe deformation of the engine and nose section, as well as the right wing. The three propeller blades were severed near the spinner, indicative of an engine that was producing power on impact. The integrity of the aircraft was not compromised, and all the flight controls were accounted for.

Figure 7: Police boat with divers in the water during the recovery process.

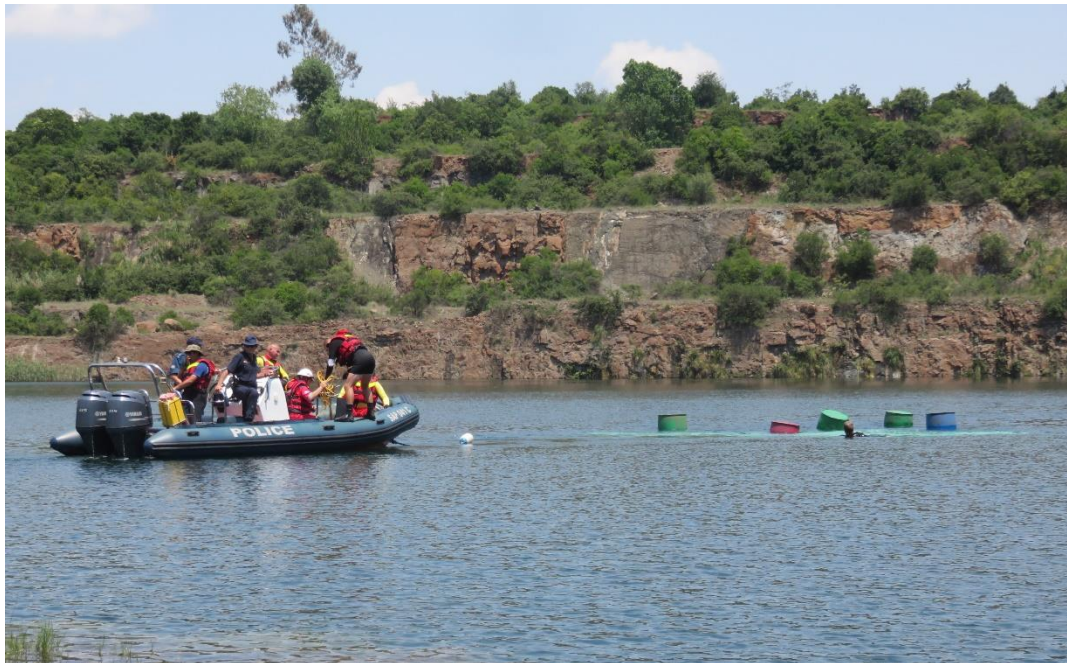
Figure 8: The police boat slowly tows the wreckage to shore.

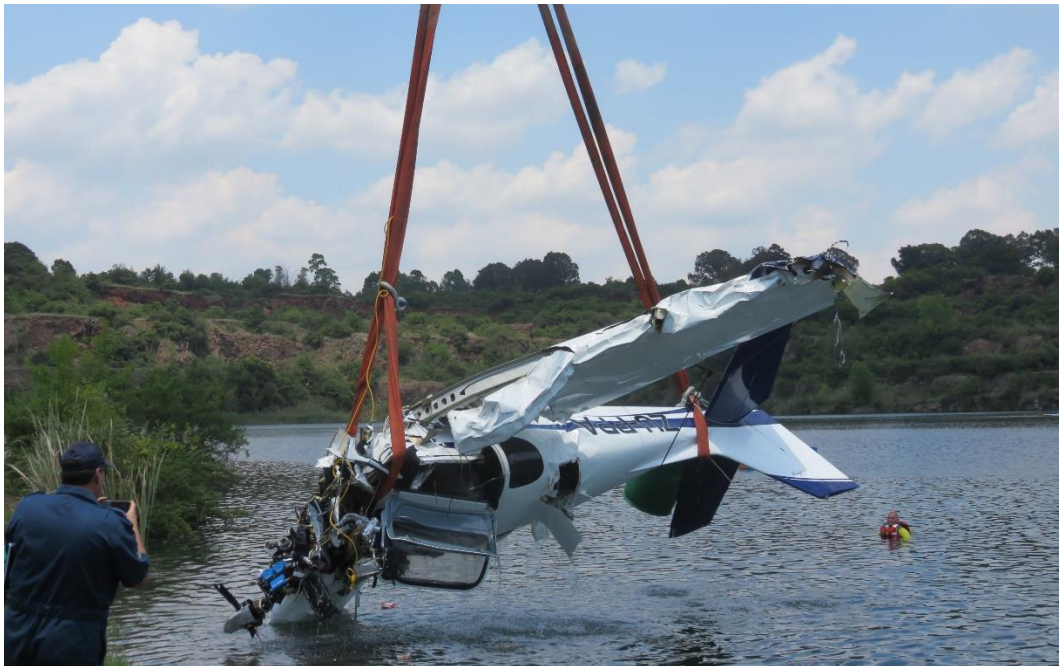
Figure 9: The mobile crane lifts the wreckage out of the water.
