AIRCRAFT ACCIDENT REPORT AND EXECUTIVE SUMMARY

Reference:		CA18/2/3/10248			
Aircraft Registration	ZS-EAW	Date of Accident	15 January 2023	Time of Accident	0605Z		
Type of Aircraft	Piper PA-30-160 Twin Comanche		Type of Operation	Training (Part 141)			
Pilot-in-command Licence Type	Commercial Pilot Licence (CPL) Aeroplane		Age	28	Licence Valid Yes		
Pilot-in-command Flying Experience	Total Flying Hours	539.4	Hours on Type	55.0			
Last Point of Departure	Grand Central (FAGC) Aerodrome, Gauteng Province						
Next Point of Intended Landing	Grand Central (FAGC) Aerodrome, Gauteng Province						
Damage to Aircraft	Destroyed						
Location of the accident site with reference to easily defined geographical points (GPS readings if possible)							
Crown Mines dump site near National Recreation Centre (NASREC) at Global Positioning System (GPS) co-ordinates determined to be 26°14'05.5" South 027°58'24.0" East, at an elevation of 5600 feet (ft)

Reference Number : CA18/2/3/10248
Occurrence Category : Category 1
Type of Operation : Training (Part 141)
Name of Operator : Flight Training Services (FTS)
Aircraft Registration : ZS-EAW
Aircraft Make and Model : Piper PA-30-160 Twin Comanche
Nati

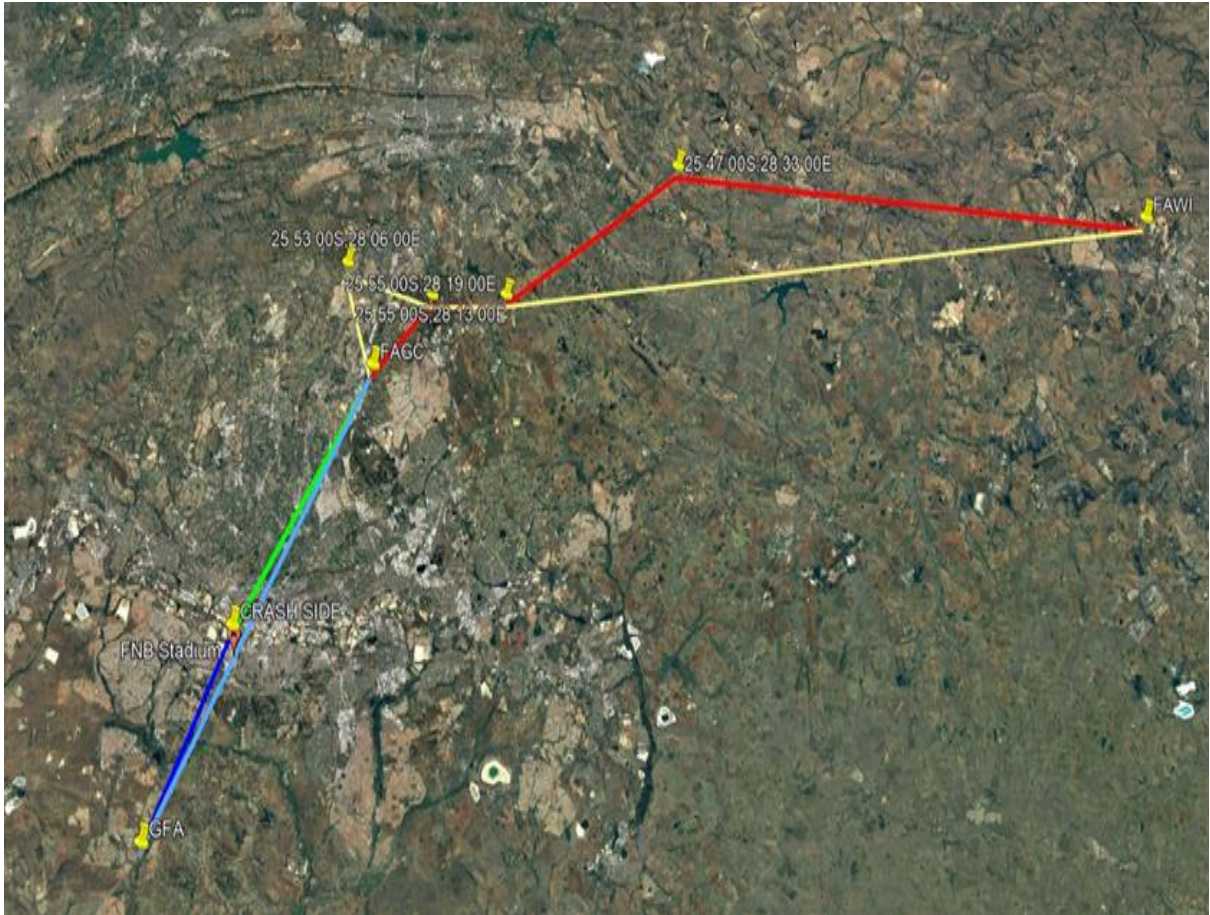
Figure 1: The red line indicates the filed flight path (departure path), the yellow line indicates the filed return path, the green line indicates the actual path flown from FAGC to the crash site, the dark blue line indicates the remaining path from the crash site to the GFA, and the light blue line indicates the direct route from FAGC to the GFA. (Source: Google Earth)

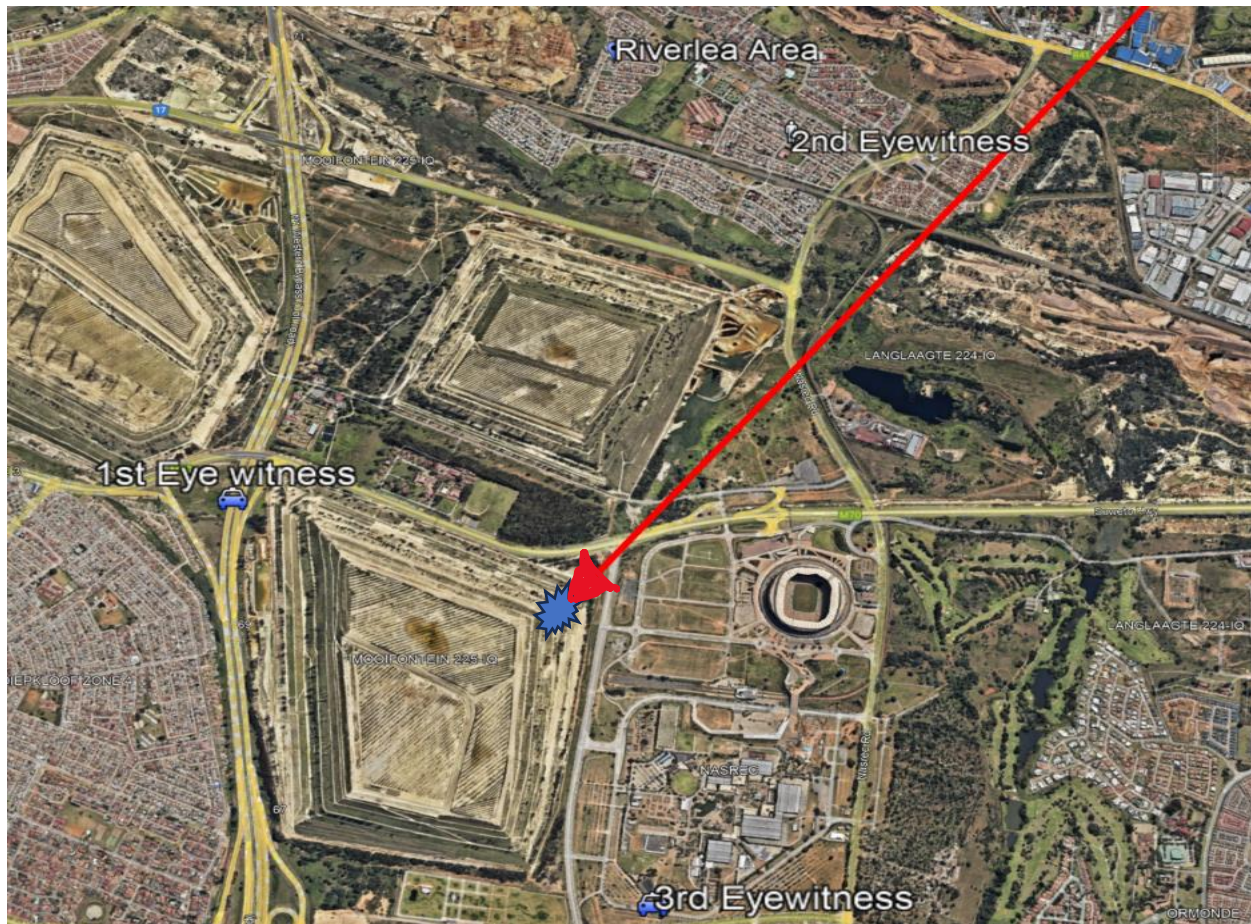
Figure 2: The arrow indicates the direction of flight, the position of the witnesses and the crash site. (Source: Google Earth)
